St. Sylvesters Church, Chivelstone

Survey of the plaster and wall decoration

October 2019

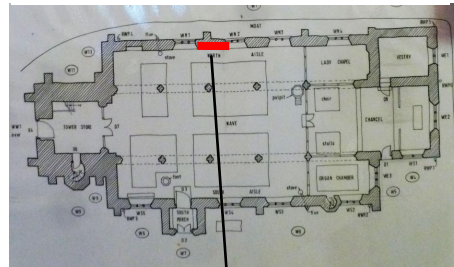
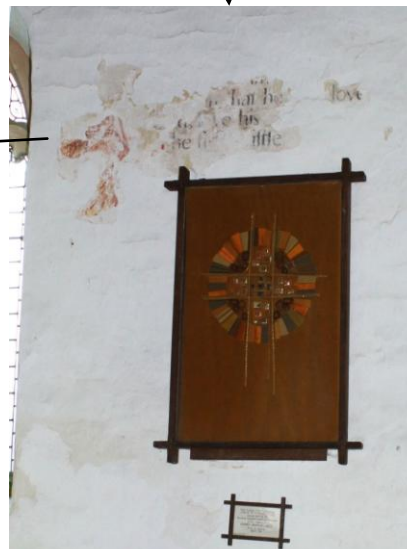
Figs 3 & 4.

Details of the ornate border painted largely in red and yellow ochres and the cursive style text. The letters measure approximately 4 - 7 cm in height which makes them extremely legible from the floor.

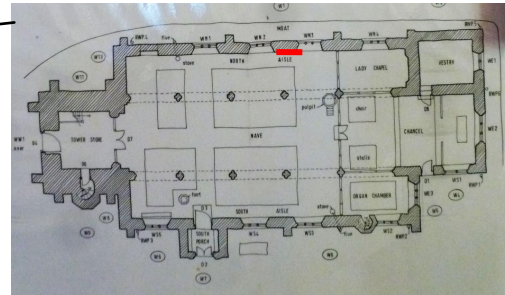
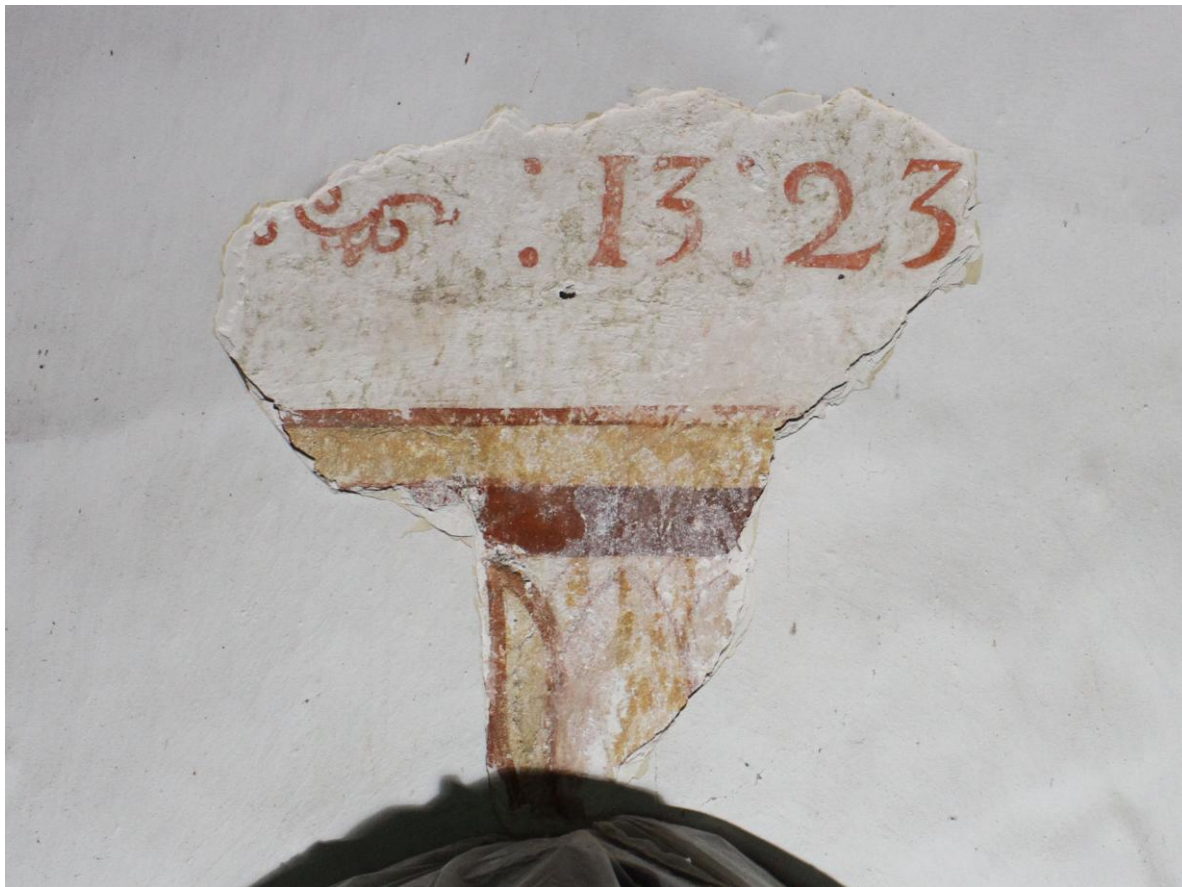
Figs 6 & 7.

Details showing an area of text panel that was revealed. This is a rectangular panel. The lettering uncovered so far is in remarkably good condition

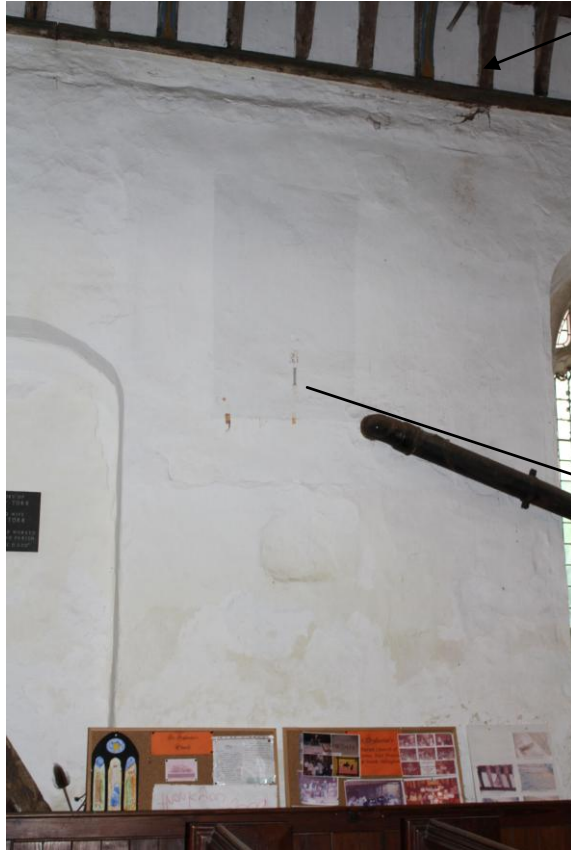
Fig 9.

Text panel at the west end of the north wall. This panel has been previously uncovered and was only relatively recently painted over. A stove pipe was inserted into the wall in the 19th century

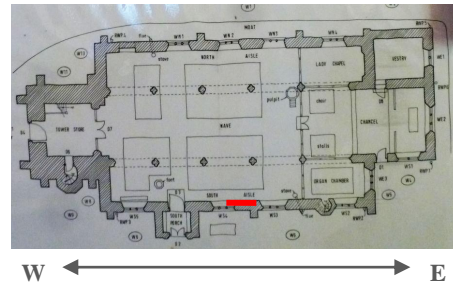
Fig 12

Oval text panel partially uncovered on the south wall.

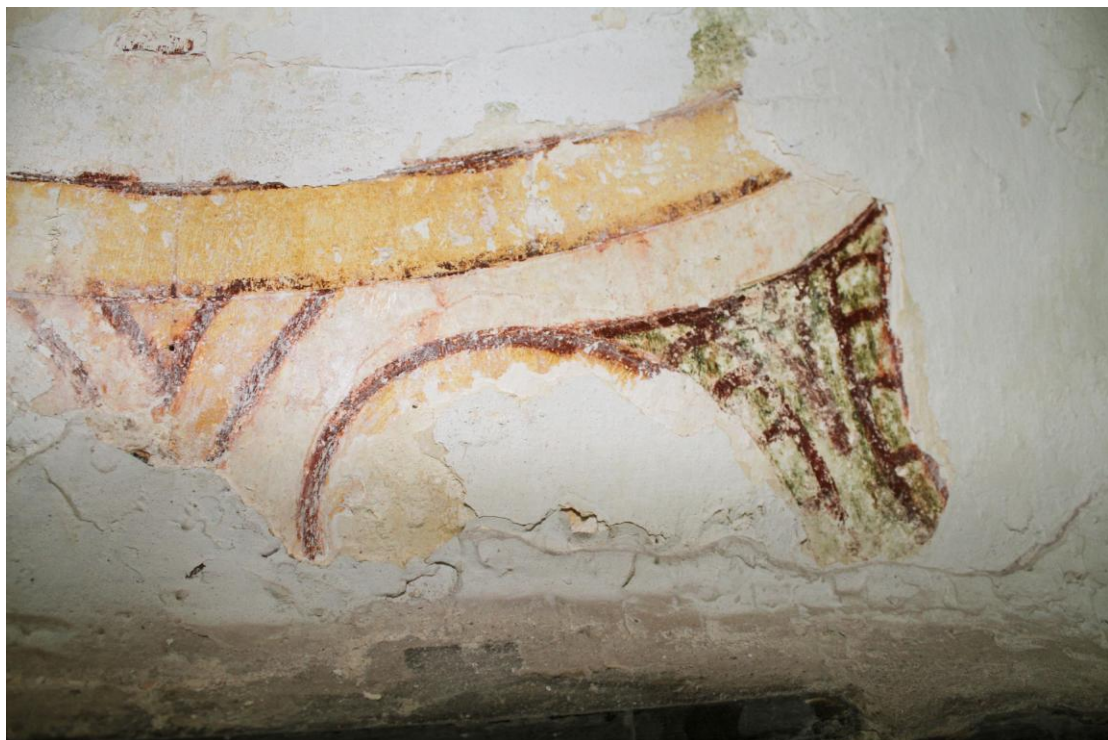
Fig 13.

Detail showing the dark red outlines with yellow ochre and organic green glazes used for the coloured decoration.

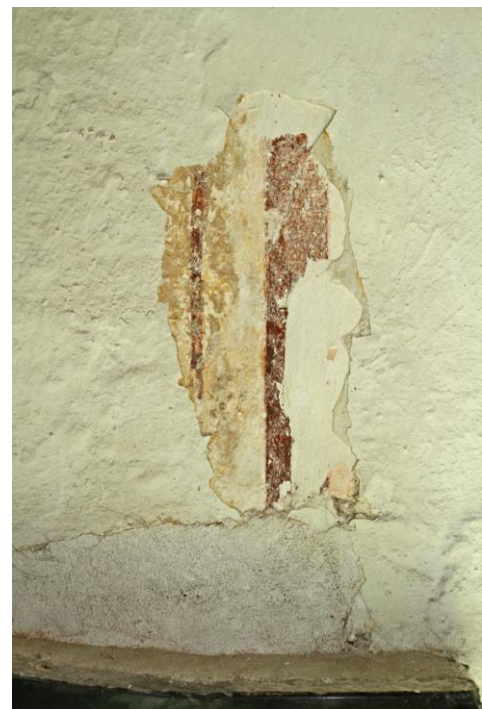
Fig 17.

Detail of letter which has been covered with a thick brown sealant.

The text panel partially uncovered at the east end of the south wall has been covered with a hard thick brown layer, thought to be a sealant applied when the walls were partly re-plastered. Removal of this layer is possible but it significantly slows down the uncovering process.

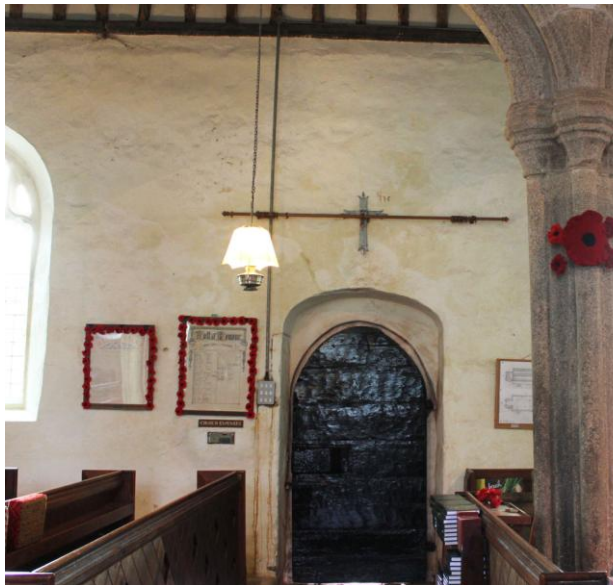
Fig 19.

Text over the south door. A tie beam was inserted in this wall in 2013. The fragments below were recovered during this process.

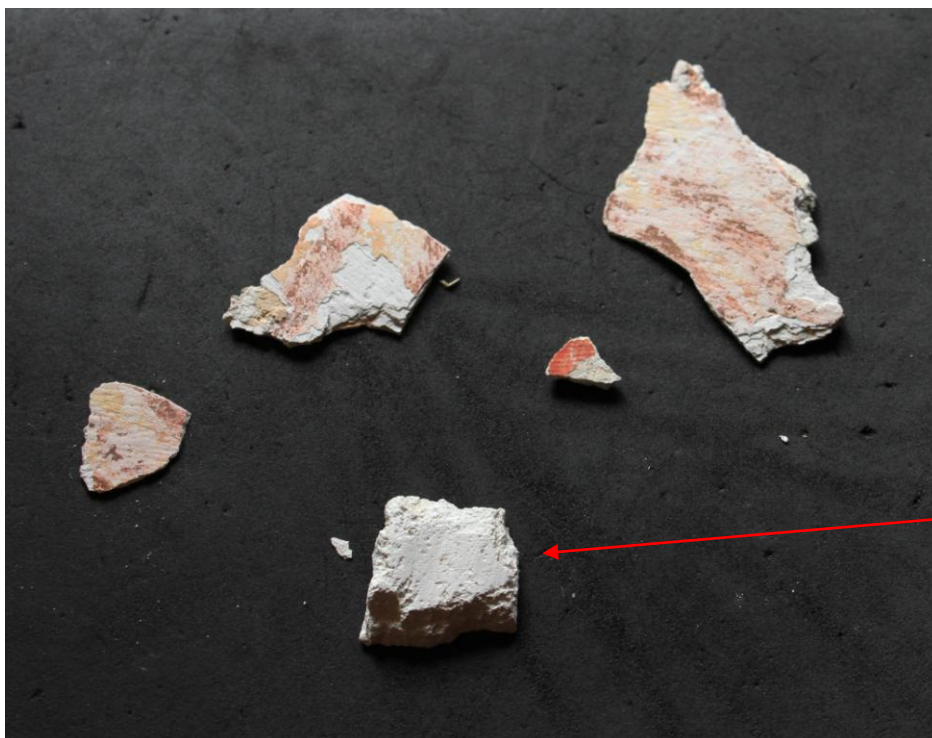
Fig 21

Fragments of an 18th century text panel, recovered when the tie beam was inserted.

Detail of the back of the fragment, showing the upper plaster layer which contains gypsum.

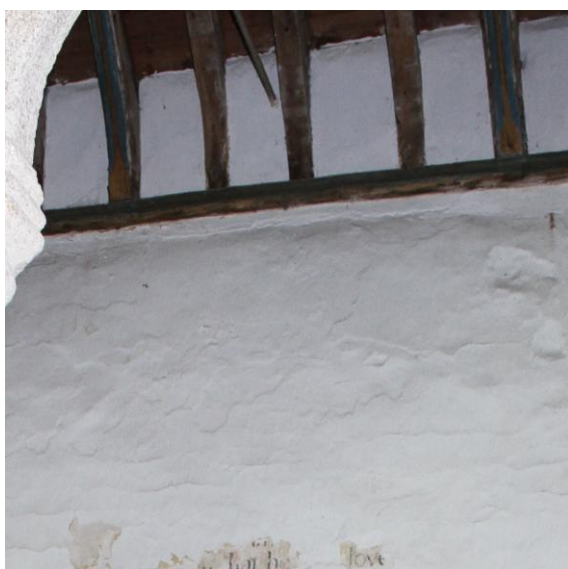
Fig 22.

Detail showing the later plaster at the top of the north wall

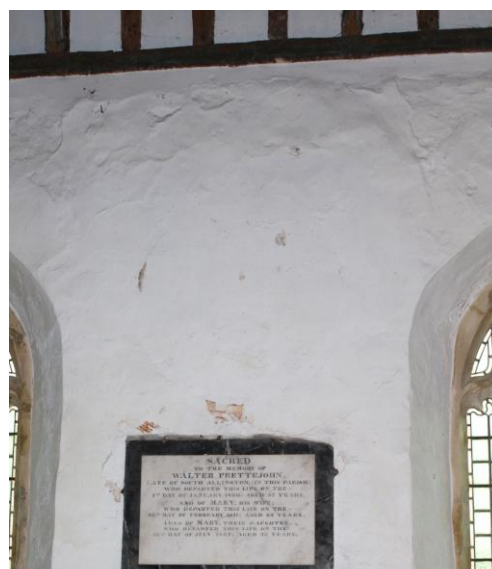
Fig 23

Detail showing the later plaster at the top of the south wall

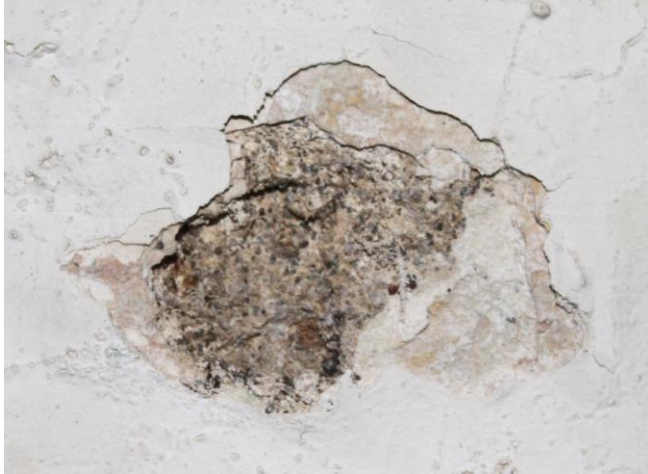
Fig 24

The first layer of plaster is a coarse coat, consisting of lime and largely black silica which is poorly bound. The silica content is extremely high creating a weak mortar. In a number of areas on the south wall it can be seen to have completely lost cohesion creating large voids behind the wall paintings. The upper coat of plaster consists of a lime and gypsum mix and is relatively hard. The addition of gypsum to plasters is a practice that started in the 18th century. In many areas it is this layer which is supporting the painting and retaining the level wall surface. It is not unusual to find a weak coarse coat supporting a wall painting. (a very similar situation was found in Newton St Cyres). This may be due in part to availability of suitable sand.

Detail showing the coarse coat of plaster which is very high in aggregate.

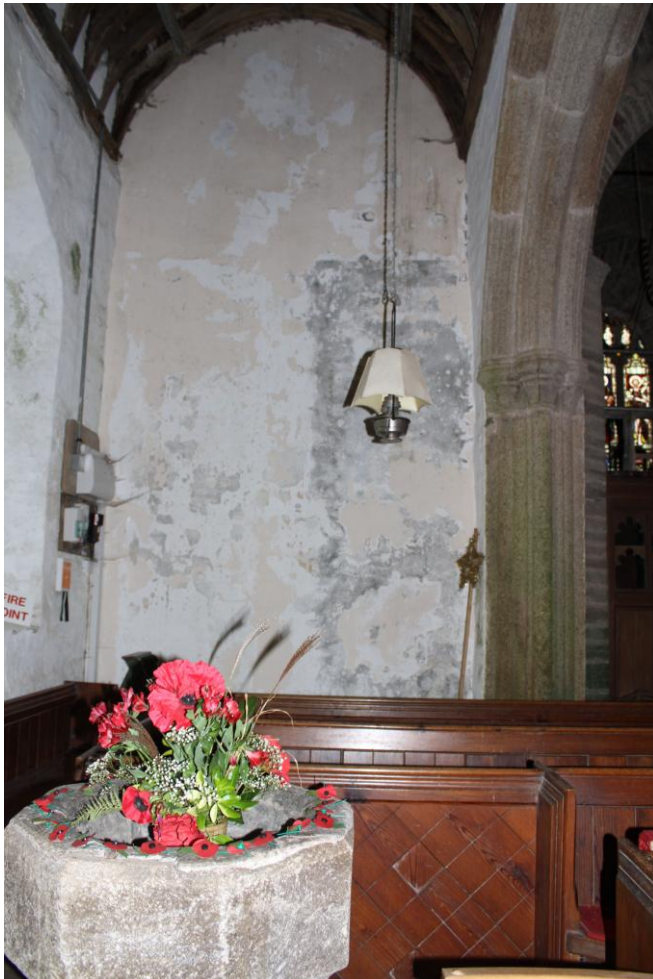
Fig 25

View of the west wall of the south aisle which has been re-plastered with a cement based mortar.

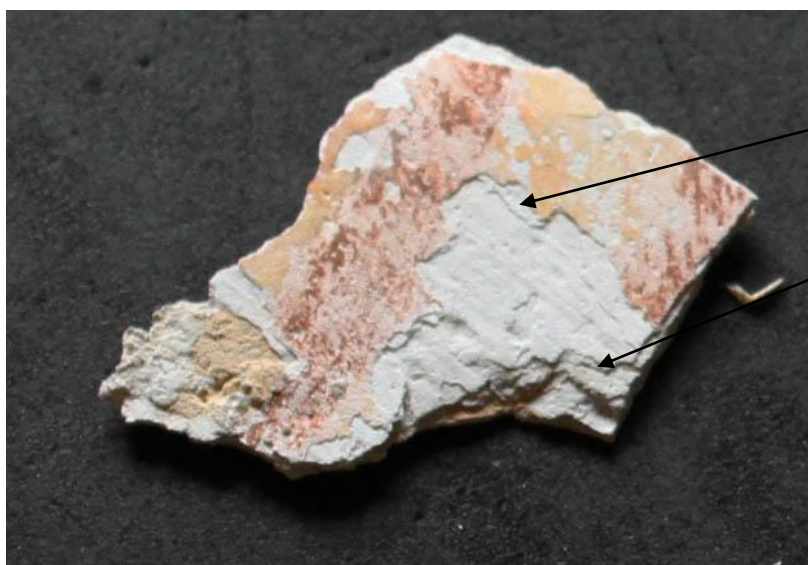
Fig 26

Detail of the fragment from over the south door showing the earlier limewash and lime and gypsum plaster layer.

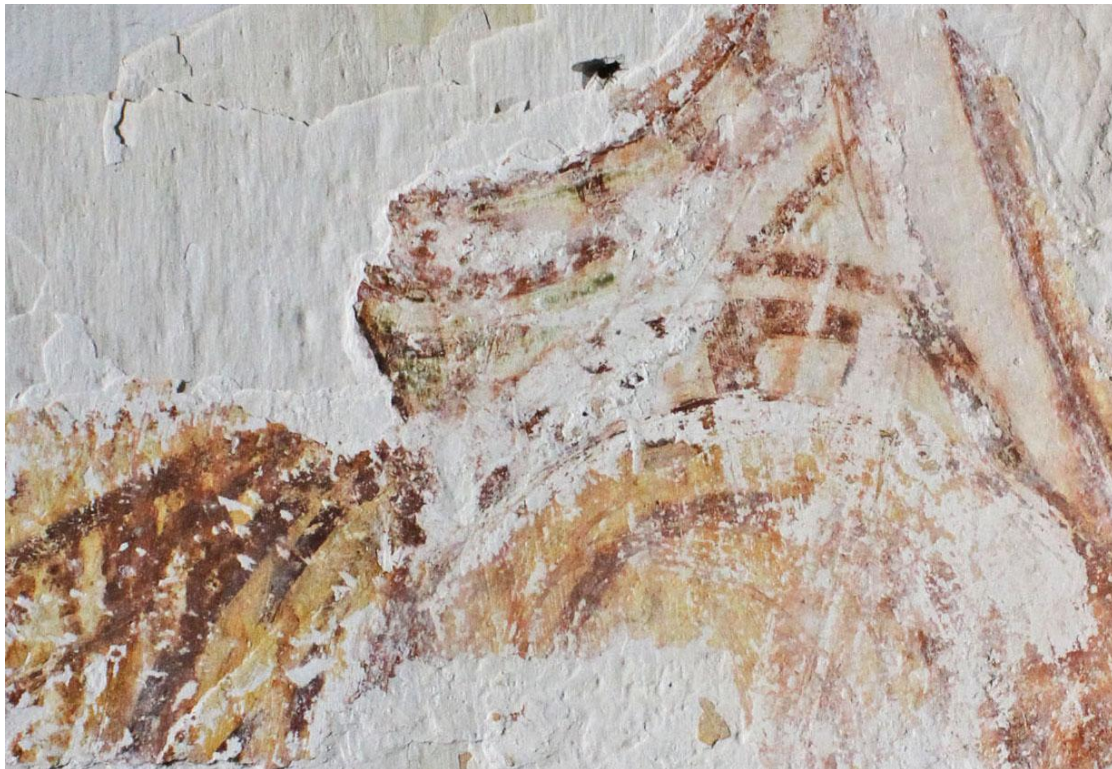
Fig 27.

Detail of the decorative border on the north wall showing the build up of overlying limewash layers.

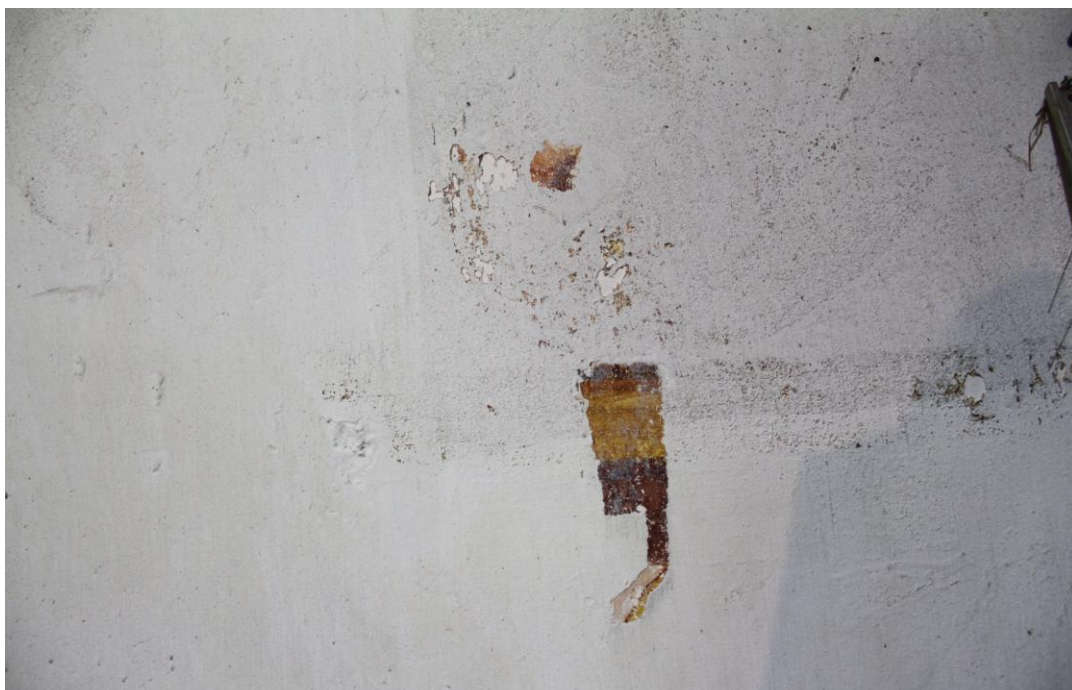
Fig 28.

Detail of the border of the text partially uncovered at the west end of the north wall. Note the area that has been previously exposed and then repainted with the modern paint finish.

In areas where it has been previously uncovered and then repainted over there is some loss of the surface layer.

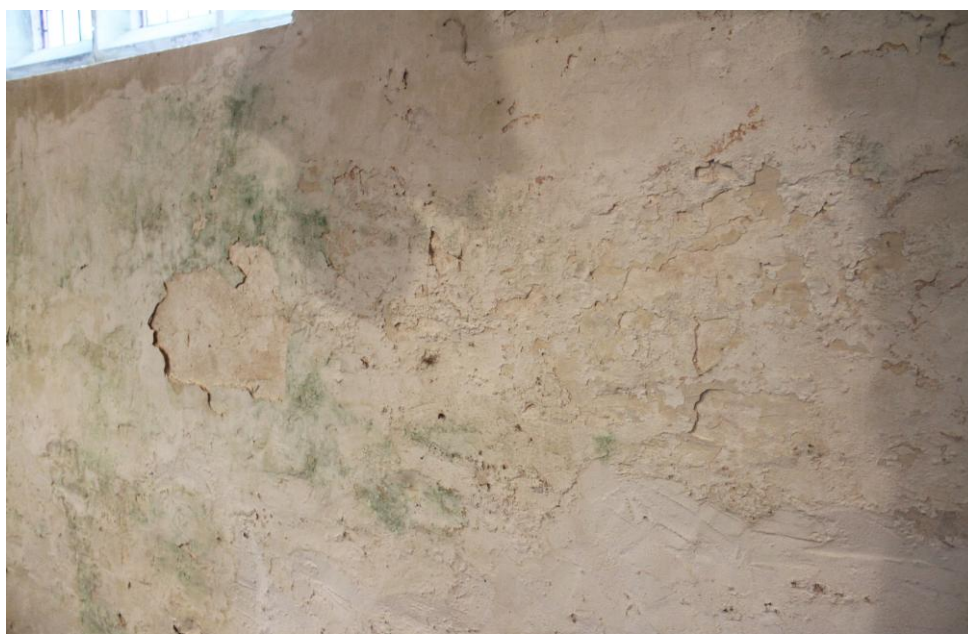
Fig 31.

The lower section of the north wall has clearly suffered from the long-term affects of moisture ingress with the loss of plaster and limewash layers. There are a number of later repairs. A calcite crust is visible in some areas indicating that there has been considerable amount of moisture carrying the calcium to the surface. This failure is associated with high ground levels on the exterior which have recently been rectified with the insertion of a French Drain. The plaster higher up the wall is also suffering from a loss of cohesion and significant voids were noted behind the wall paintings. These failures are thought to be associated with historic failure of pointing and rainwater goods.

Lower north wall of the nave showing deterioration of the plaster and evidence of microbiological growth

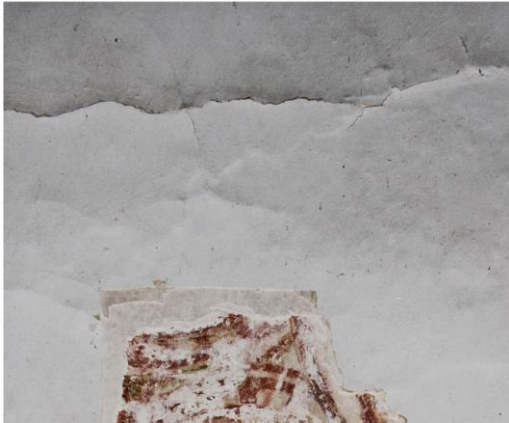
**Fig 32**

There is considerable detachment of the limewash layers on the north wall, particularly in the central area. On examination most of the detachment is occurring between the earlier and later layers. The most recent modern paint layer is much stronger and more impermeable than the layers beneath and this has probably exacerbated the problem trapping the moisture within the wall and causing the weaker layers to pull away from the wall. Fortunately the separation appears to be occurring between the limewash and the 18th century decorative scheme beneath which is relatively stable in the areas examined.

Detail showing the detachment of the later paint layers on the north wall

8.1a *Removal of the later limewash layers partially detached from the surface*

This work involves the painstaking removal of the later limewash layers using a combination of scalpels and fine spatulas with the aid of a magnified head lens. As the overlying limewash layers are removed care is taken to ensure that these later layers do not themselves support text schemes.

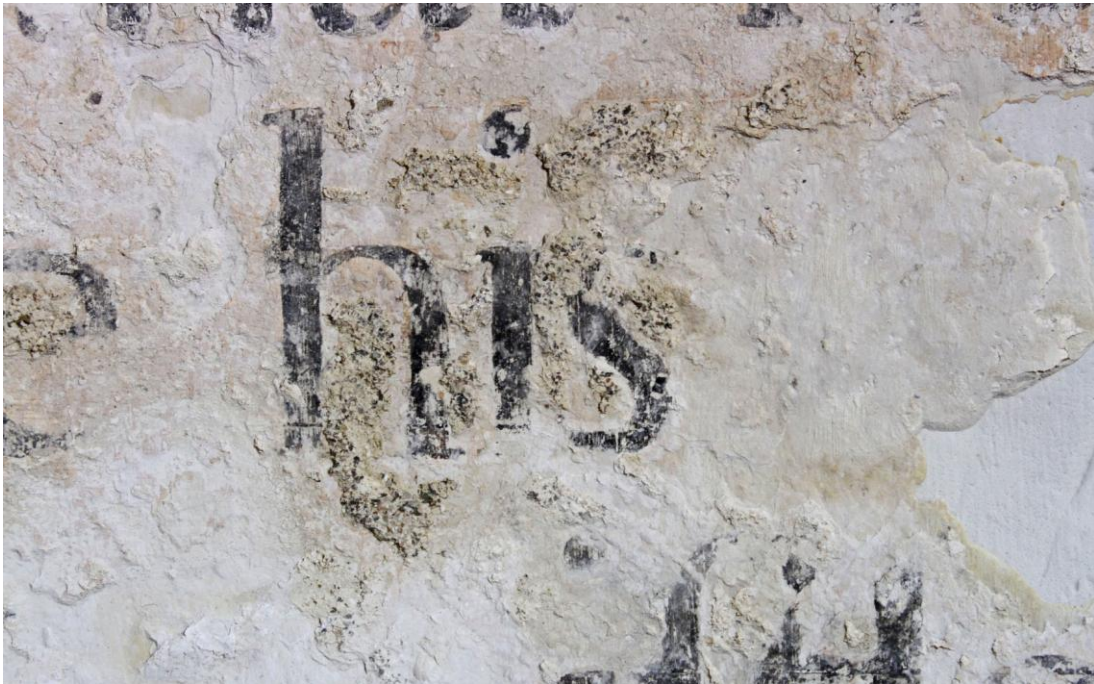
**Fig 33**

The condition of the painted decoration is variable. From the small windows of painted decoration that have been exposed it is clear that there is some loss of cohesion of the painted decoration which is powdering. This is particularly the case in areas where the plaster has lost cohesion on the north wall. However, in other adjacent areas it has also been found to be remarkably stable

Detail from the north wall where the first coat of plaster has lost cohesion in some areas leading to the deterioration of the painted surface.

8.1c *Consolidation of the plaster support.*

Areas of crumbling and powdering plaster that have lost cohesion can be consolidated using Syton X30 (colloidal silica) or Calosil Nanolime³. This can be injected into exposed edges or applied to the surface through Japanese tissue as appropriate.

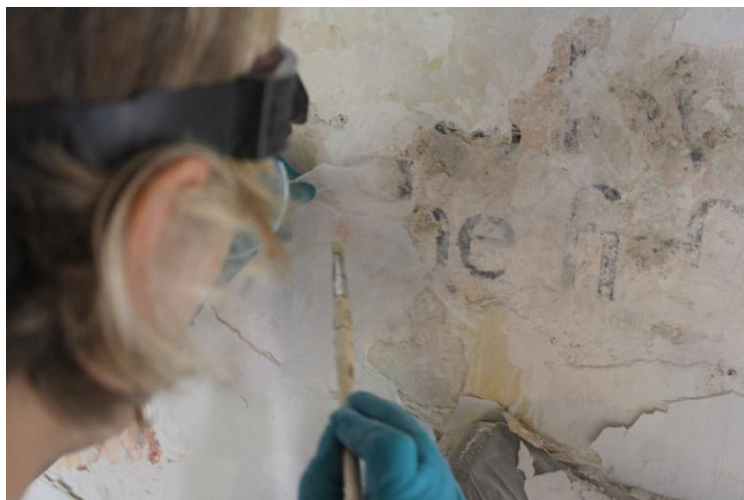
Fig 33.

Detail showing emergency treatment being carried out during the uncovering process. An acrylic dispersion B60a is being applied to areas of the lettering that have lost cohesion. The dispersion is applied with a brush through Japanese tissue.

In some areas it was necessary to undertake emergency consolidation of the paint and plaster layer where the plaster had lost cohesion. In these areas the plaster was consolidated using a 5% solution of Syton X30 (water based colloidal silica) applied to the surface with a brush through Japanese Tissue.

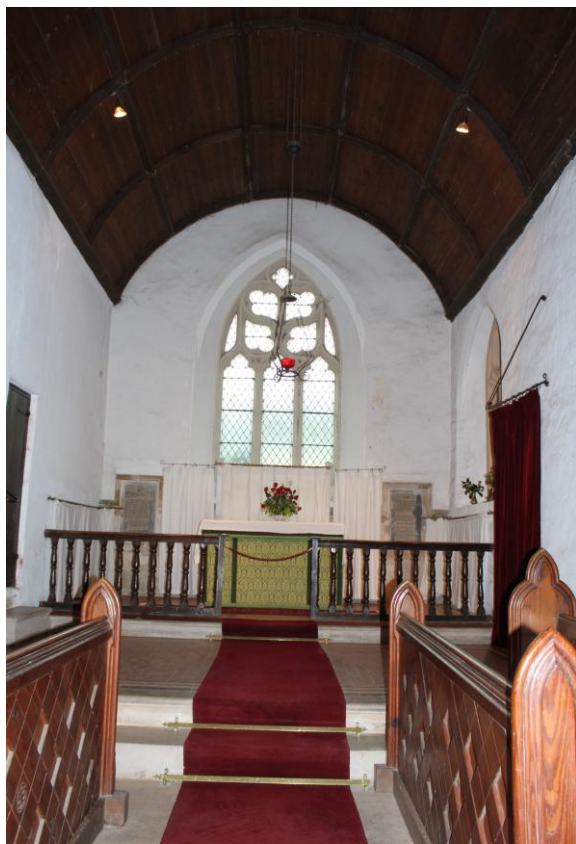
Fig 34.

Chancel looking east. These walls have largely been re-plastered. No evidence of earlier decorative schemes was found.

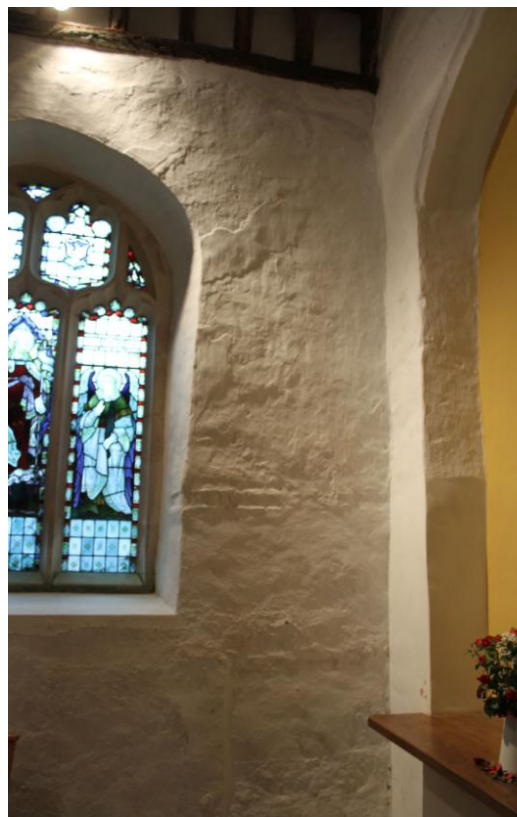
Figs 35.

North chapel – north wall. This wall has a patchwork of later repairs.

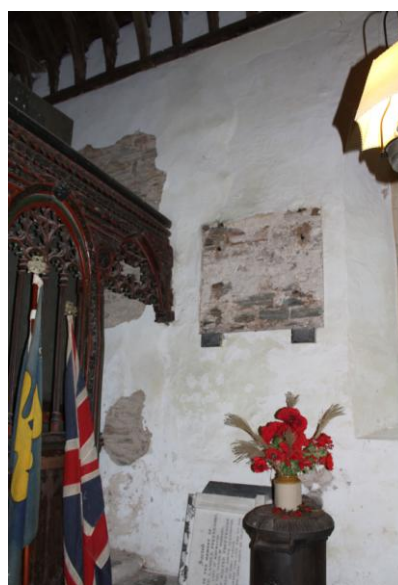
Fig 37

The fall of the monument on the south wall indicates that there are likely to be further failures of iron cramps in other monuments caused by the long-term high moisture levels within the wall. The monument in the same position on the north wall opposite is also in a precarious condition and the church are currently looking into the possibility of having it repaired.

East end of the south wall showing the area where the monument fell off the wall. This has now been repaired.

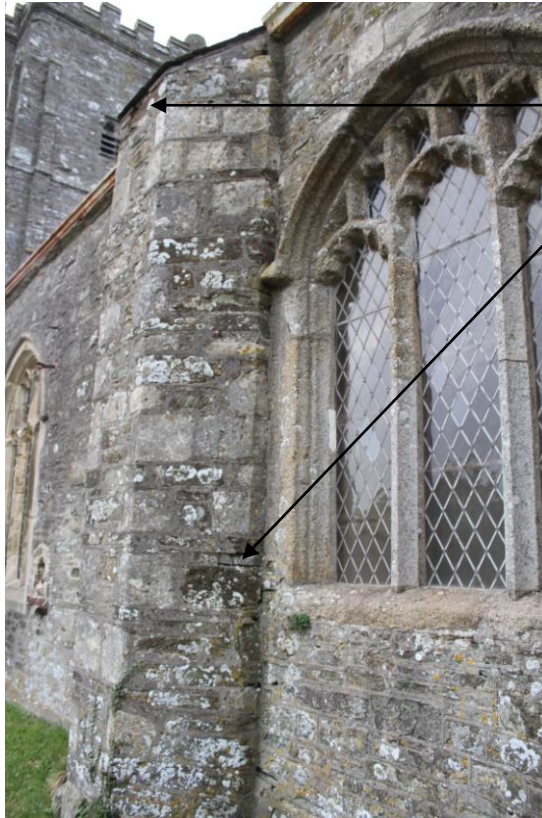
Fig 37.

Detail showing the rood stair tower, which has a number of failed mortar joints.
