ST SYLVESTER'S CHURCH ~ CHIVELSTONE

PARCLOSE SCREENS, ROOD SCREEN  
& DECORATIVE ROOF TIMBERS

CONDITION ASSESSMENT &  
CONSERVATION RECOMMENDATIONS

JUNE 2019

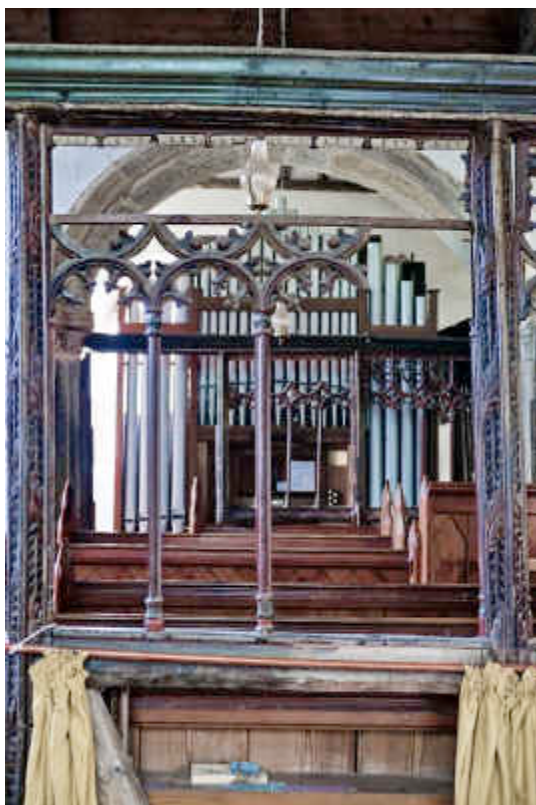
*Figure 14 ~ North elevation of parclose screen between chancel and Lady Chapel to the north, showing upper section (right) with carved tracery and lower section (above) with missing timber panels.*

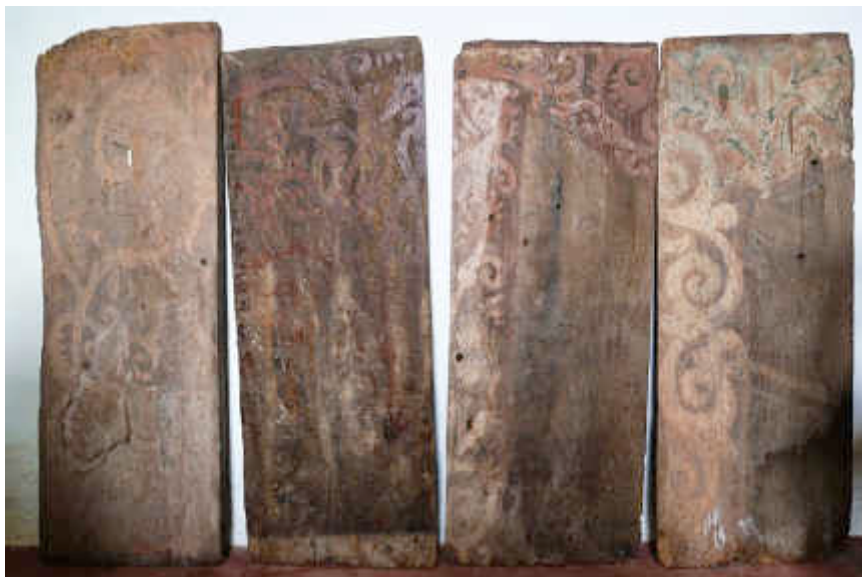
*Figure 17 ~ Detached lower panels stored in Vestry and assumed to be from Parclose Screen.*

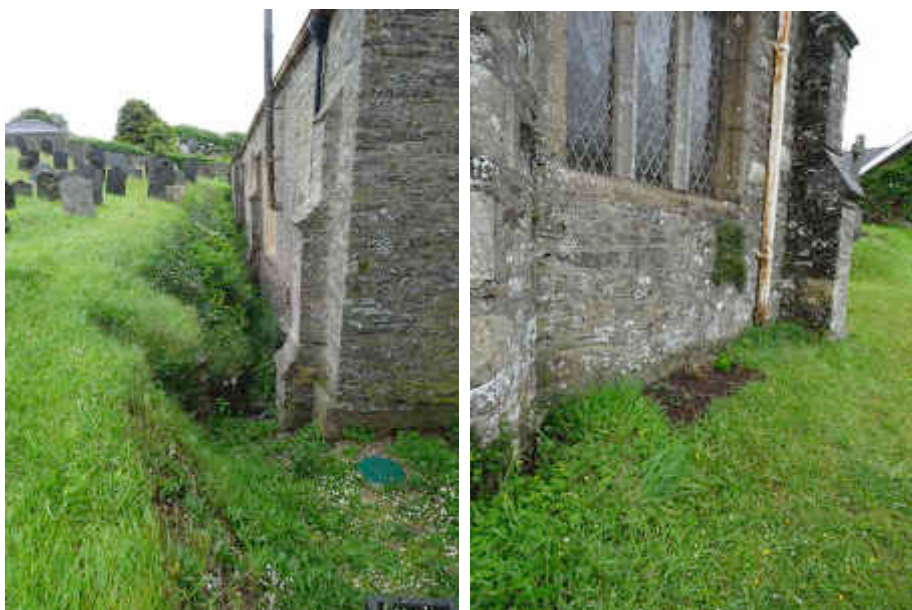
*Figure 32 ~ Over grown vegetation around the perimeter of the building, north (left) and south (right).*

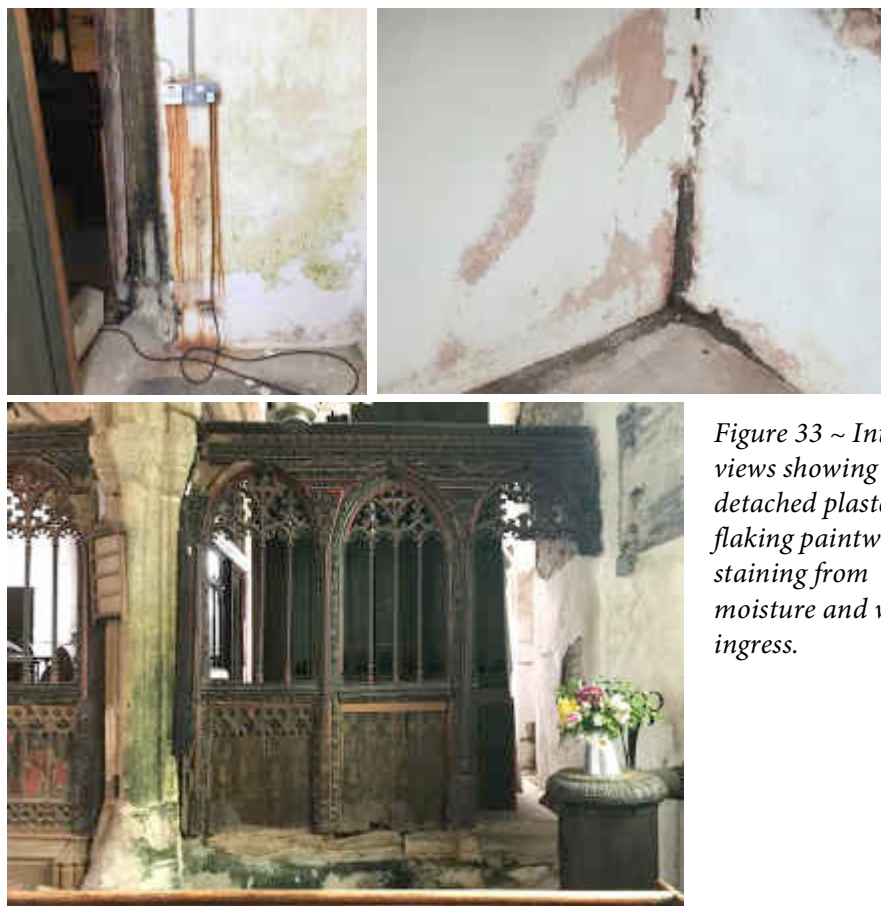
The condition of the building envelope has an impact on the interior fixtures and furnishings. The internal body of the church is damp. Intermittent heating is provided by means of a portable heater<sup>1</sup> that is only used prior to services and under pew heaters. Successive Quinquennial Reports have highlighted a number of issues associated with the church's cementitious pointing and render. This will inevitably encourage the retention of moisture within the walls and the internal plaster is failing as a result of the underlying damp. Other associated issues highlighted in the past have included the on-going maintenance and repair of rainwater goods such as downpipes and lead valley gutters as well as the overgrown vegetation around the perimeter of the church.

At the time of inspection damp and water ingress were an on-going issue. It should be noted that, even when aggravating causes are resolved it can still take time for the fabric of the building to attain a satisfactory equilibrium. A damp environment and fluctuating temperatures are detrimental to all the timber features examined as part of this investigation; it is a continual problem and contributes to among other things, insect infestation, dry rot and corrosion of iron fixings.

*Figure 33 ~ Internal views showing algae, detached plasterwork, flaking paintwork and staining from moisture and water ingress.*

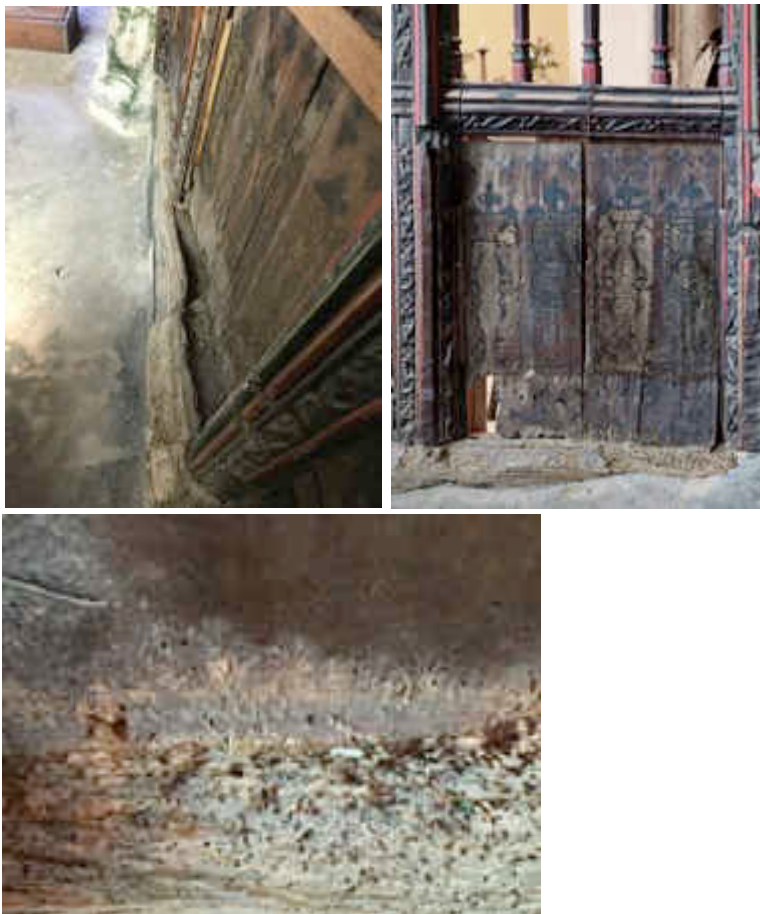
Historic deathwatch beetle *Xestobium Rufovillosum* decay on the rood screen is widespread. The infestation has caused carved details of the timber mouldings to be lost and compromised the structural integrity of the whole screen. The surface of the timber has broken down and dusting was apparent across these areas. The most severely affected areas are low level, on all the cills, particularly the south section of the screen.

It is difficult to establish if the deathwatch beetle infestation is on-going from the inspection. The decay observed did not appear recent. Confirmation can only be ascertained by further observation and the placement of dust/frass traps after de-dusting or hoovering. We would suggest continued monitoring in late spring and early autumn to look for any new activity and if found, or suspected the advice of the church architect should be obtained as to appropriate action to take.

*Figure 35 ~ Evidence of insect damage was observed across the timber screen.*

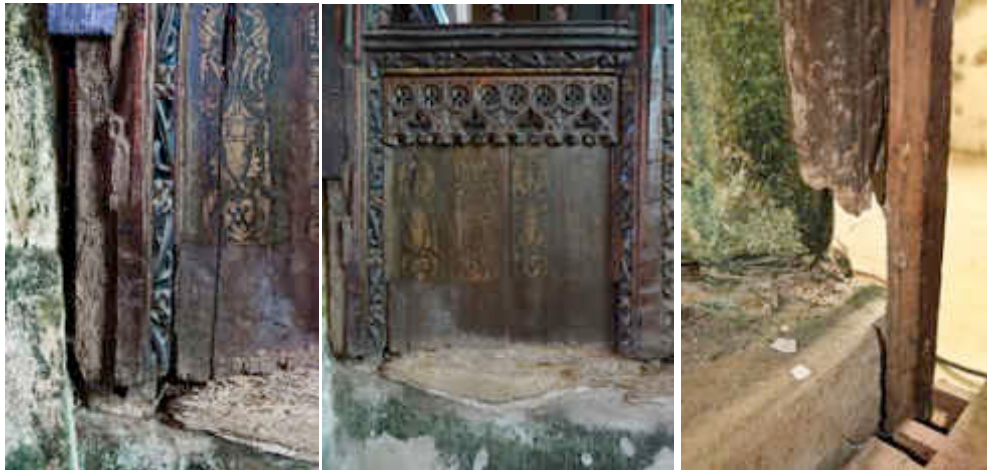
The main vertical posts are decayed and structurally unsound. Various iron straps and interventions have been added over the years to offer support, however these too are failing or have failed.

Across all the screens, though particularly apparent on the aisle sections of the rood screen, joints have opened, the panels, tracery and other carved elements are cracked, worn, decayed and in several areas missing, thus making adjacent elements more vulnerable to loss and further damage. Panels are thin and in places they are splitting and have dropped or are lifting away from the support structure.

*Figure 36 ~ Details showing various areas of losses and vulnerable sections observed across the rood screen.*

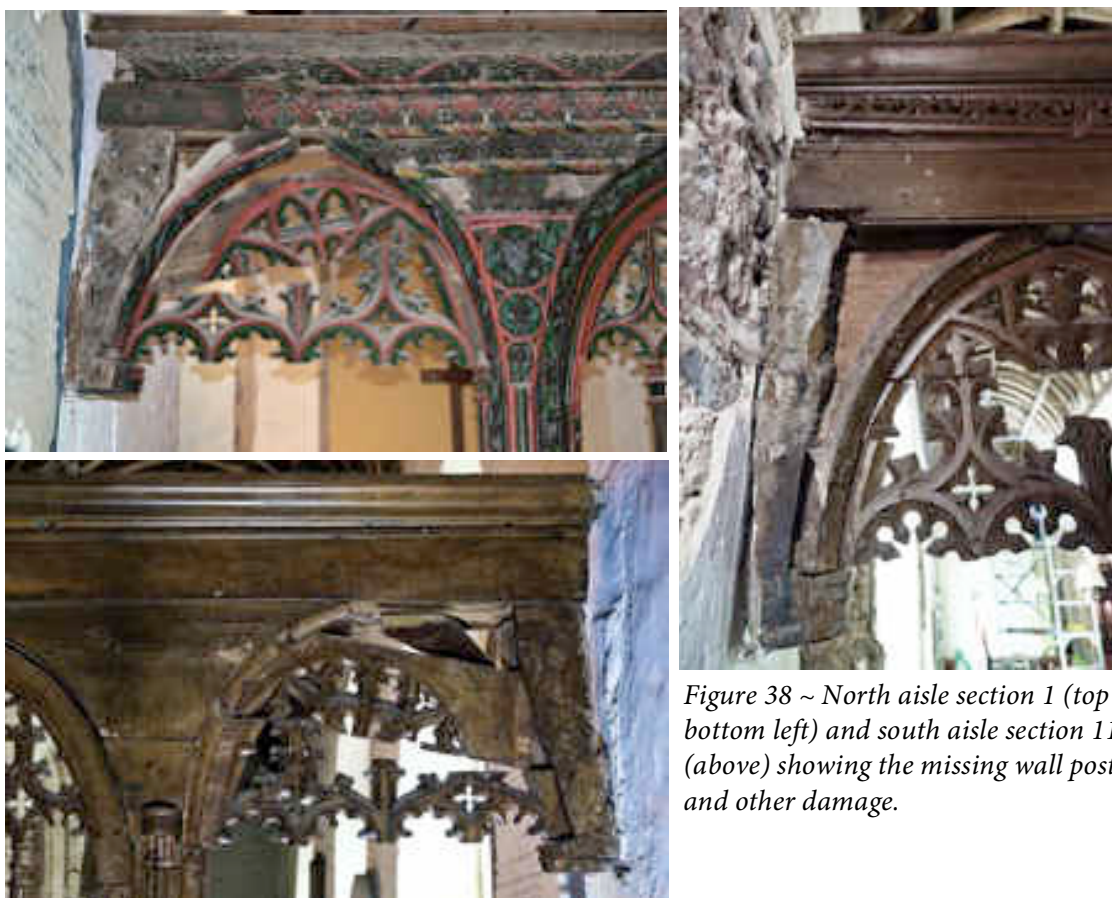
Over the centuries the screen has suffered extreme interventions, such as the removal of the vaulting and reordering of the upper mouldings. This major intervention was most likely to have occurred during the late 16<sup>th</sup> or 17<sup>th</sup> centuries, however the detrimental consequences are on-going and have compromised the overall structure of the screen significantly. The main impact is due to the cutting of the timbers to the wall supports. The South chapel screen is significantly out of line. The Chancel rood screen doors are missing and the chapel screen doors, although present in the central bays, are no longer opening. Bays 1 and 11 have been partially removed to allow open access to the side Chapels.

*Figure 38 ~ North aisle section 1 (top & bottom left) and south aisle section 11 (above) showing the missing wall posts and other damage.*

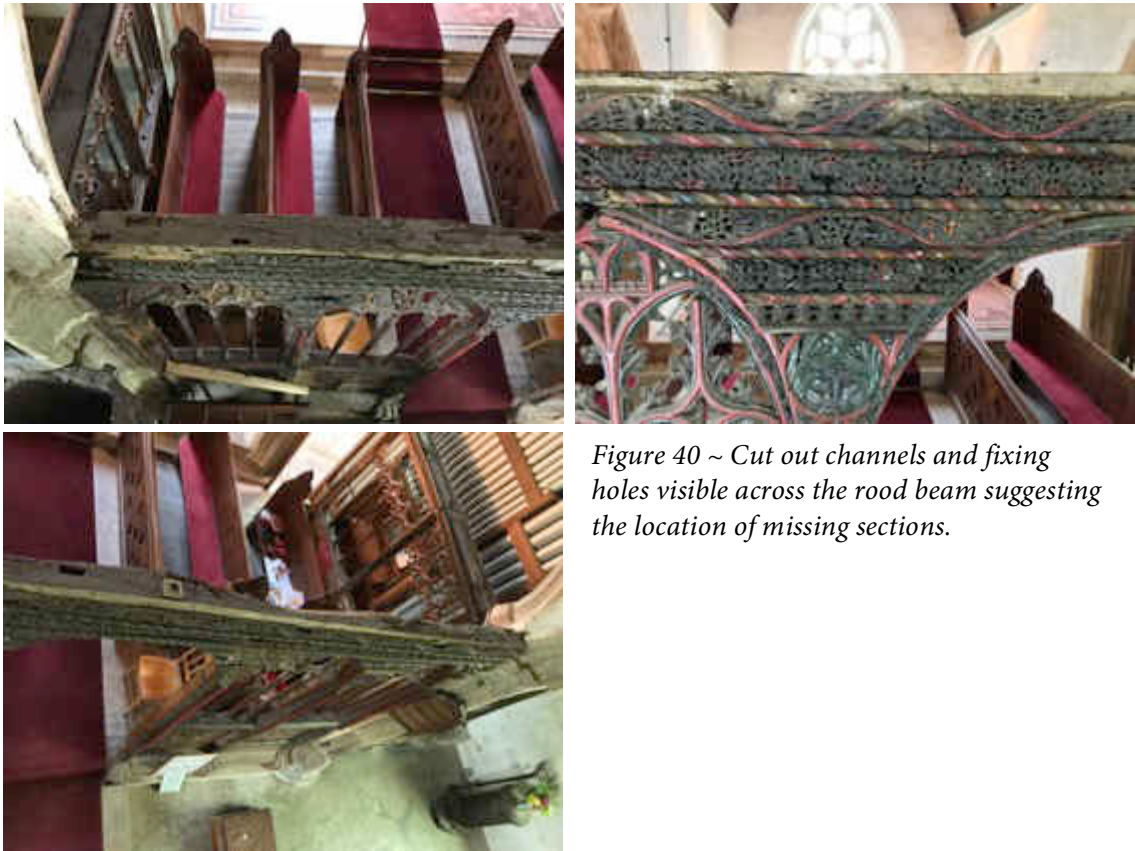
The rood screen would originally have appeared quite different, with a vaulted upper section. Chiselled out holes evident along the sky face of the main beam, indicate locations of fixings for the upper gallery/loft.

*Figure 40 ~ Cut out channels and fixing holes visible across the rood beam suggesting the location of missing sections.*

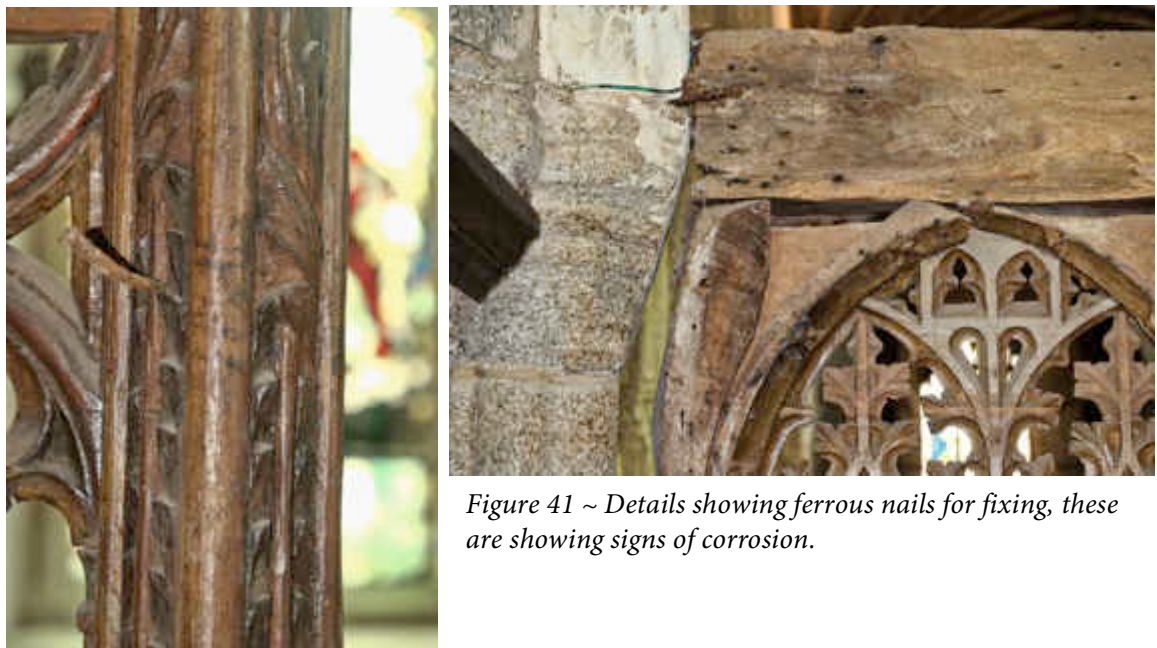
Ferrous fixings from structural straps to nails were observed across the timberwork. These are showing signs of corrosion most probably due to the damp conditions in the church. Some of the corroding nails will contribute to timber loss, cracking of elements and darkening/staining of adjacent timber if left unchecked. The corroding straps are compromising the structural integrity of the screen.

*Figure 41 ~ Details showing ferrous nails for fixing, these are showing signs of corrosion.*

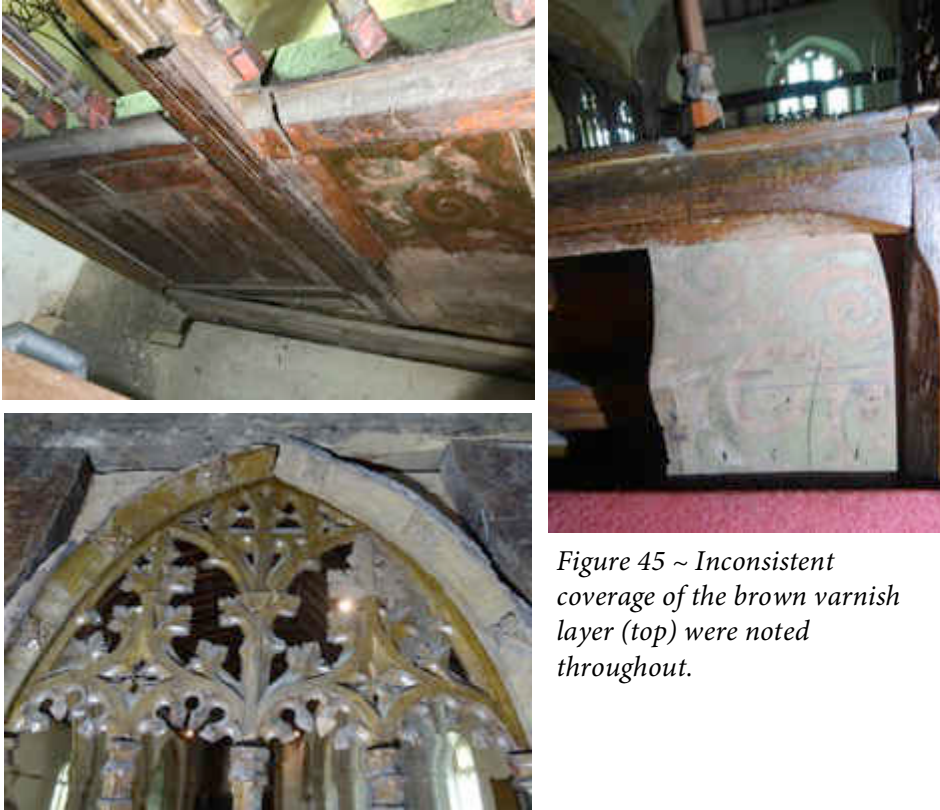
The framework retains extensive polychromy, both original and from different decorative schemes. The polychromy is veiled in many places with dirt and dust. An application of varnish has discoloured over time and now masks the vibrancy of the earlier colour schemes. The coverage of this brown varnish is not consistent and areas of thick pooling and drip runs were observed in several areas.

*Figure 45 ~ Inconsistent coverage of the brown varnish layer (top) were noted throughout.*

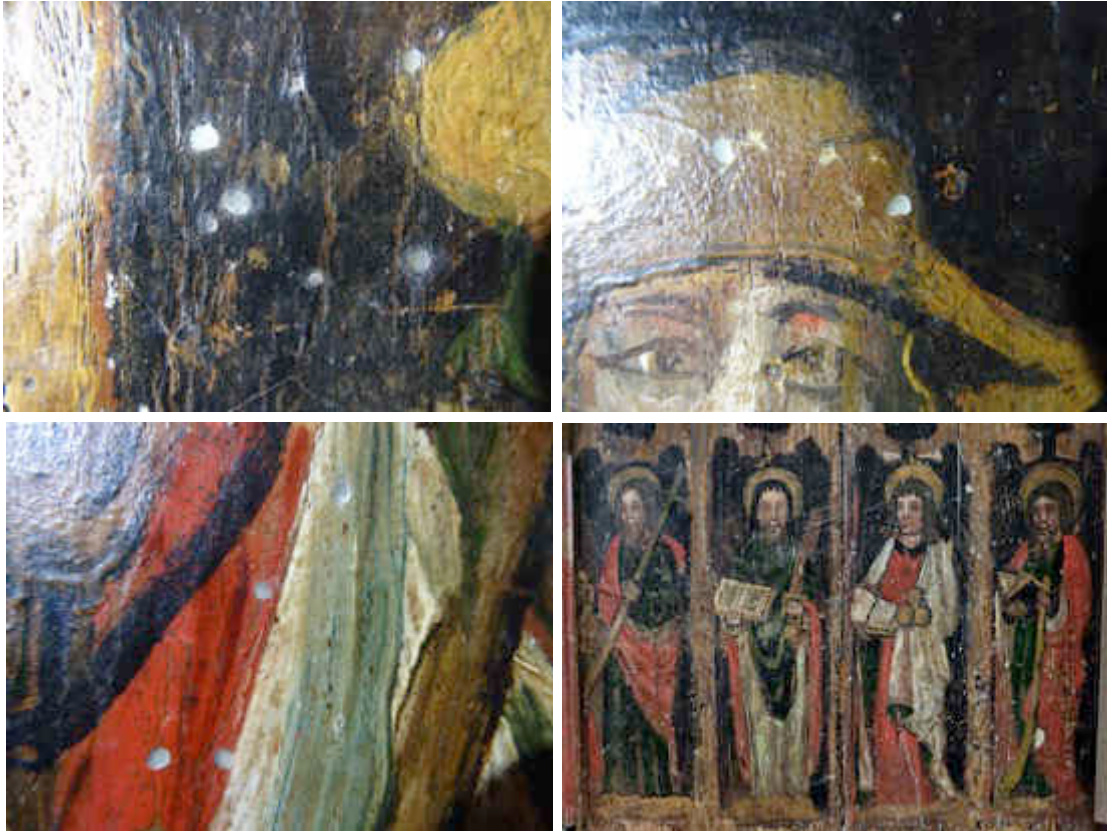
A wax surface coating has accumulated within old insect flight holes across the central section (nave) of the rood screen. Whilst they are not causing any damage as such, they are visually disfiguring.

*Figure 46 ~ Wax deposits have accumulated within the flight holes located on the central section.*

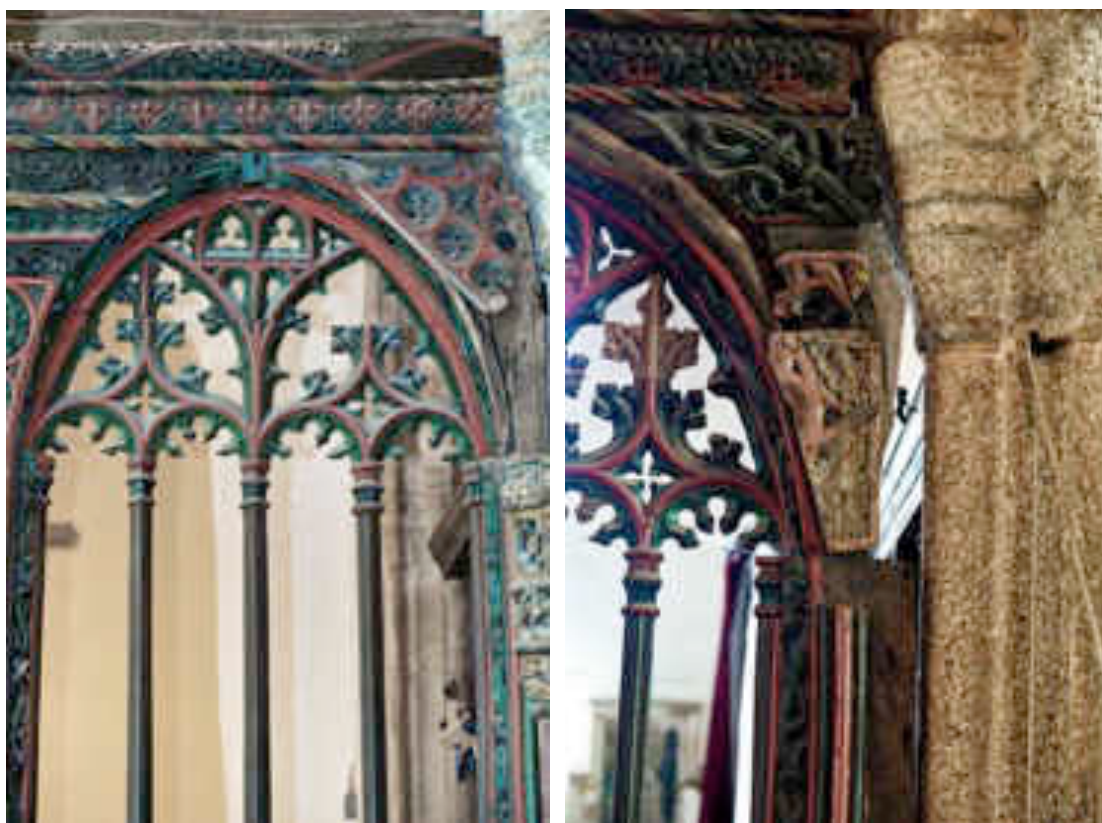
The screen has been dismantled and reassembled and reordered several times in its history. There are areas of replacement carving and the lower tracery on the dado panels has been removed in several areas. See also previous comments in 5.2.4.

*Figure 47 ~ Sections of carvings have been repositioned within the flattened spandrels (top left & right) and run of moulding are misaligned with inconsistent gaps (below left & right).*

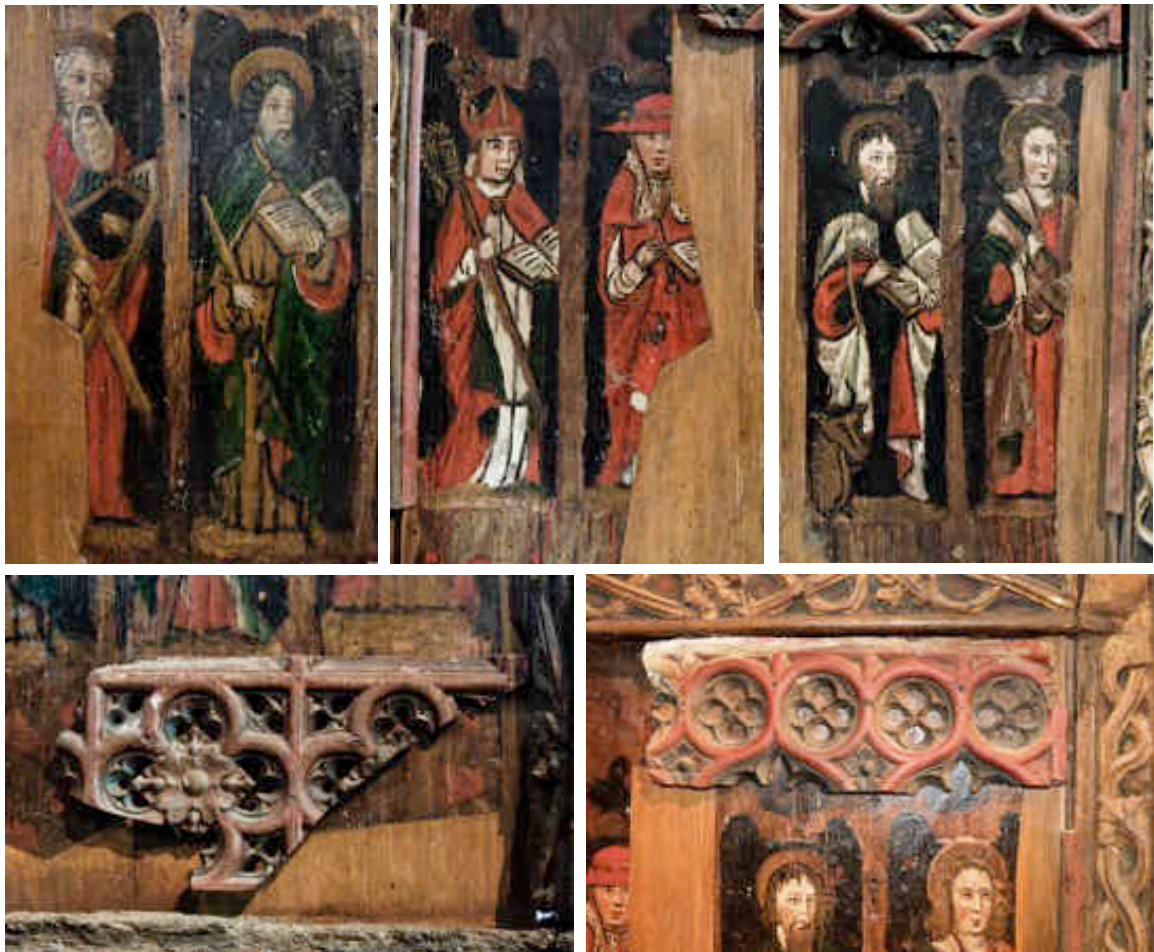
Sections of moulding were re-carved and attached to the screen to fill vulnerable missing areas and offer support. Examination of the restored screens indicate that the figure panels were pared back and apparently glued onto new panels. It has been assumed that the panels would have been consolidated and treated with an insecticide at the time.

*Figure 49 ~ Details of the plain timber in-fills on the restored dado panels of the central section.*

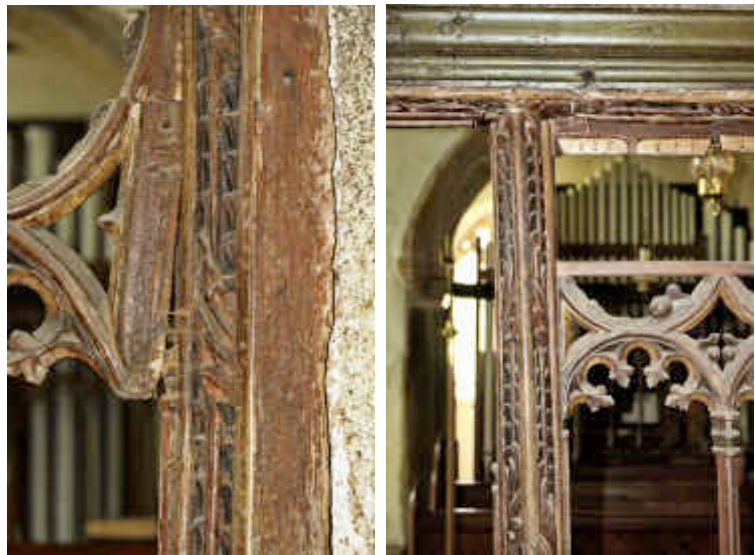
*Figure 52 ~ dirt and debris together combined with a discoloured varnish is obscuring the polychromy.*

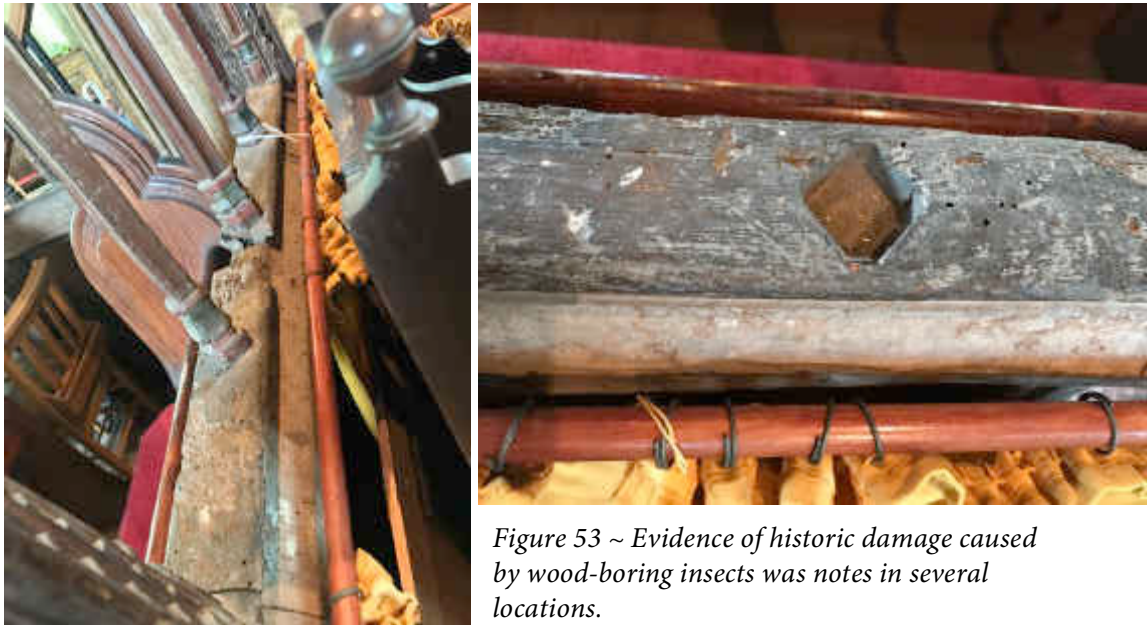
The damage caused by the insect infestation does not appear to be active in these locations, though we would recommend continued monitoring for signs of frass and fresh, clean flight holes.

*Figure 53 ~ Evidence of historic damage caused by wood-boring insects was notes in several locations.*

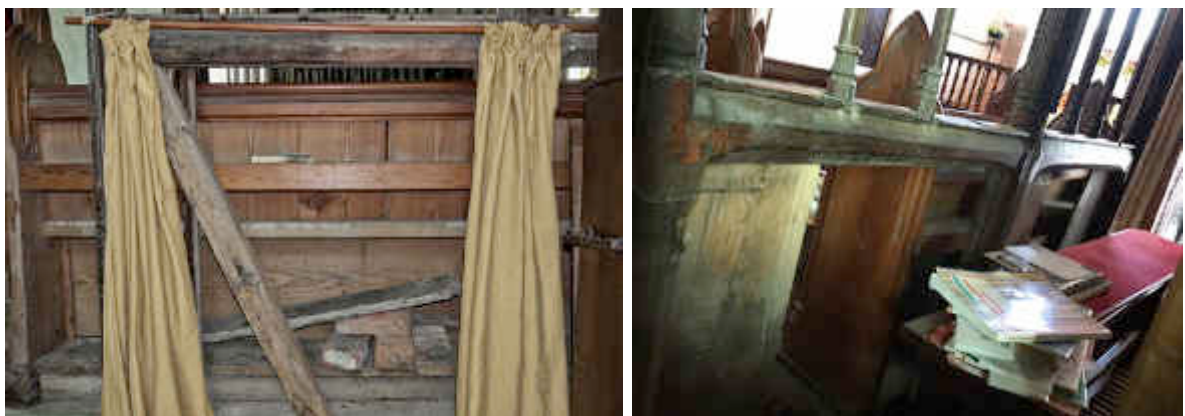
*Figure 54 ~ Most of the painted panels from both the lower dado sections of the parclose screens are no longer in situ. Four are currently stored in the vestry.*

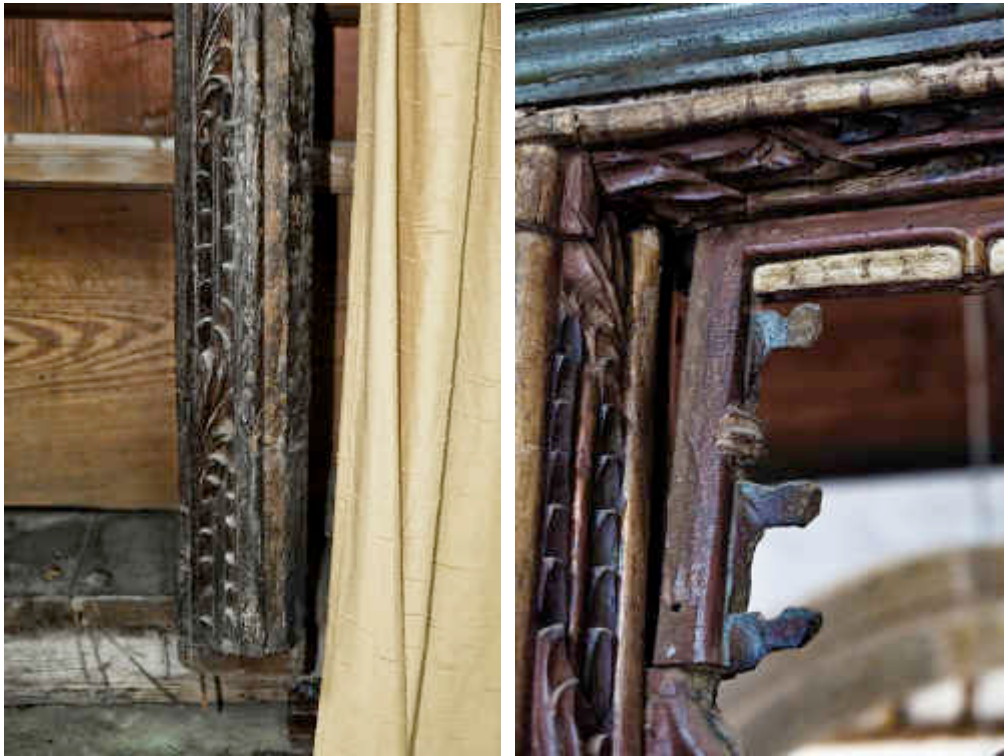
*Figure 58 ~ Details showing missing support to the base of carved upright post on north screen (left) and dropped / misaligned section of tracery on north screen (right).*

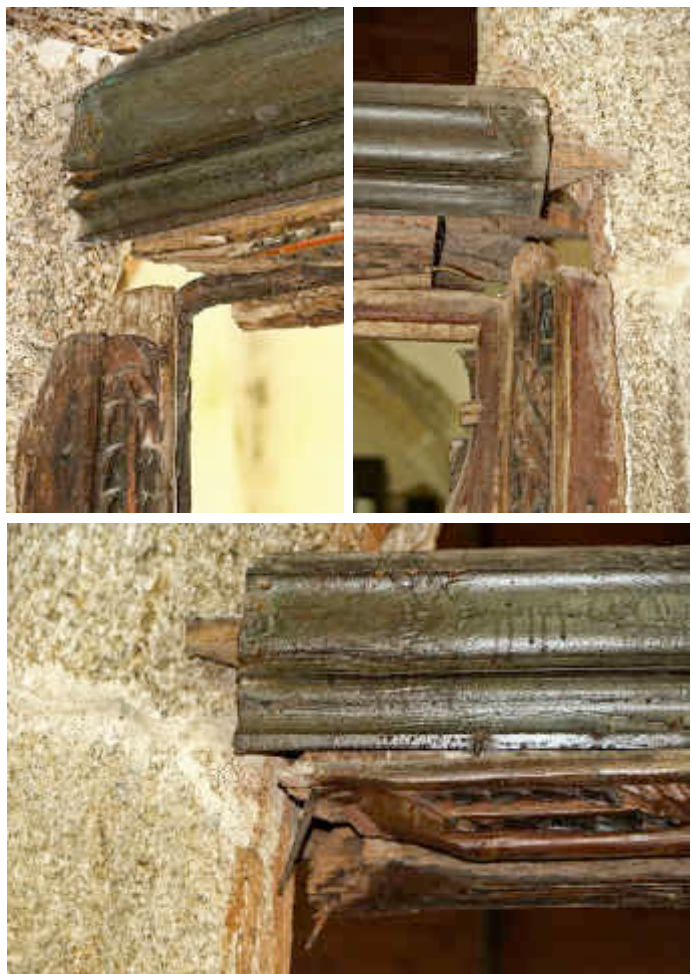
*Figure 59 ~ Details showing fixings and ferrous nails through the timberwork. The fixing mechanism to the granite is inadequate.*

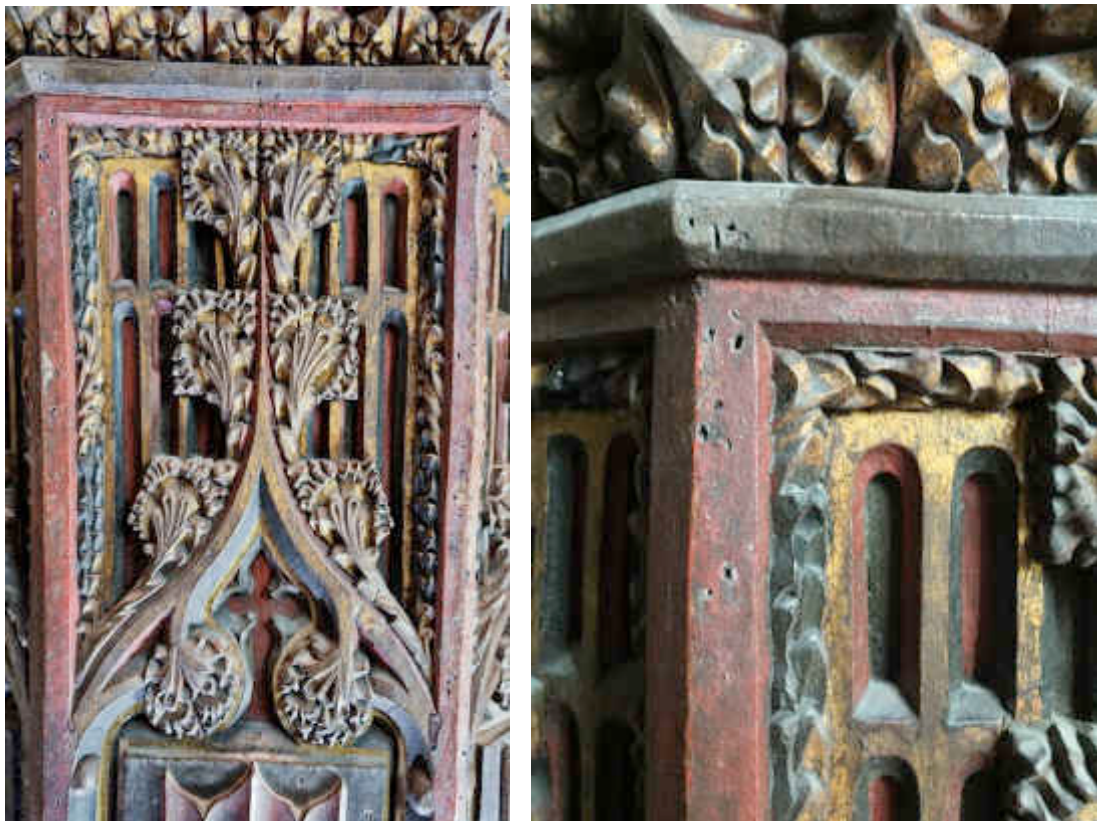
Figure 67 ~ Small flight holes from historic insect infestation observed on pulpit outer carvings.

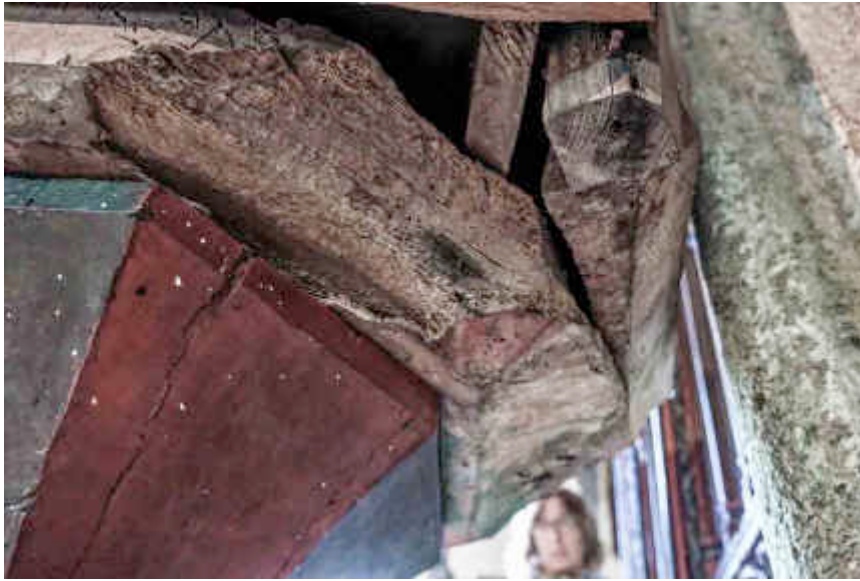
*Figure 68 ~  
Area of timber  
at base of pulpit  
floor (right side  
of opening)  
above pedestal  
showing  
particularly bad  
signs of  
previous insect  
infestation.*

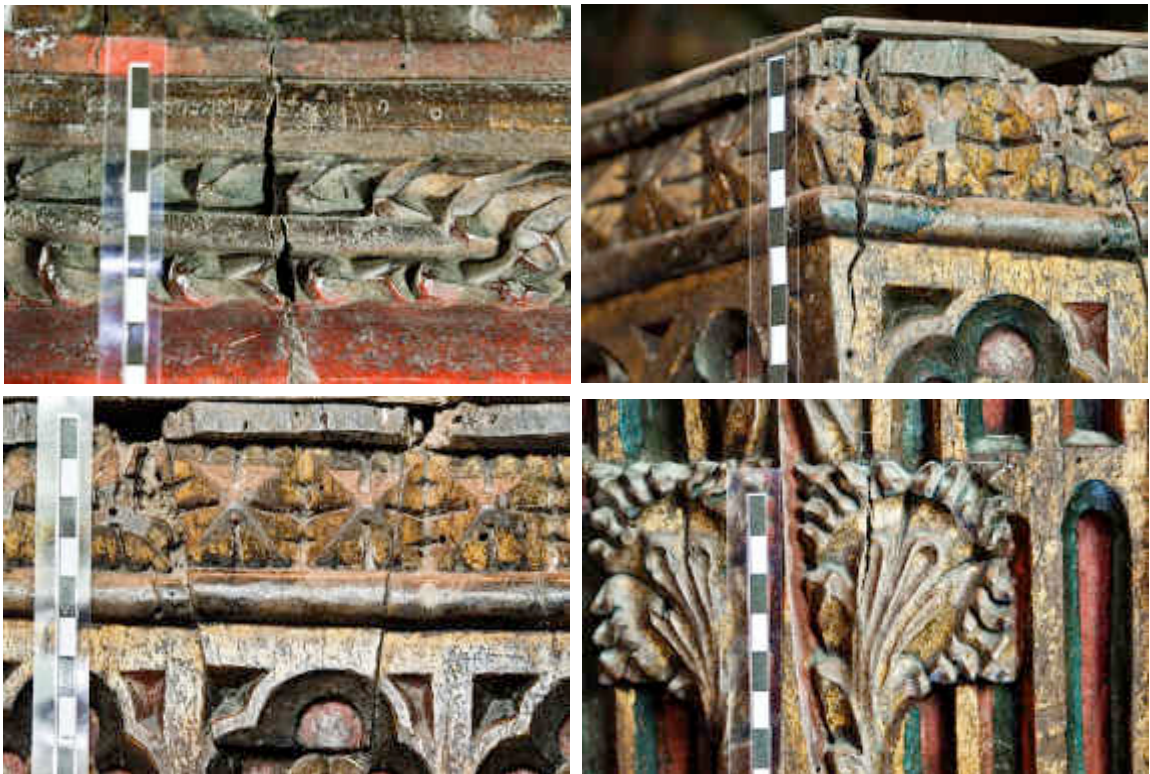
*Figure 69 ~ Details showing cracks and splits in the carved timber face of the pulpit.*

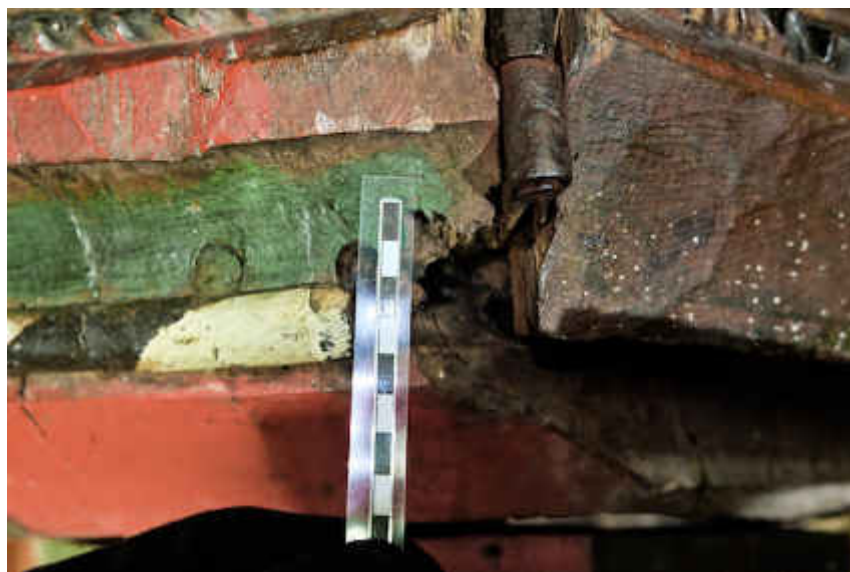
*Figure 72 ~ Detail of the condition and relationship between the lower hinged edge of the pulpit door and the pedestal.*

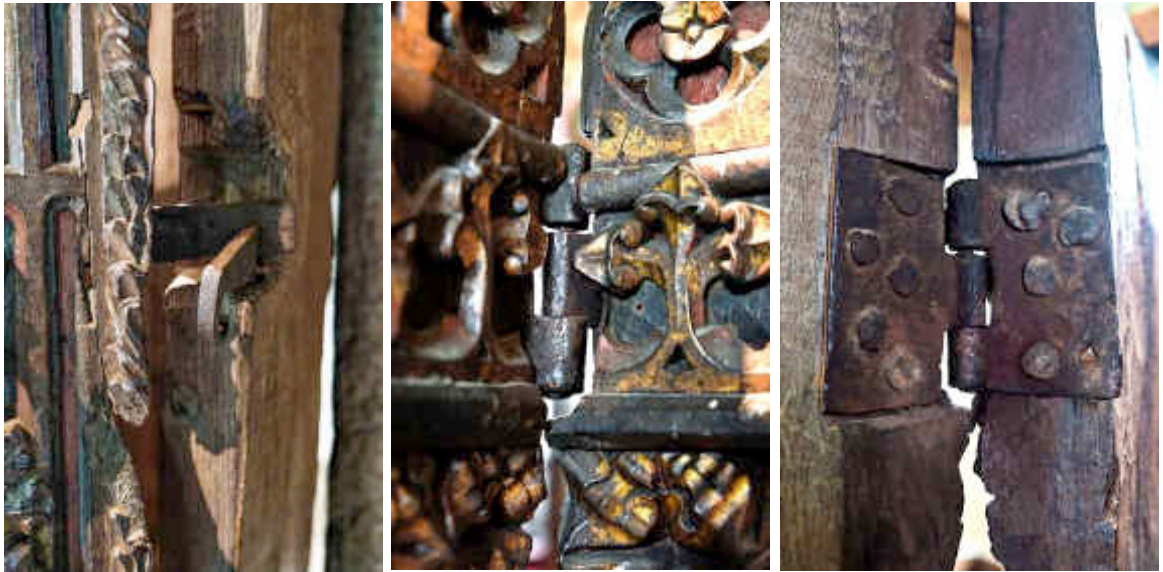
*Figure 73 ~ Details of ferrous fixings on the pulpit showing signs of corrosion but relatively stable.*

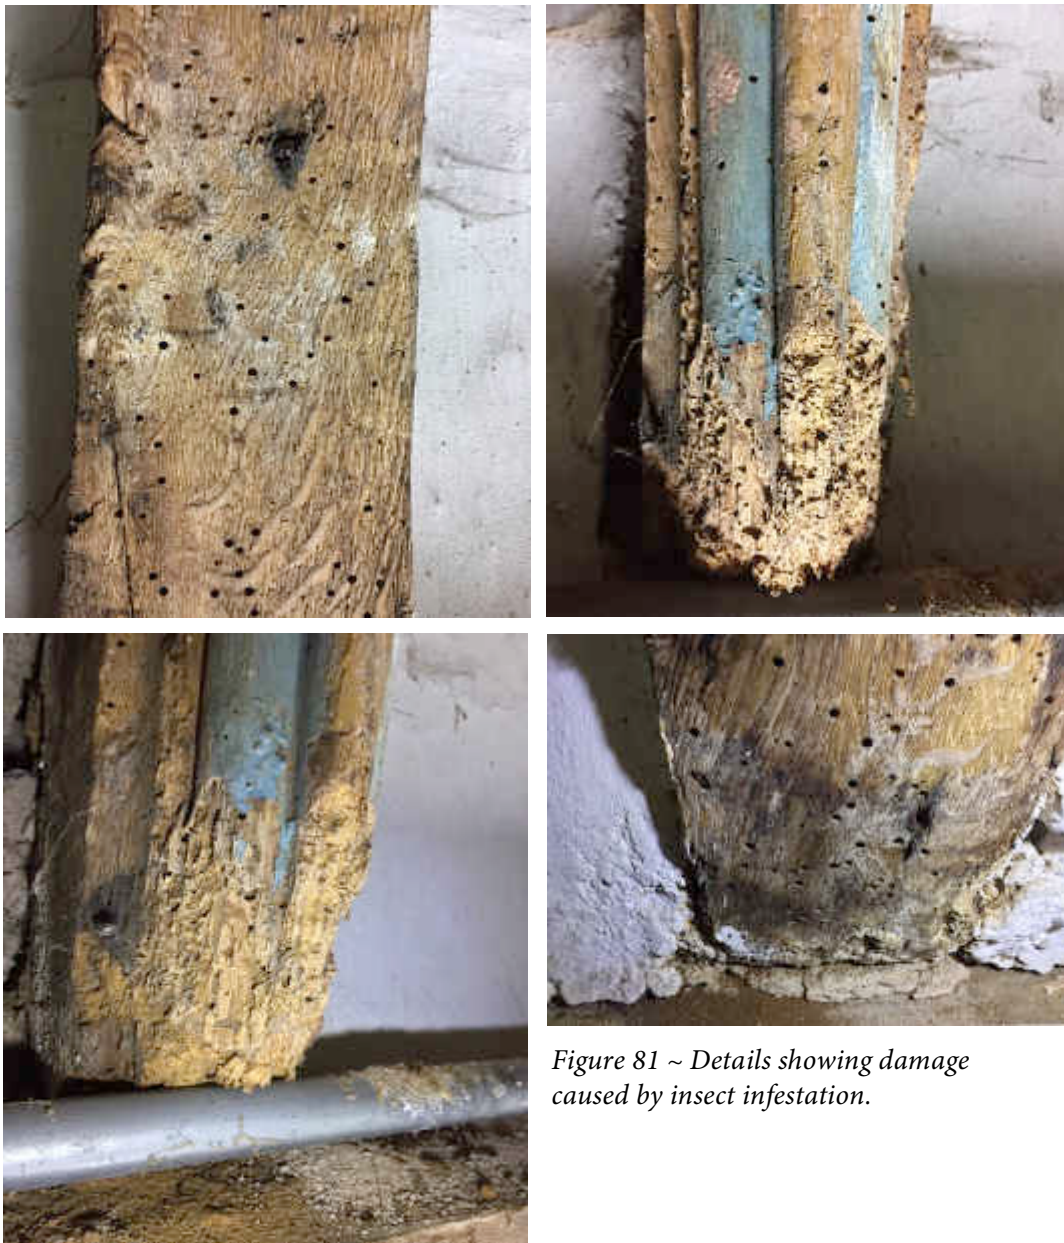
Figure 81 ~ Details showing damage caused by insect infestation.

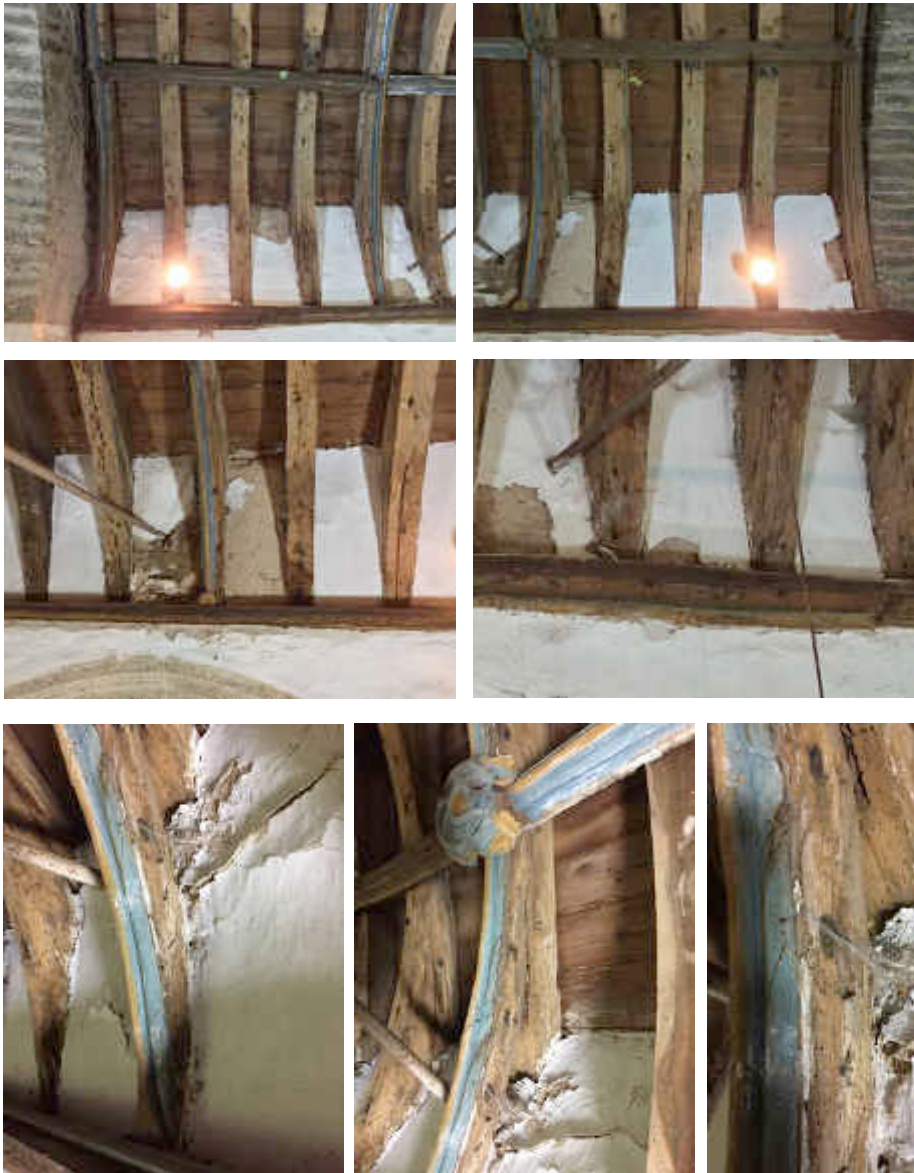
*Figure 82 ~  
Areas of  
detached and  
flaking  
plasterwork in  
the nave at the  
west end.*

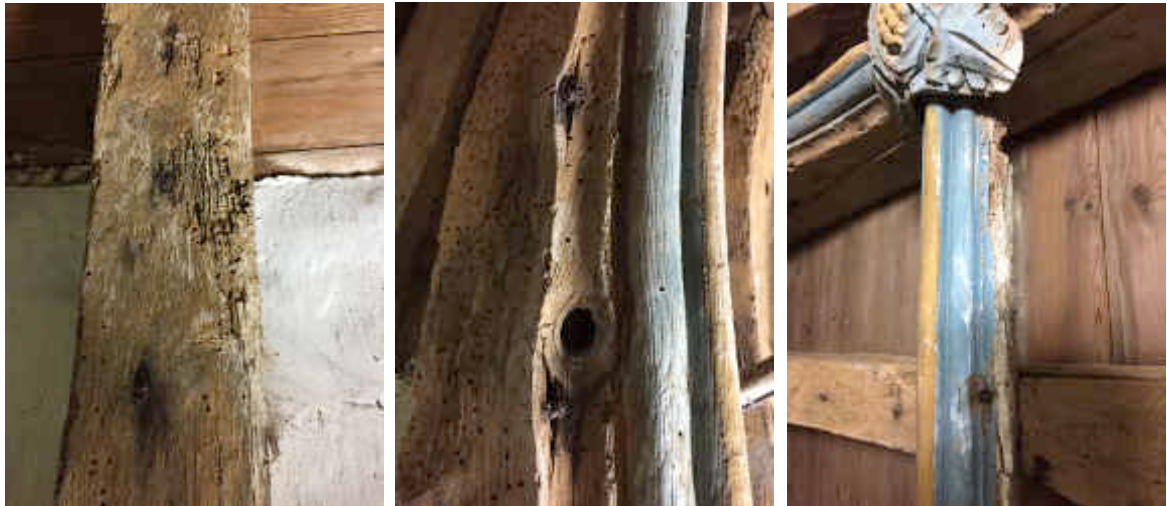
*Figure 88 ~ Staining and splits to timberwork observed as a result of corroding ferrous fixings.*

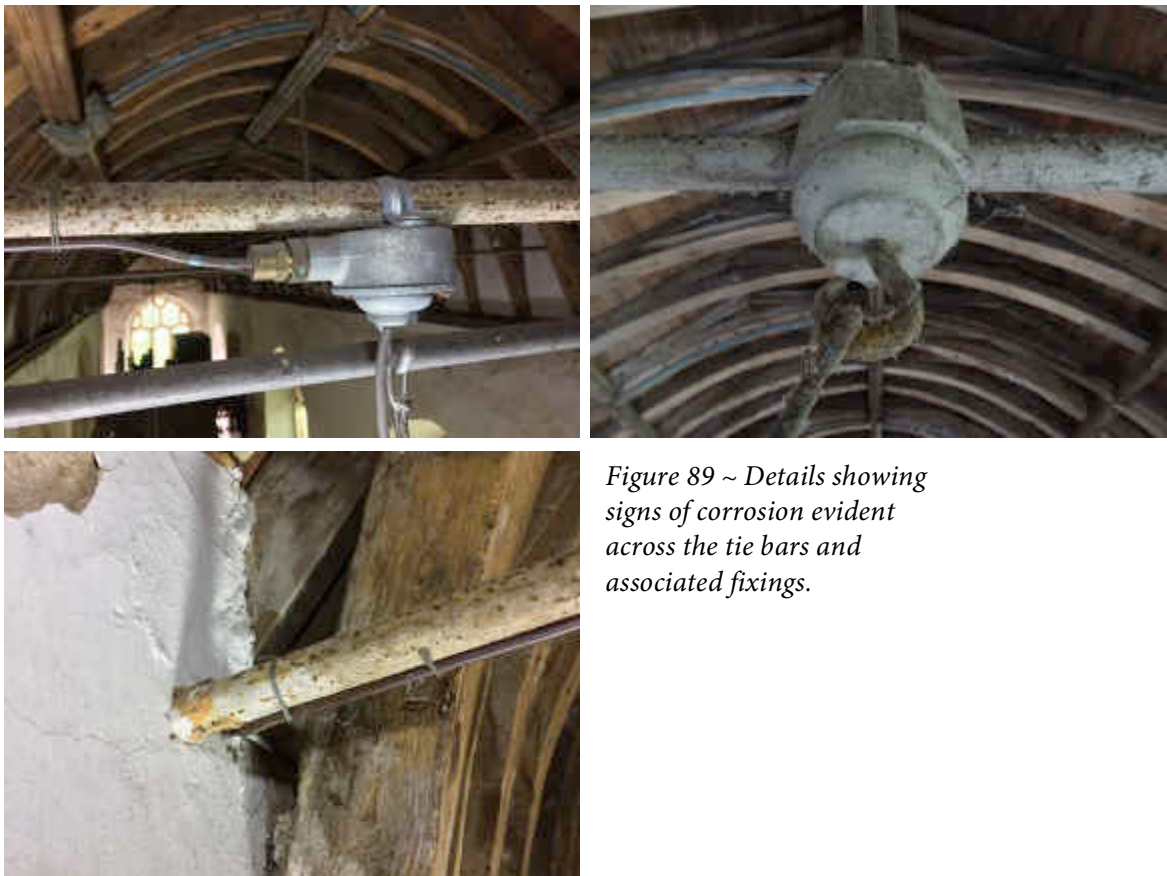
*Figure 89 ~ Details showing signs of corrosion evident across the tie bars and associated fixings.*
