ST SYLVESTER'S CHURCH ~ CHIVELSTONE

PARCLOSE SCREENS, ROOD SCREEN  
& DECORATIVE ROOF TIMBERS

CONDITION ASSESSMENT &  
CONSERVATION RECOMMENDATIONS

JUNE 2019

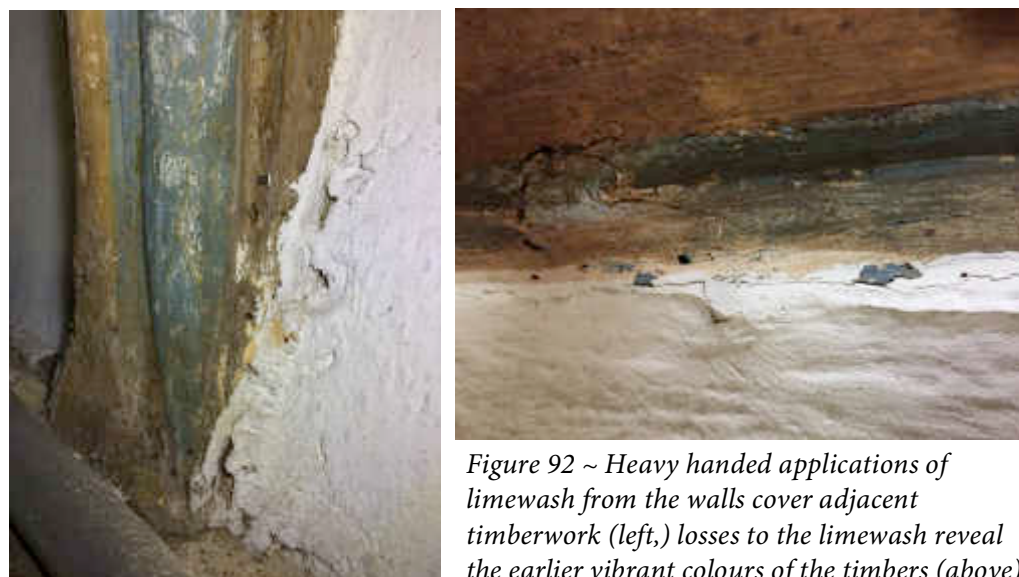
*Figure 92 ~ Heavy handed applications of limewash from the walls cover adjacent timberwork (left,) losses to the limewash reveal the earlier vibrant colours of the timbers (above).*

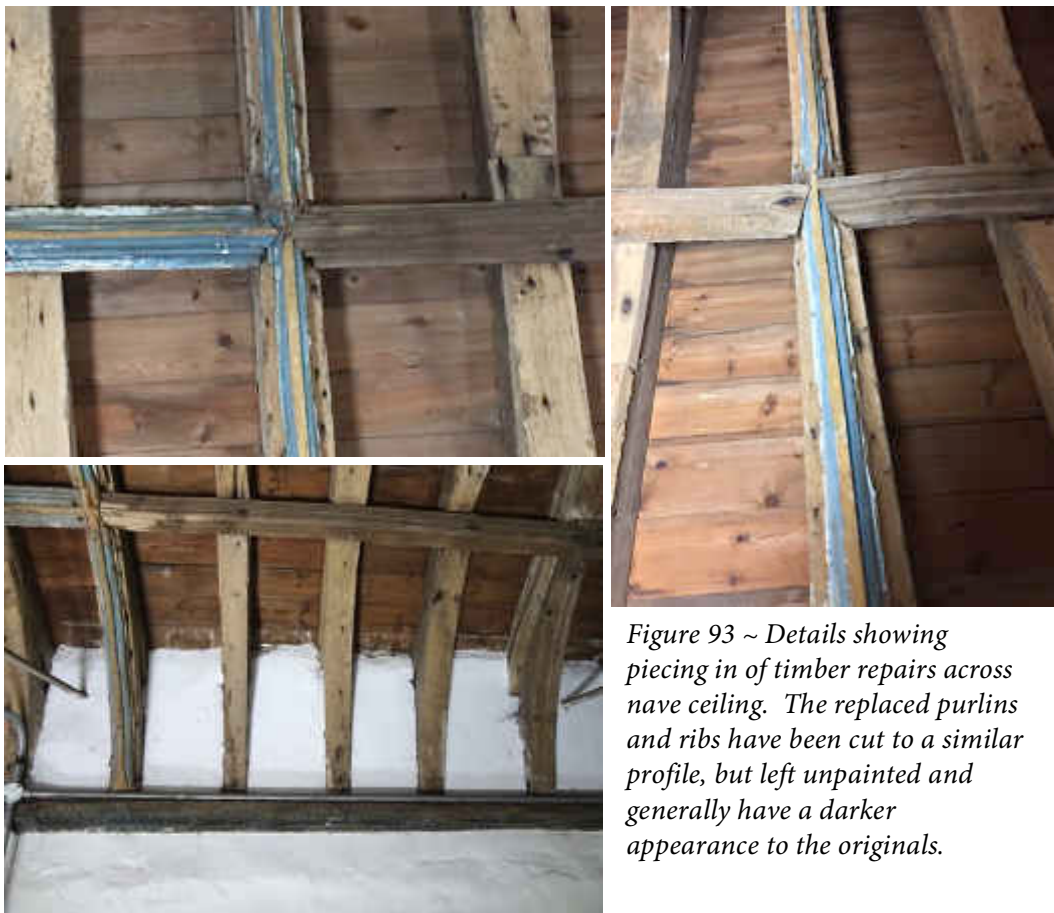
*Figure 93 ~ Details showing piecing in of timber repairs across nave ceiling. The replaced purlins and ribs have been cut to a similar profile, but left unpainted and generally have a darker appearance to the originals.*

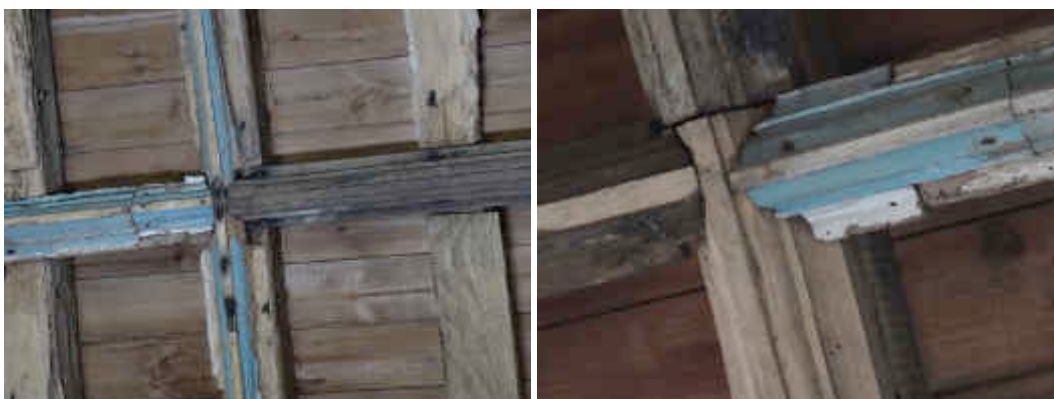
*Figure 94 ~ There appears to be later painting over some repairs.*

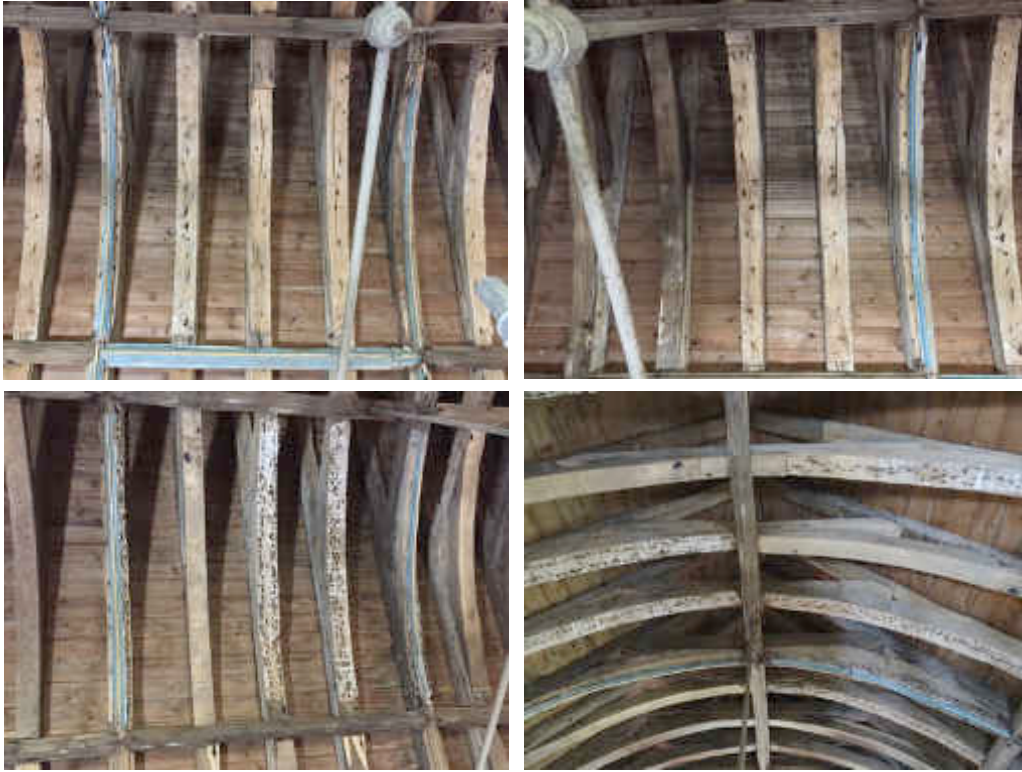
*Figure 98 ~ Areas of ribs with larger number of nail holes in bays 8B, 8C & 9C. It has been presumed that this area was repaired with lath and plaster at some point.*

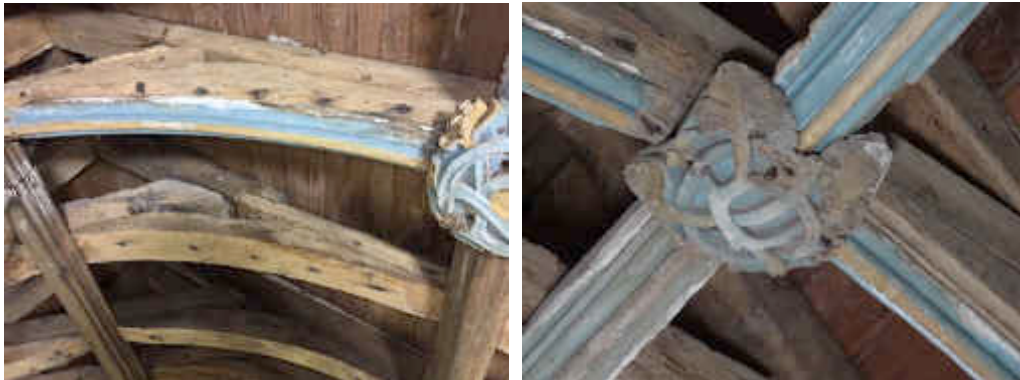
*Figure 99 ~ Corroding ferrous fixings have stained adjacent timberwork.*

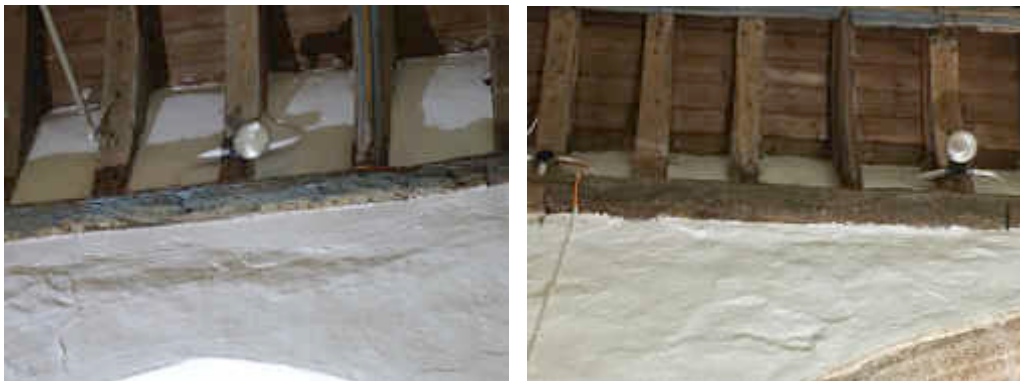
*Figure 100 ~ Electrics and lighting have been fixed to timberwork above the wall plate line.*
