ST Sylvester Church, Chivelstone ~ Pulpit Conservation

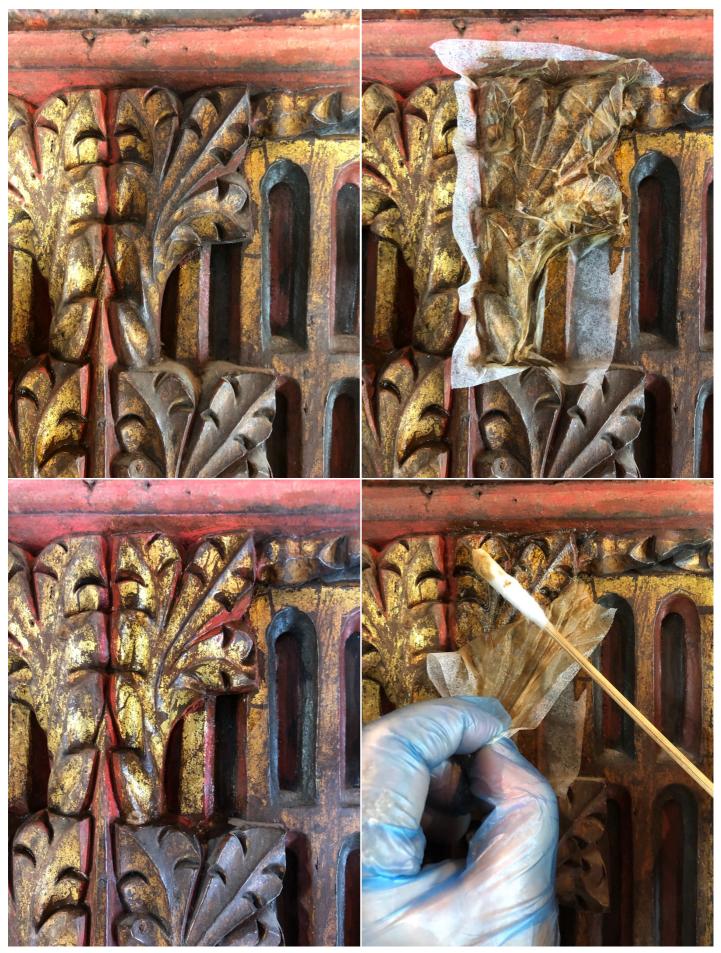
Clockwise from top left: Before conservation; Solvents applied to the area through Japanese tissue; Tissue carefully removed after a specified dwell time and the softened varnish is removed using cotton wool swabs; The conserved area is neutralised.
