St. Sylvester's Church, Chivelstone

Additional investigation of the plaster and wall decoration

March 2022

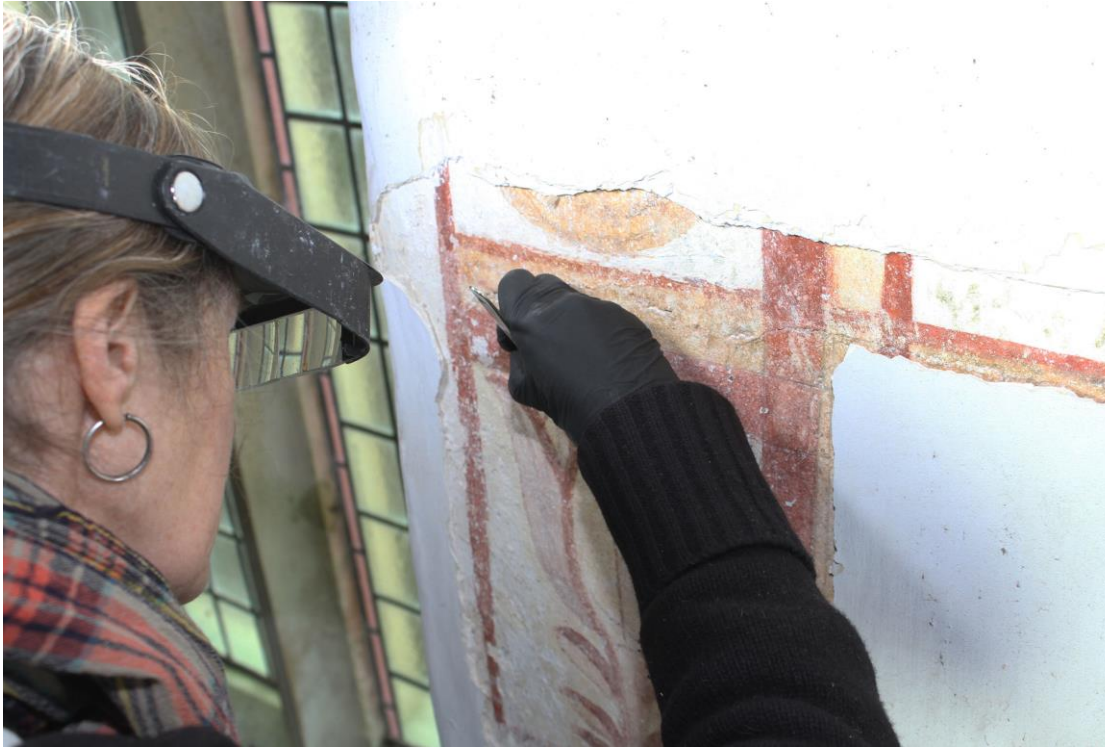
Fig. 1 Careful removal of overlying paint and limewash layers using a scalpel with the aid of a magnified head lens.

Uncovering trials were undertaken using a scalpel with the aid of a magnified head lens. For the central cartouche, which was more delicate, the overlying limewash layers were dampened with water to soften them. The brittle overlying limewash were then carefully removed using a scalpel with a small hammer, slowly working through the layers.

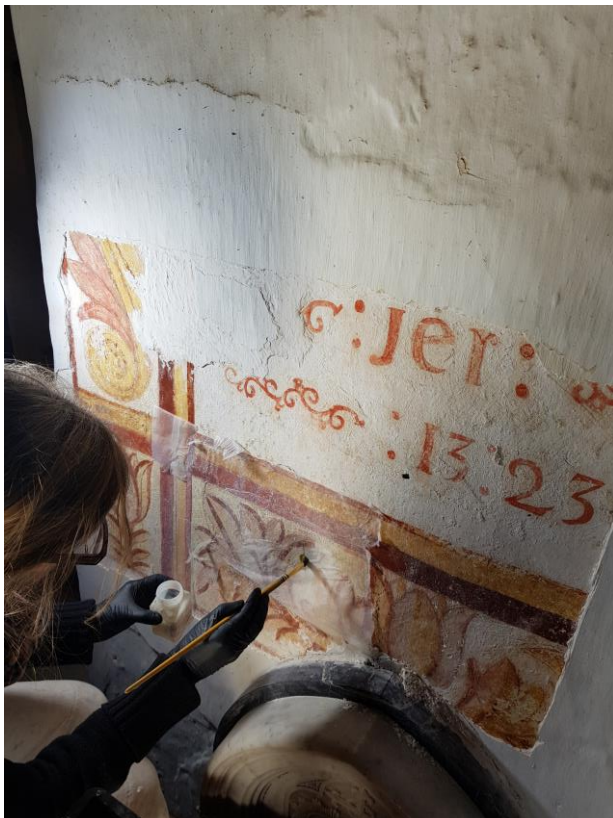
Fig. 2

Application of the consolidant in areas of powdering paint (through Japanese tissue).

Areas of powdering paint were consolidated with a 5% dispersion of Primal B60a applied through Japanese Tissue. No plaster consolidation was undertaken during this phase of work.

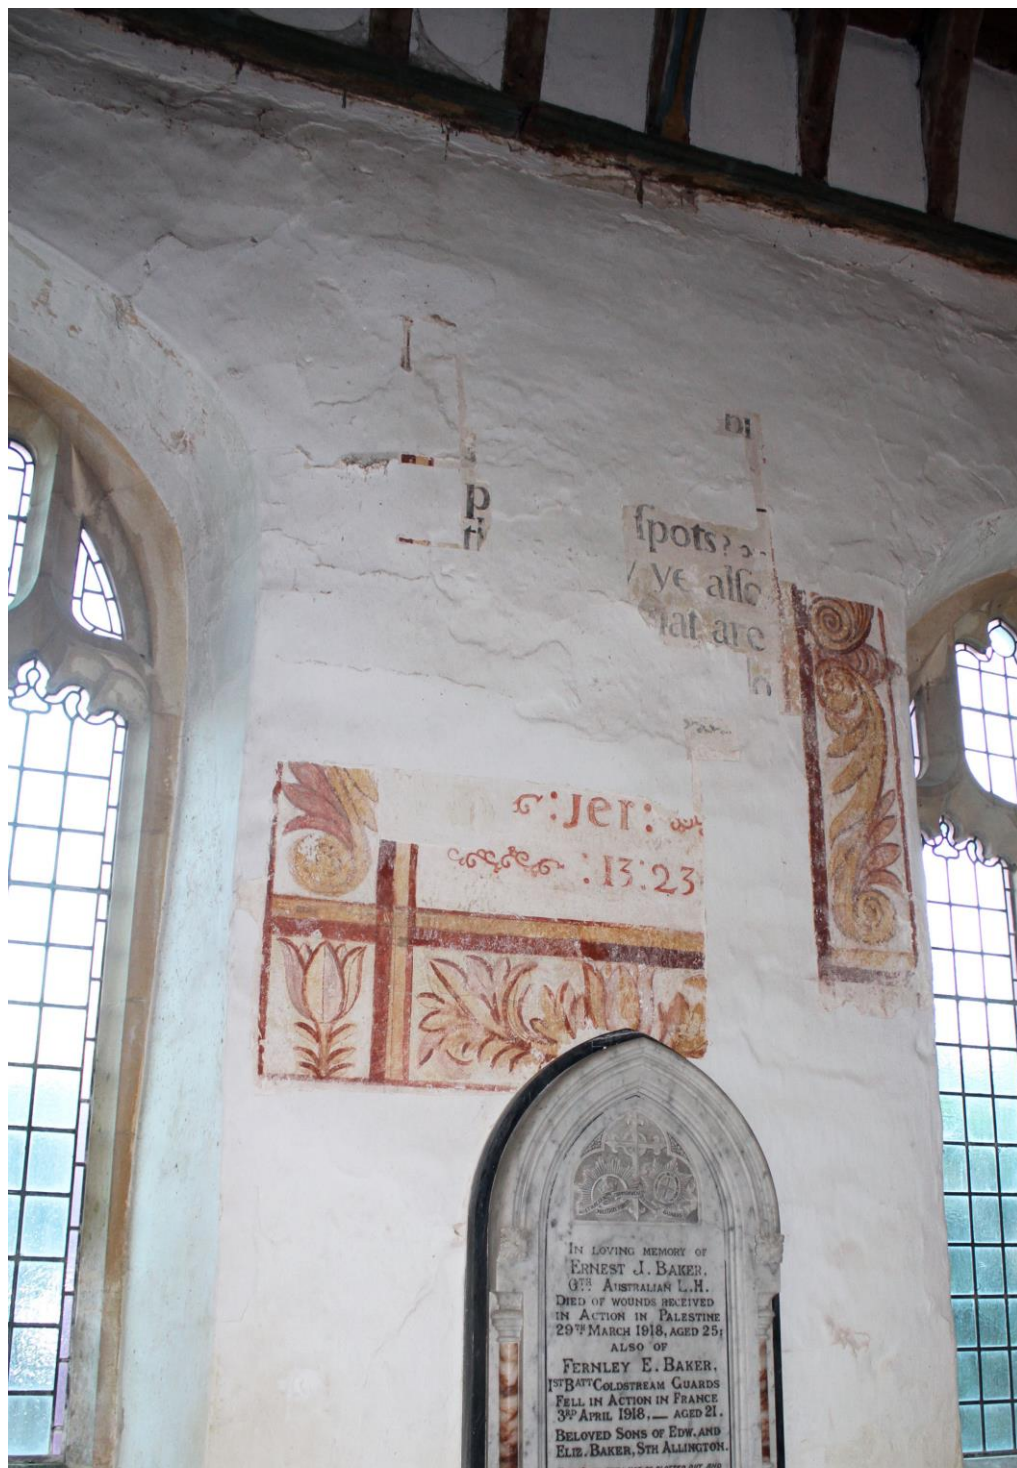
This recent survey has revealed an unusual painting of a flower included in the border design of the central panel on the north wall. The flower is probably a lily but it also shows some similarity to the popular late 17th century depictions of tulips that were found in sgraffito fireplaces in Topsham and Lympstone.

The area that includes the lower border of the painting had clearly been replastered prior to the application of the painting. Here the painting is applied directly onto the plaster and there is a visible joint along the line of the border. The upper part of the painting was applied to an older plaster that was already covered with a number of limewash layers.

The condition of the paint beneath was variable. In some areas, particularly on the lower east side salts had formed on the painted surface and the paint had lost cohesion and was largely lost. However, the majority of the areas uncovered had retained the decoration. Much of it had lost some cohesion and was powdering but it was still adhered to the surface.

The main issue with this painting is the deterioration of the plaster support. Significant voids were detected. In areas where the plaster has deteriorated the painting is largely supported by the limewash layers which have become remarkably hard and brittle. In some areas there is some movement of the of the limewash layers that support the painting and the situation is precarious.

Detail showing the east panel on the north wall that was partially uncovered during this survey. Note the unusual flower (lower left) and the very large text.

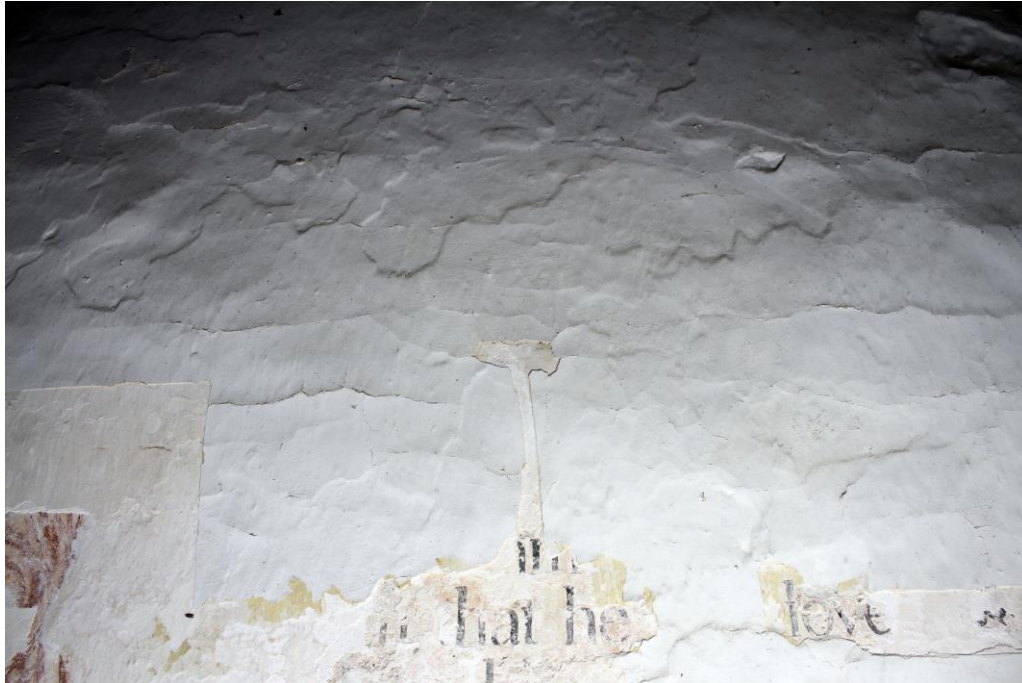
Fig. 4

Further investigations were also undertaken on the wall between the two central windows on the north wall. The plaster here appears to be contemporary with the wall painting. It is generally extremely weak and has lost cohesion. The uncovering process is slow due to the delicate nature of the plaster and the weak adherence of the limewash layer that supports the painting.

North wall – central panel. Detail showing the surface of the wall in raking light. The plaster support in this area was weak and crumbling making the uncovering process much slower.

Areas of crumbling and powdering plaster that have lost cohesion can be consolidated using Syton X30 (colloidal silica) or Calosil Nanolime¹. This can be injected into exposed edges or applied to the surface through Japanese tissue as appropriate.

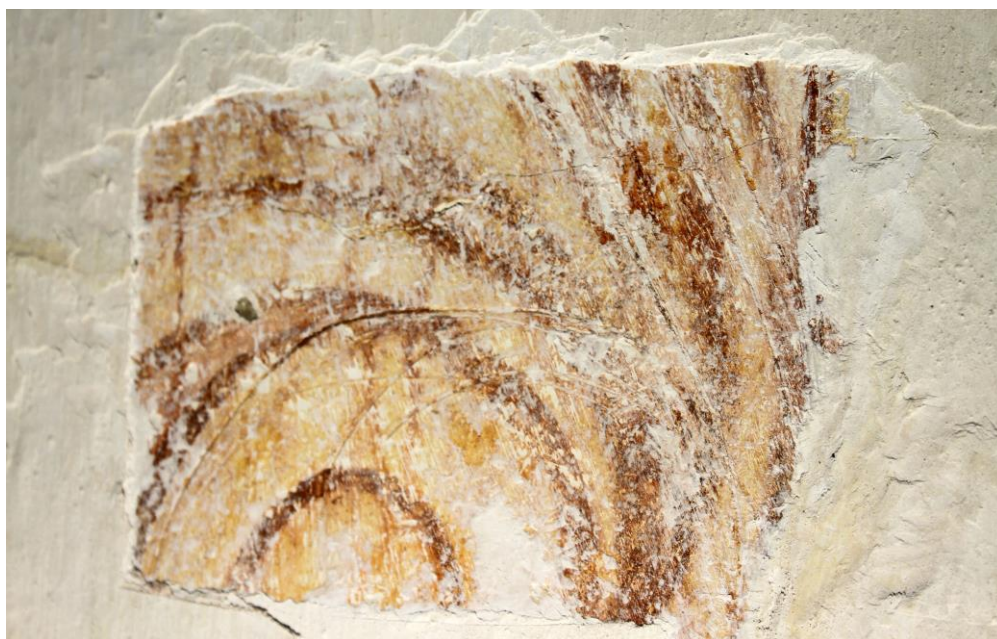
Fig 5.

North wall – central panel. Detail showing incisions made in the plaster to sketch out the design prior to painting.

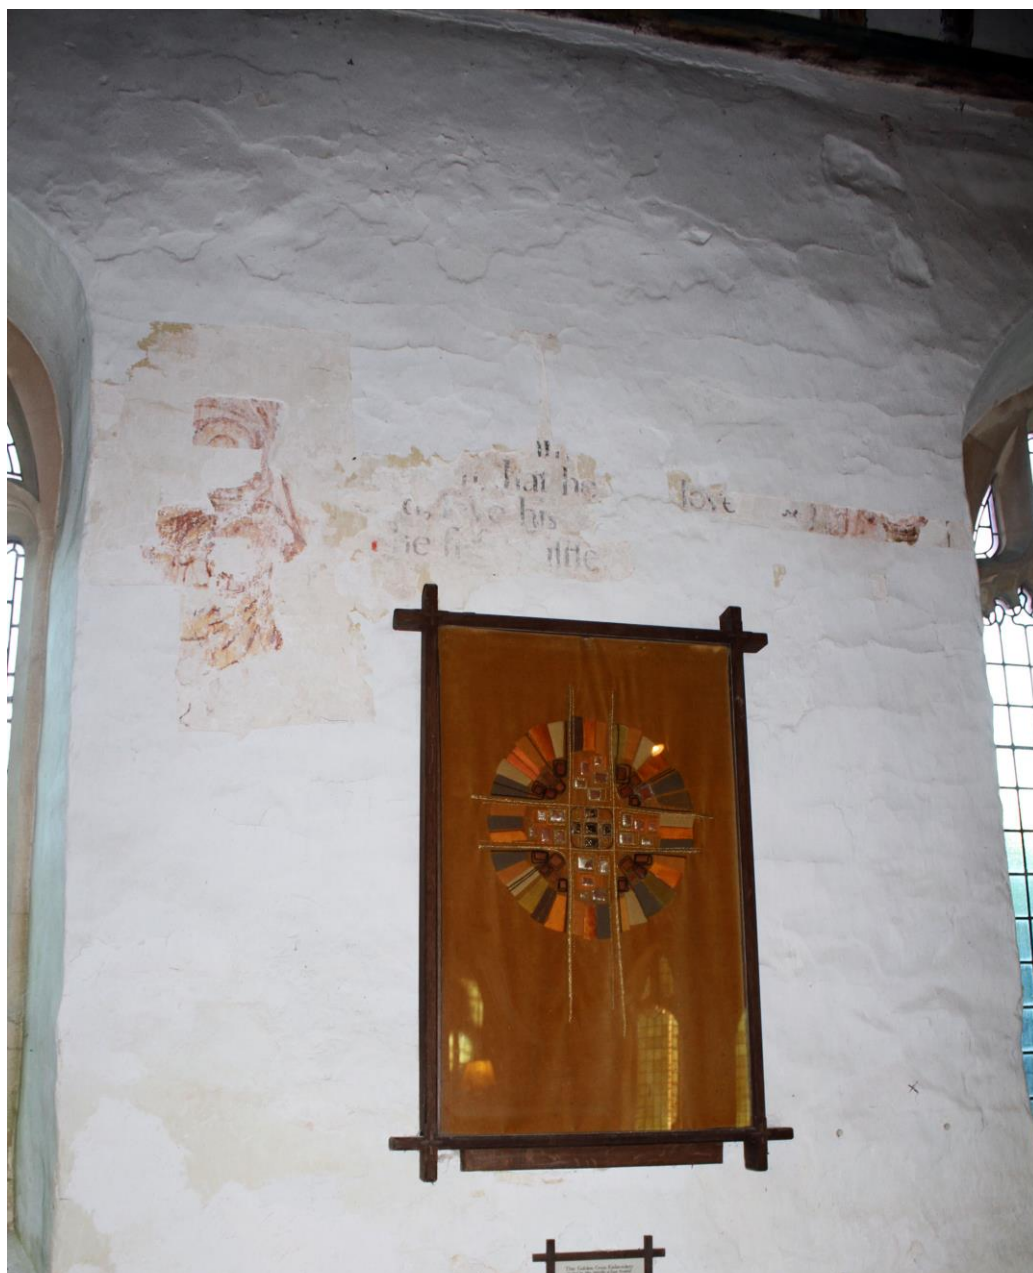
Fig. 6.

View showing the central panel on the north wall after uncovering investigations.

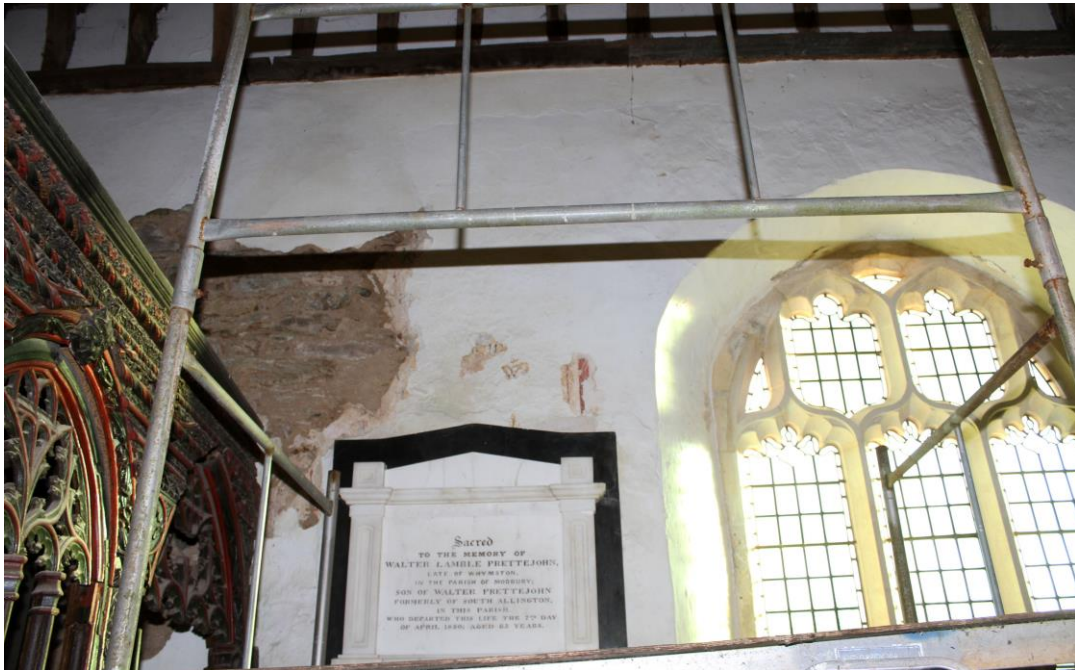
Fig. 7.

The south wall of the south chapel, that contains the organ has in the past been partially rebuilt and replastered. This plaster continues onto the east end of the south aisle where it overlaps the area of wall painting discovered in 2019. The later plaster has extremely poor adherence and is generally pulling away from the wall. There have been concerns that this later plaster may pull the earlier plaster that supports the wall painting away from the wall.

South wall – east end. View showing the edge of the wall painting exposed after the removal of the later plaster.

Access was made possible to the lower half of the wall painting and the most precarious areas of later plaster adjacent to the wall painting were removed. Any areas that require grouting were faced up with Japanese tissue applied with a 2% solution of Tylose MH300 (hydroxymethyl cellulose).

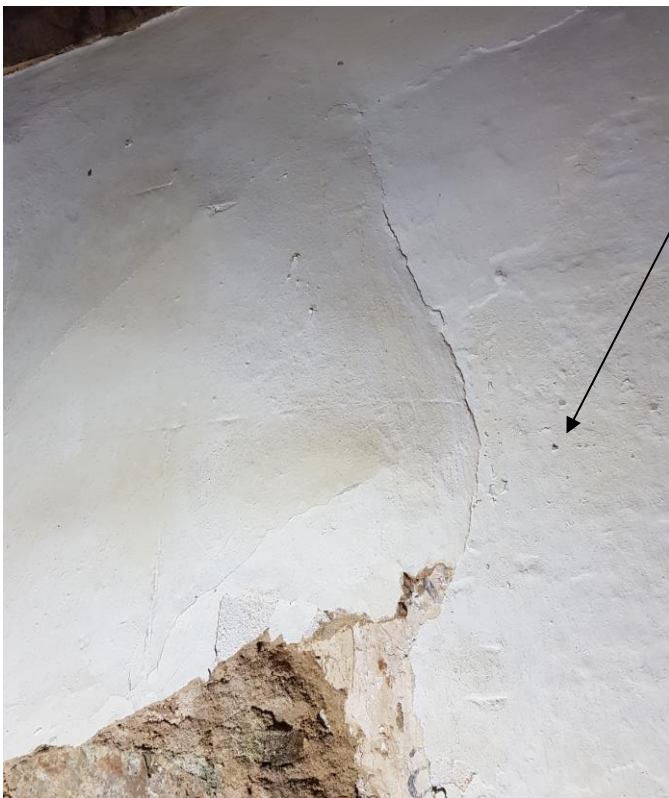
Fig 8.

Detail showing the upper area of the above where the later plaster can be seen to overlap the earlier wall painting.
