ST SYLVESTER'S CHURCH ~ CHIVELSTONE

PARCLOSE SCREENS, ROOD SCREEN  
& DECORATIVE ROOF TIMBERS

CONDITION ASSESSMENT &  
CONSERVATION RECOMMENDATIONS

JUNE 2019

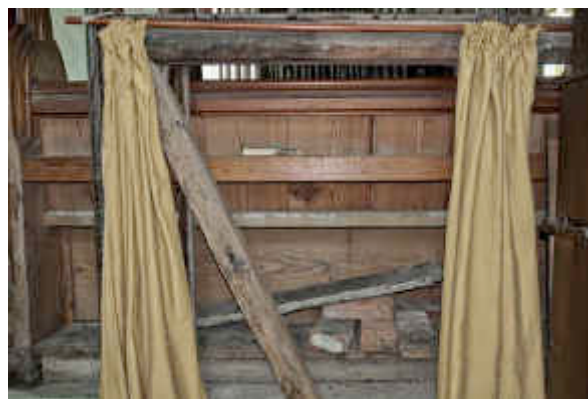
*Figure 14 ~ North elevation of parclose screen between chancel and Lady Chapel to the north, showing upper section (right) with carved tracery and lower section (above) with missing timber panels.*

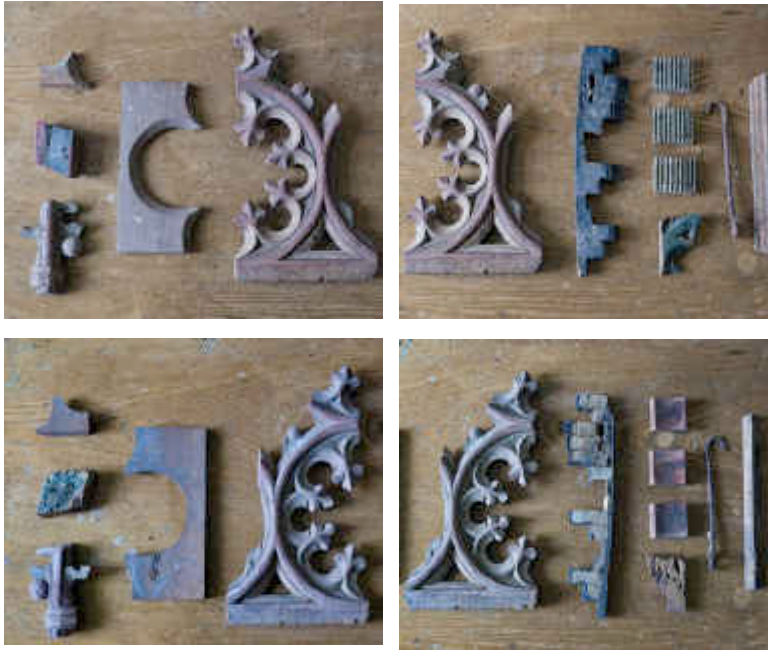
*Figure 18 ~ Details of different faces of the fragments currently stored in the vestry.*

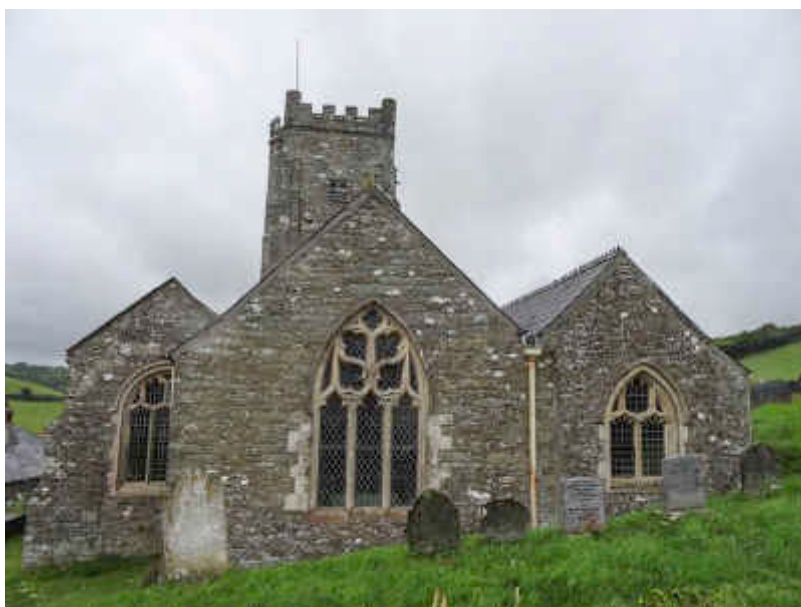
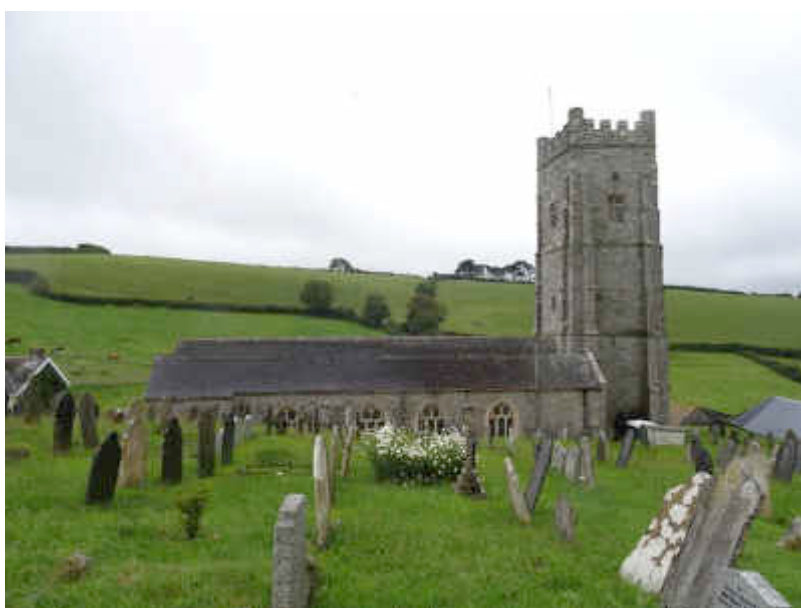
The condition of the building envelope has an impact on the interior fixtures and furnishings. The internal body of the church is damp. Intermittent heating is provided by means of a portable heater<sup>1</sup> that is only used prior to services and under pew heaters. Successive Quinquennial Reports have highlighted a number of issues associated with the church's cementitious pointing and render. This will inevitably encourage the retention of moisture within the walls and the internal plaster is failing as a result of the underlying damp. Other associated issues highlighted in the past have included the on-going maintenance and repair of rainwater goods such as downpipes and lead valley gutters as well as the overgrown vegetation around the perimeter of the church.

At the time of inspection damp and water ingress were an on-going issue. It should be noted that, even when aggravating causes are resolved it can still take time for the fabric of the building to attain a satisfactory equilibrium. A damp environment and fluctuating temperatures are detrimental to all the timber features examined as part of this investigation; it is a continual problem and contributes to among other things, insect infestation, dry rot and corrosion of iron fixings.

*Figure 31 ~ Views of exterior of the church illustrating variation between ground levels, east elevation (top) and north elevation (bottom).*

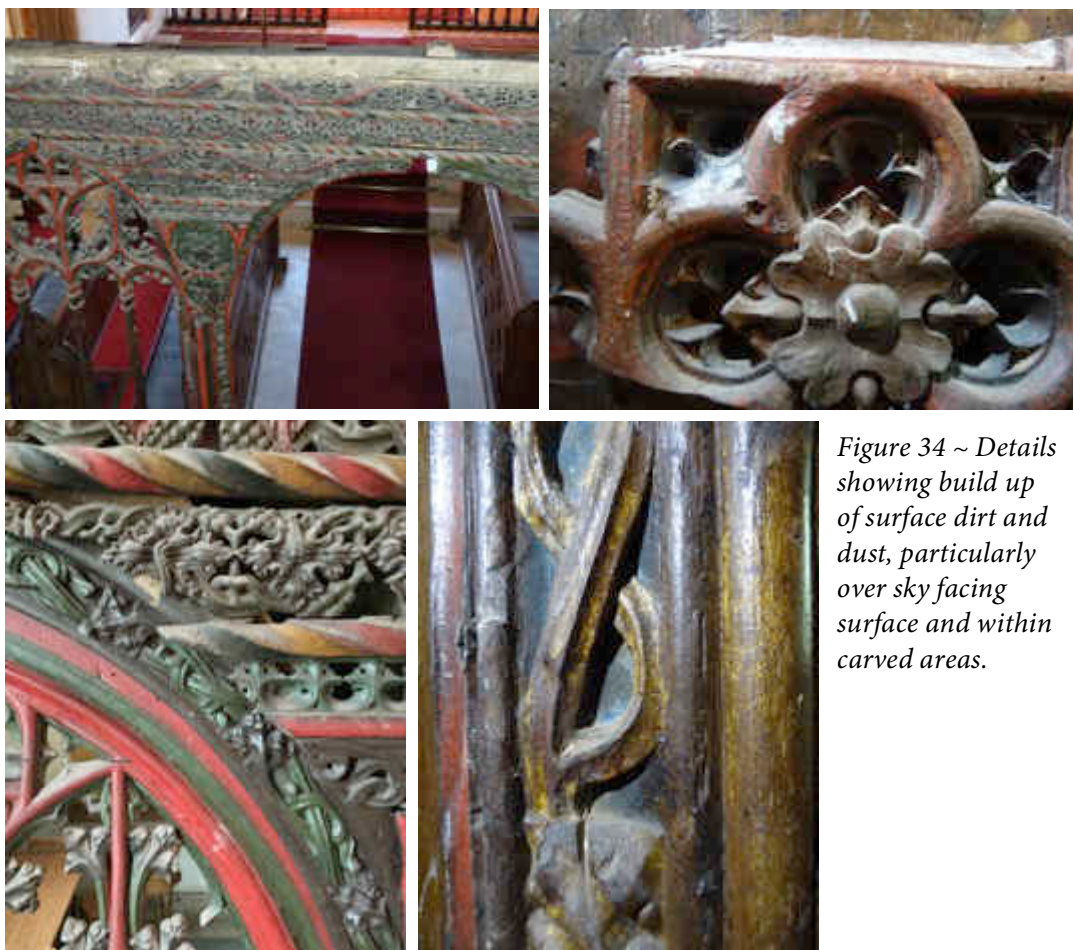
A heavy build up of dust and debris is present across all surfaces, with dust sticking to waxy/oily coatings. The soiling has muted the overall appearance of the polychromy. Surface blooming of the polychromy on the back of the south section of the screen may be due to the damp environment in this area.

Figure 34 ~ Details showing build up of surface dirt and dust, particularly over sky facing surface and within carved areas.

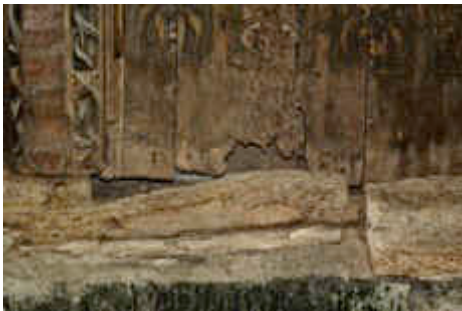
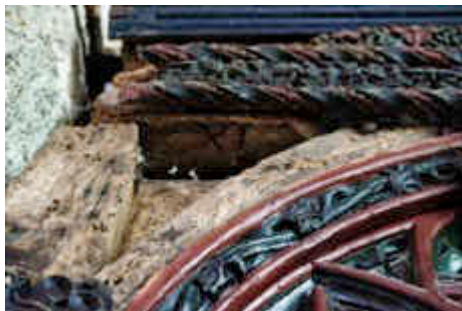
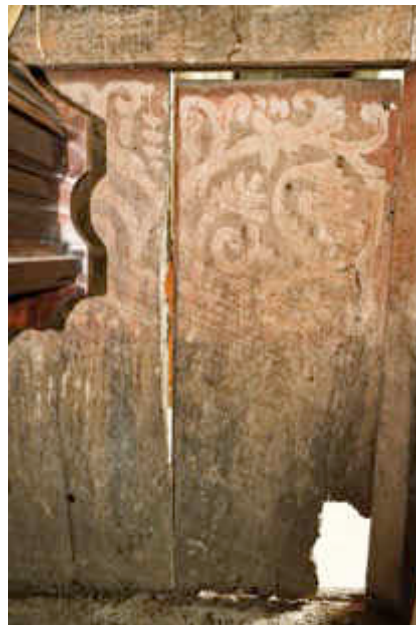
Across all the screens, though particularly apparent on the aisle sections of the rood screen, joints have opened, the panels, tracery and other carved elements are cracked, worn, decayed and in several areas missing, thus making adjacent elements more vulnerable to loss and further damage. Panels are thin and in places they are splitting and have dropped or are lifting away from the support structure.

*Figure 36 ~ Details showing various areas of losses and vulnerable sections observed across the rood screen.*

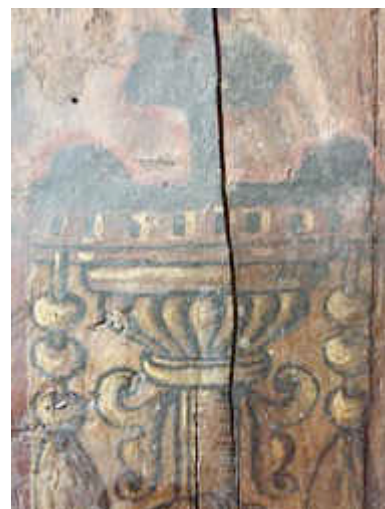
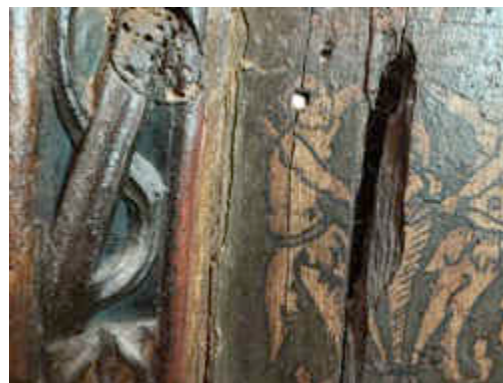
*Figure 37 ~ Cracks and damaged sections noted on the painted dado panels on the south aisle screen.*

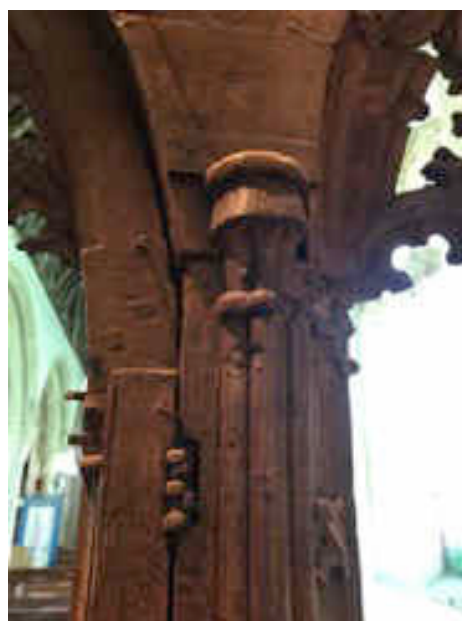
Hinges noted on the middle sections of the north aisle screen indicate that the door opening was positioned centrally. The current openings adjacent to the external walls would have been filled in with decorative dado panels and tracery above.

*Figure 39 ~ Hinges still visible on section 2 of the rood screen.*

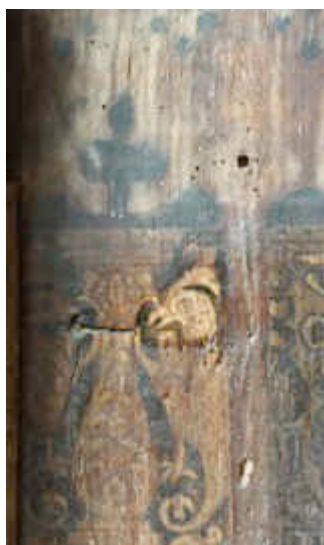
*Figure 42 ~ Previous cleaning trial on the west elevation of the north rood screen panels, showing the detail and bright polychromy beneath.*

Tests would establish which of these coatings can be safely removed to reveal original decoration beneath and further paint analysis would inform conservation as well as provide information on materials and techniques of the early craftsmen.

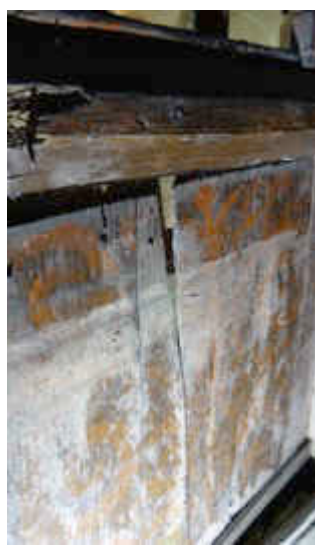
A white bloom noted in a few areas, but mostly over the arabesque paintings of the north and south rood screen extensions, this may be a possible indication of residue from over-paint.

*Figure 43 ~ Back (west elevation) of the dado panels on the south section of the screen, showing white blooming and surface dirt covering the polychromy.*

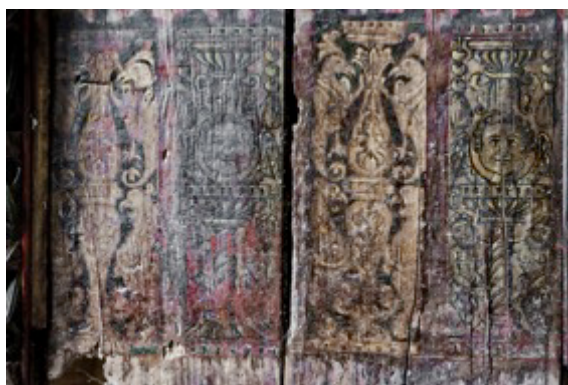
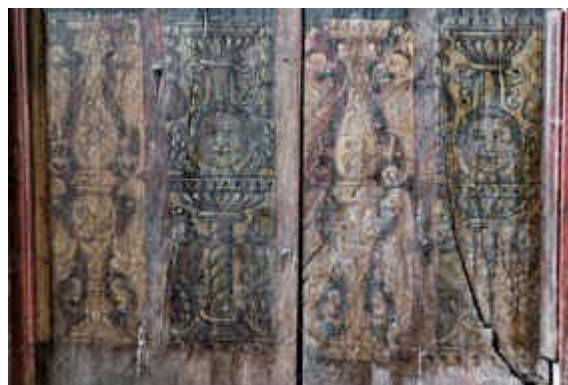
*Figure 44 ~ The panels on the west elevation of the north aisle sections of the screen have been coated with a varnish. As noted elsewhere this coating has been thickly applied with dark drip runs observed.*

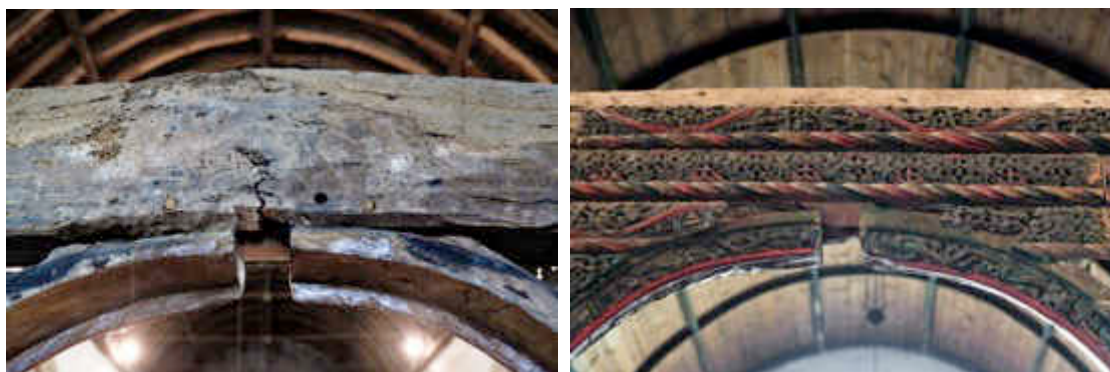
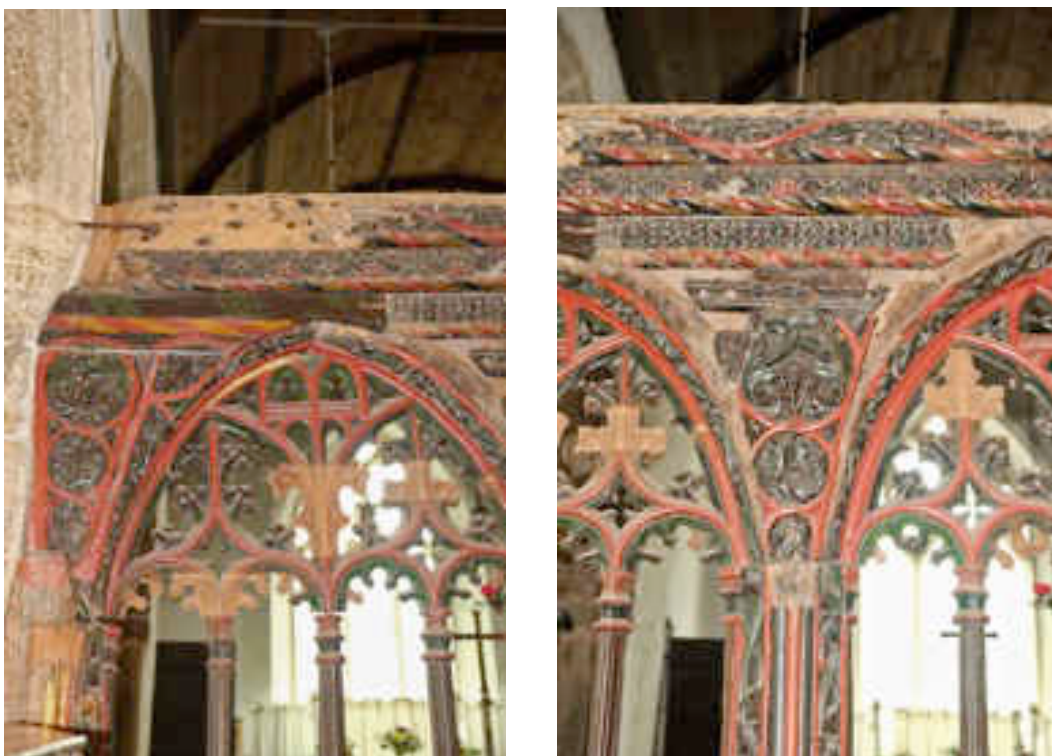
Extensive areas of the carved architectural framework have bright 19<sup>th</sup> century over paint. Whilst it may not be possible to or even desirable to remove this paint scheme it is likely that it would benefit from cleaning.

*Figure 48 ~ Details showing the bright over paint covering several areas of the architectural framework.*

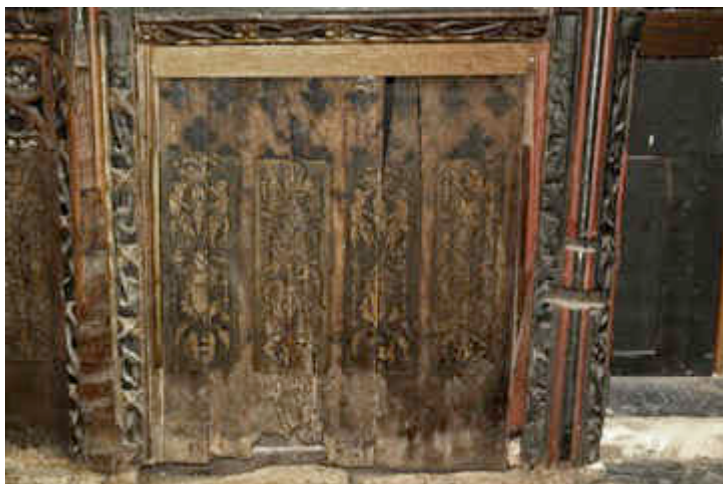
The aisle screens were not addressed as part of the Herbert Read Ltd conservation works, however temporary timber supports have been added to the face at some point. The screens are in a poor state and in need of urgent attention, with decayed timber elements where deathwatch beetle and damp have caused the wood to fragment and disintegrate.

*Figure 50 ~ Not fully addressed as part of the 1970 restoration works are in now in need of attention.*

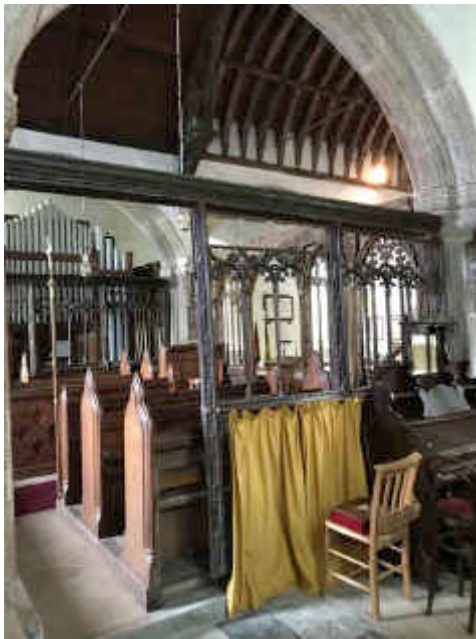
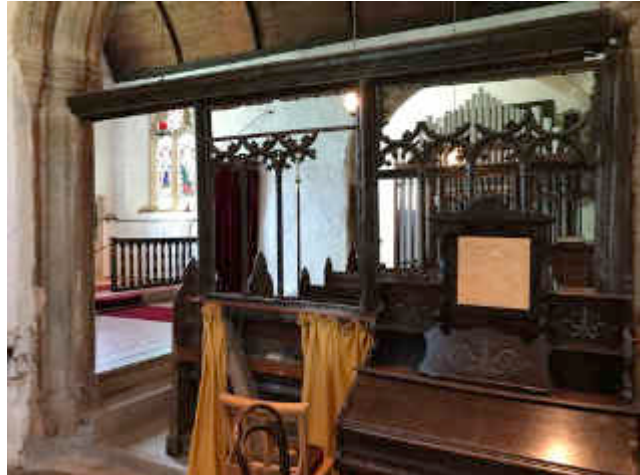
The parclose screens are in a particularly poor state of repair with damaged sills and sections crudely fixed to the walls. Detached dado panels are currently stored in the vestry. Although generally the north appears to have suffered more, both sides require urgent attention.

*Figure 51 ~ Overall views of the two parclose screens from the Lady Chapel.*

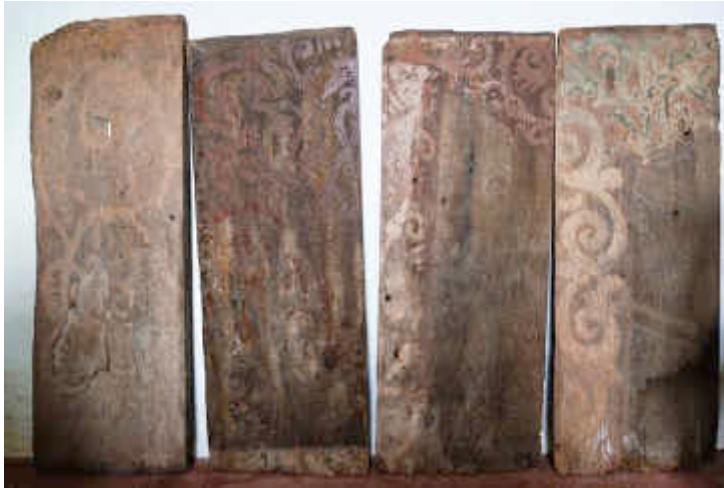
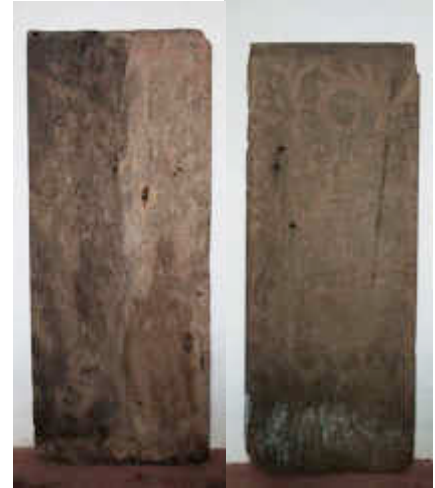
All the lower dado panels on the north parclose screen are no longer in situ and only two panels (one to the west end and one to the far east end) remain on the south parclose screen. Four detached panels are currently being stored in the vestry. They have suffered from the effects of damp and insect damage. Dark staining, mould and rotten, decayed ends were noted on all pieces. Rust staining from previous fixings and splits in the timber were also observed on several of the panels.

Figure 55 ~ Four panels currently stored in the vestry (above left) and the reverse of the far right two (right) showing rotten decay, dark staining and mould from damp and insect damage.

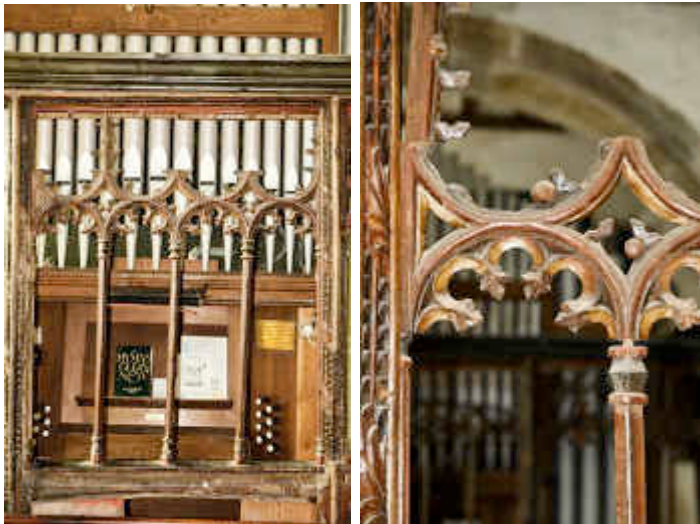
Both parclose screens tracery and other carving is damaged and missing, thus causing adjacent remaining elements to be even more vulnerable to loss and further damage. The lower cills and support framework are missing or severely compromised in their structural ability.

Figure 56 ~ Missing sections of tracery across the upper architectural sections of the parclose screens.

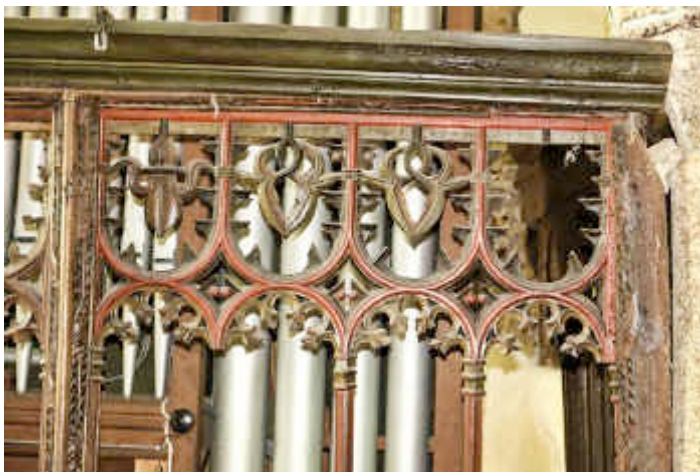
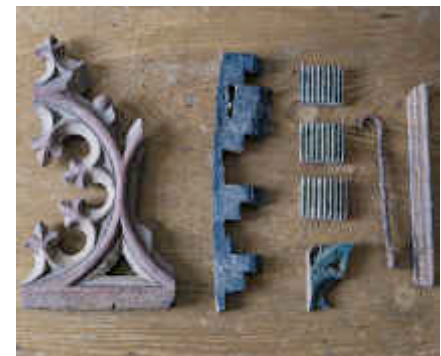
Figure 57 ~ Fragments of tracery stored in the vestry. These may be from the rood and/or Parclose screens.

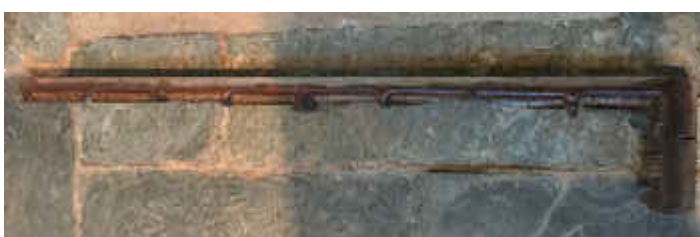
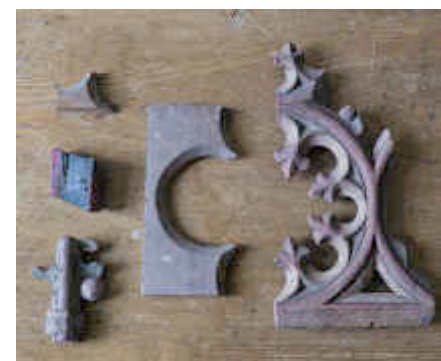
*Figure 58 ~ Details showing missing support to the base of carved upright post on north screen (left) and dropped / misaligned section of tracery on north screen (right).*

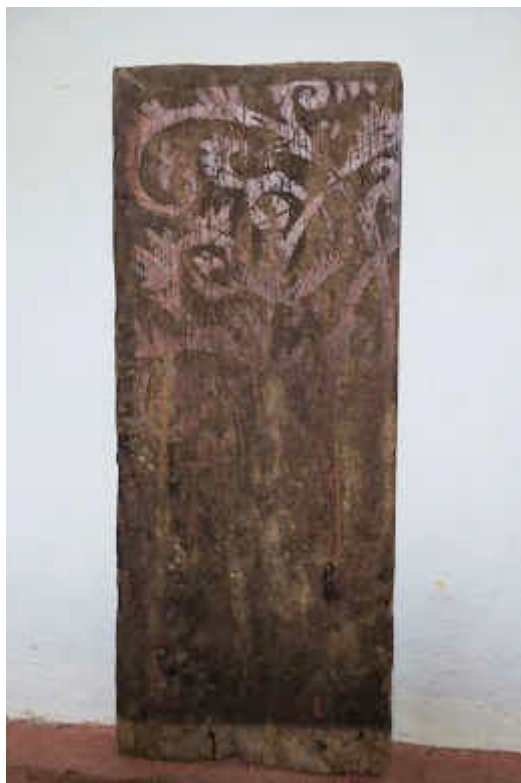
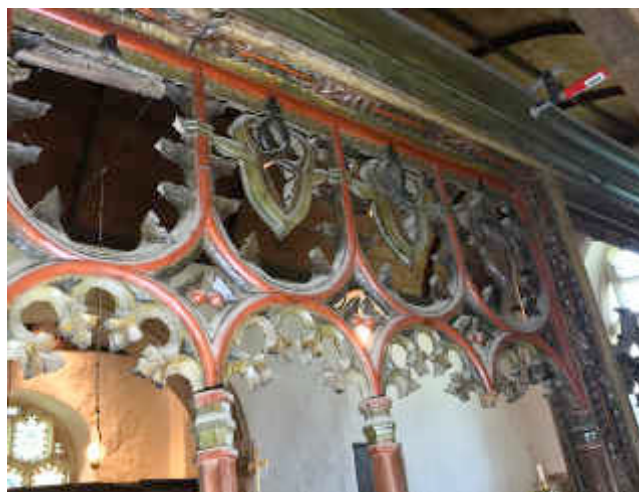
*Figure 60 ~ With additional lighting it is possible to see the same vibrant colour palette on the tracery of the parclose screen, as was noted elsewhere on the rood screen and pulpit (above right). A similar renaissance style of painting is found on the panels stored in the vestry as appears on the rood screen north and south extensions (left).*

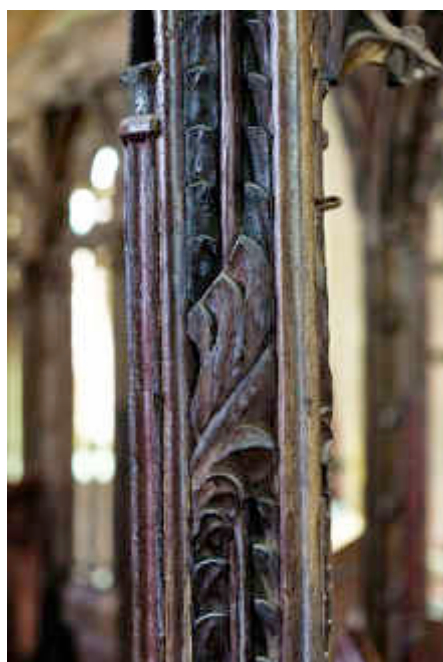
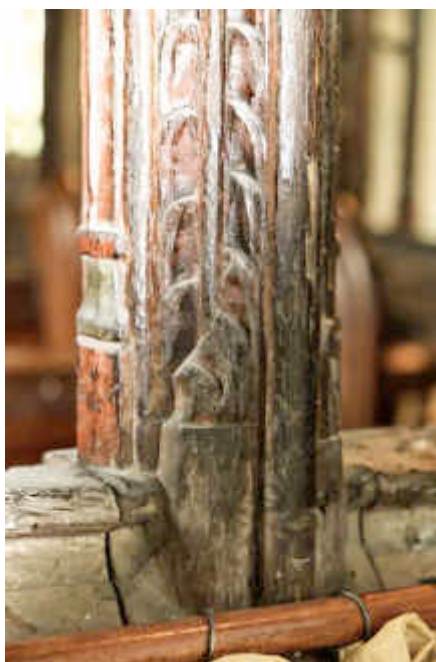
A heavy-handed application of varnish has been applied to many of the surfaces and drip runs of the varnish are visible along the top moulding of the tracery. The varnish coating has discoloured and darkened over time and obscures the vibrancy of the colours beneath. Some of the moulding on the carved uprights above the sills has a chalky, white appearance. This is most likely a reaction to the damp where the varnish coating has bloomed and become opaque.

*Figure 61 ~ Detail of upright posts showing the effect of discoloured varnish over polychromy.*

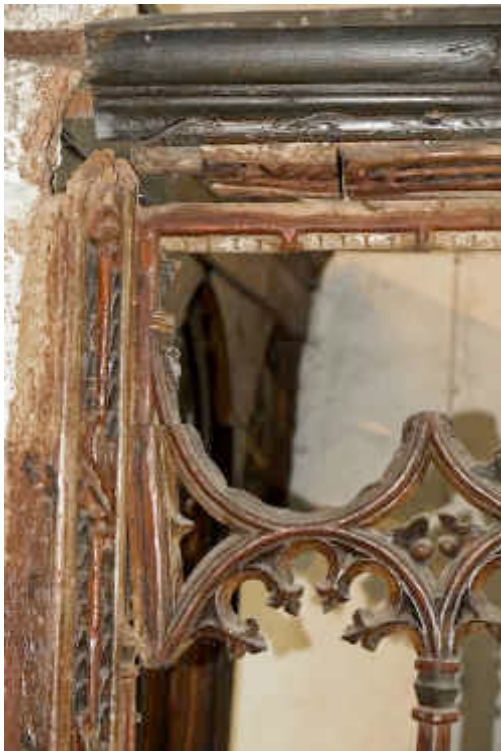
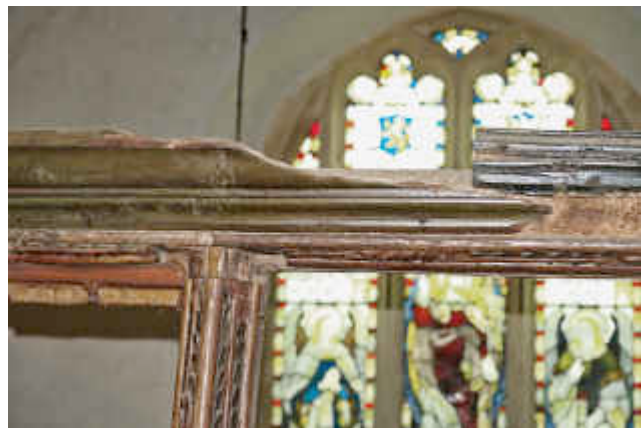
*Figure 62 ~ Details showing addition of later cornice detail along top of screen beam.*

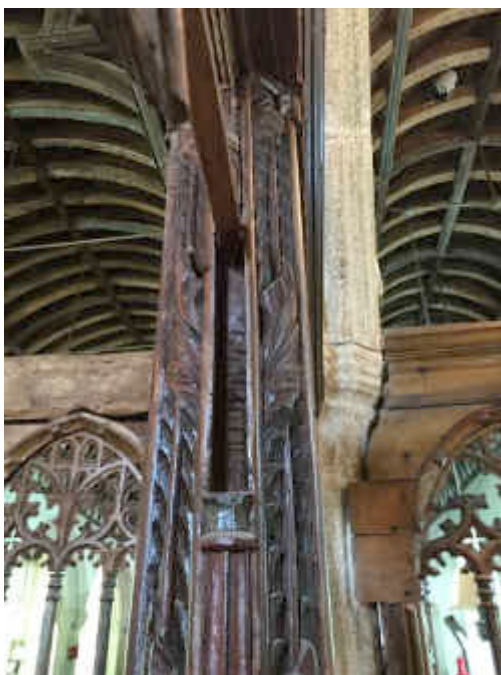
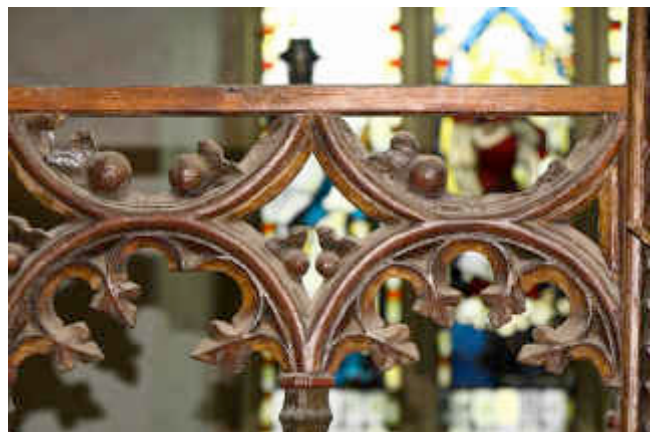
The upper sections of the screens have been dismantled /removed and what appears to be a later cornice section added. Sections of missing tracery from the upper framework are identified by the now empty locating channels. These channels exist across all sections of the screen including the doorway openings suggesting that these too once had fine, carved tracery panels. A single length of square section timber has been attached along the top of the remaining tracery on the middle section of the north screen adjacent to the door opening, to offer support.

*Figure 63 ~ Chiselled out channels in framework, indicating location of tracery sections now missing (left) and length of square section timber pieced in to offer support to vulnerable tracery (above).*

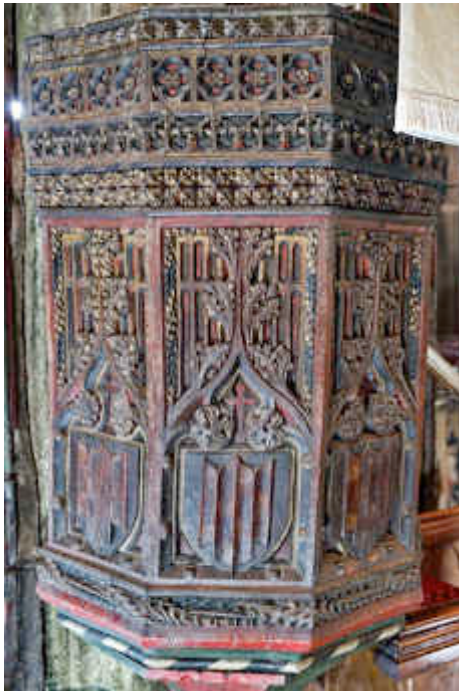
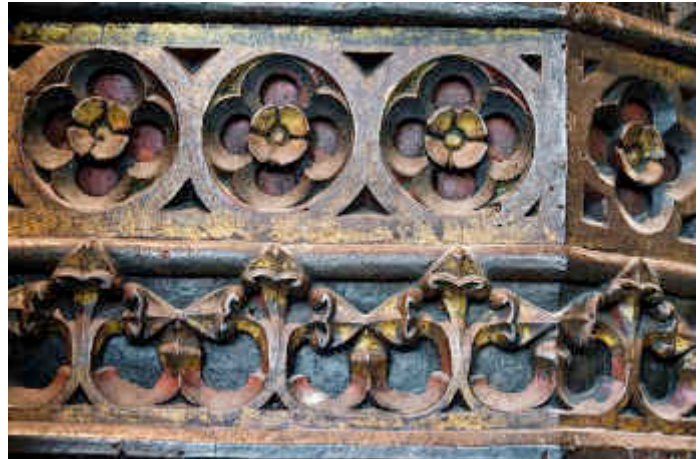
A general veil of dust and debris present across the pulpit, with thicker accumulations on sky facing surfaces and within carved reliefs has darkened and dulled the overall appearance of the vibrant polychromy. The sticky wax and/or varnish coatings have trapped layers of dirt over time. Residues of candle wax drips were noted around attached timber blocks either side of the book stand.

*Figure 64 ~ Details showing the overall dulled appearance of the polychromy due to surface dirt and dust and discoloured varnish layers. The dirt layers have accumulated within later surface coatings.*

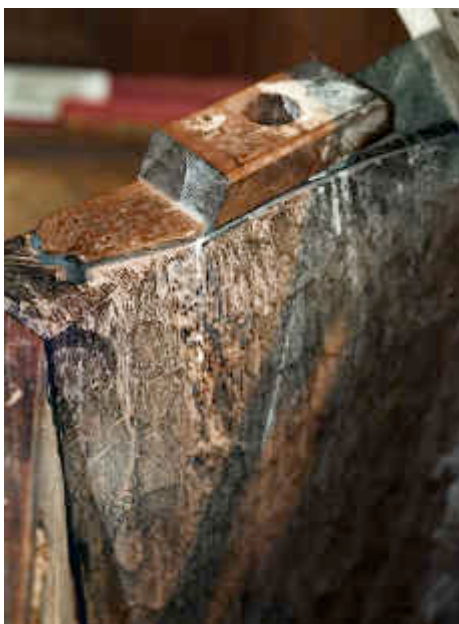
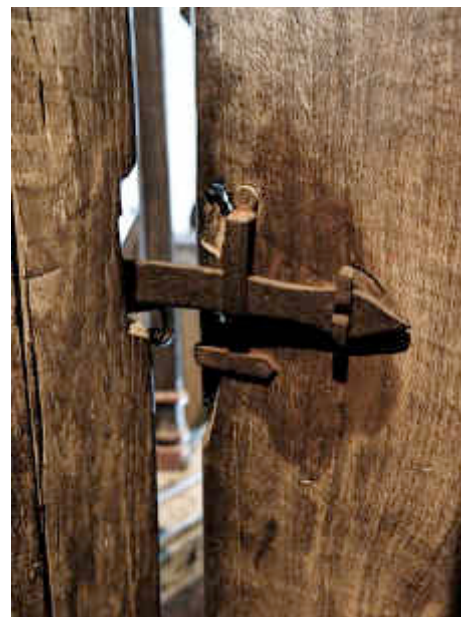
*Figure 65 ~ Candle wax drips around attached timber blocks found either side of the book stand (left) and darkened timber adjacent to the door latch and along the top edge of the pulpit from frequent handling and cleaning.*

The timber adjacent to the opening latch and along the pulpit upper ledge/sill has darkened due to natural oils from frequent handling, iron treatment and cleaning.

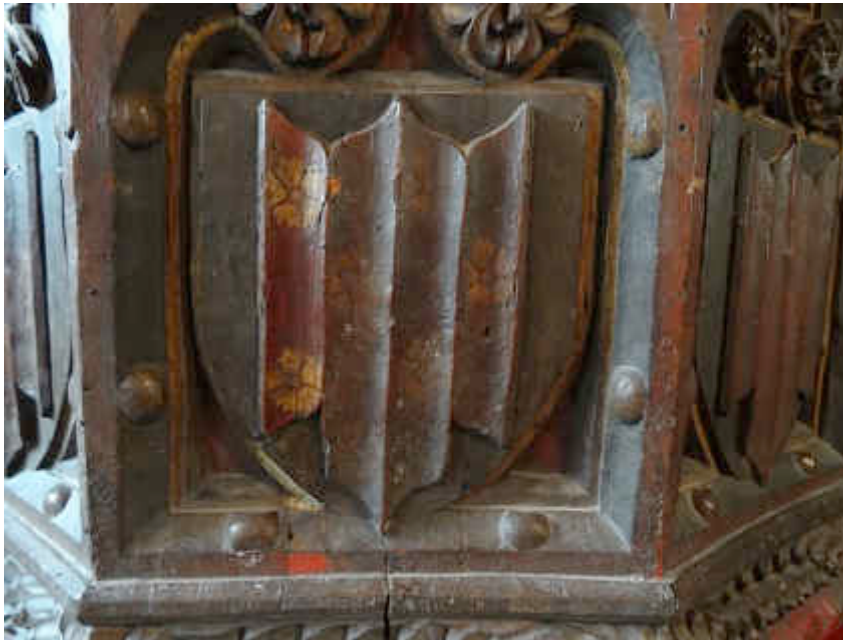
Small cleaning trials carried out by Eddie Sinclair ACR reveal the bright illuminated colours beneath.

Figure 66 ~ Detail of small cleaning trial on pulpit across decorative shield carving and vertical border surface below have revealed bright colours and stencil work.

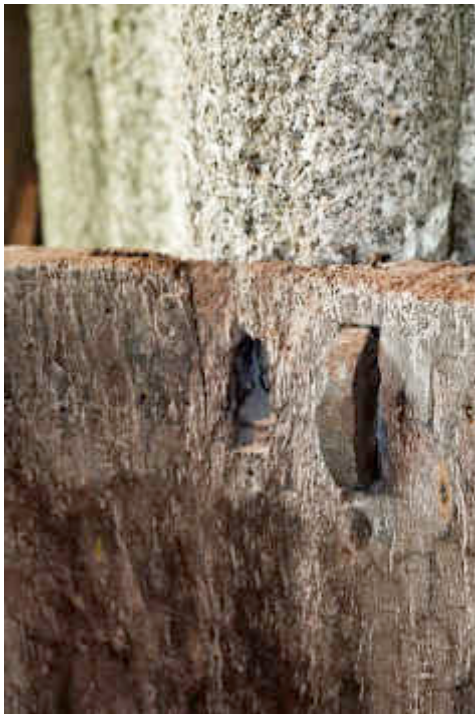
A large crude ferrous fixing anchors the pulpit to the adjacent granite column. The original location and height of the pulpit is unknown, as the base/pedestal has been replaced and the original steps no longer exist. The pedestal currently is raised on a large stone, shadowing ton the stone implies this has been moved relatively recently. The date of the pedestal is unknown. Further analysis of the polychromy could possibly establish which period this was added. The pulpit steps are also more recent.

*Figure 75 ~ Detail of ferrous fixing, anchoring the upper edge of the pulpit to the adjacent stonework.*

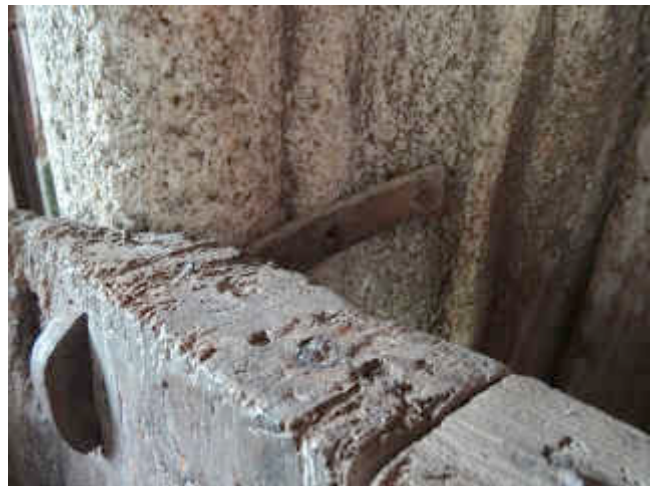
The pulpit has been repaired many times and redecorated. Additional support timbers have been applied to the upper edge and a lectern fixed to the front rim.

*Figure 76 ~ Thin timber repair to protect the vulnerable upper edge of pulpit.*

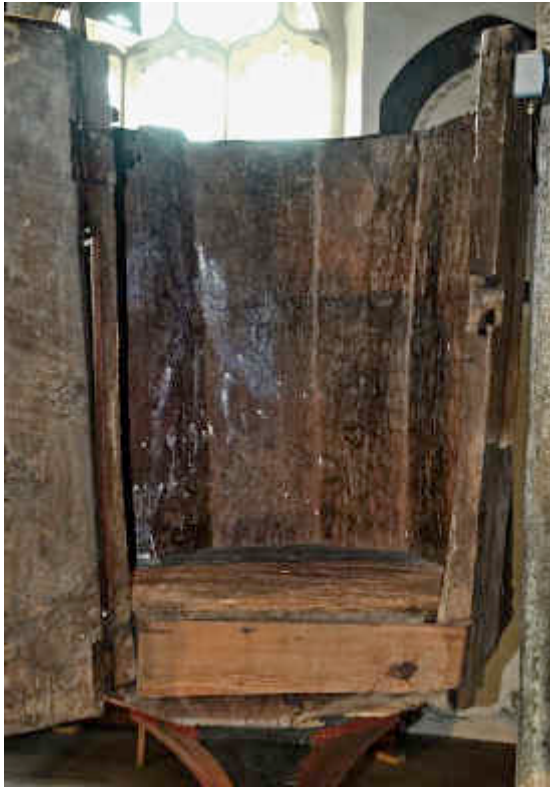
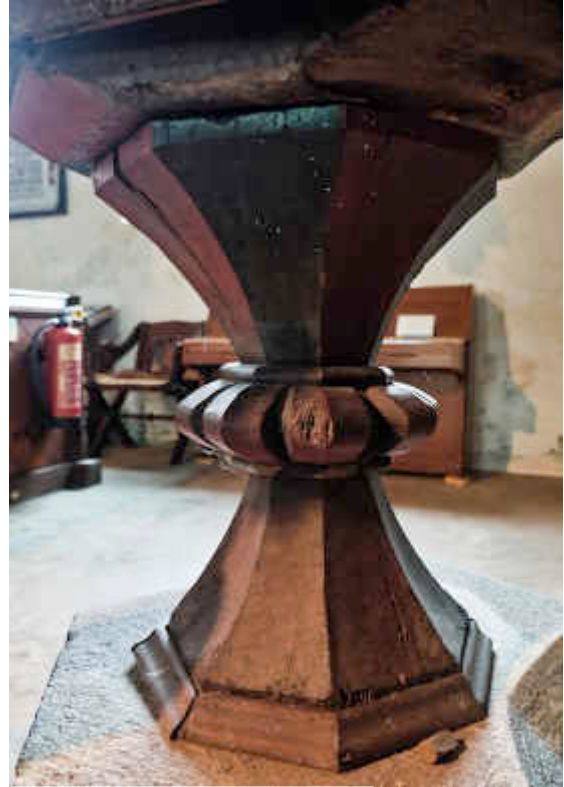
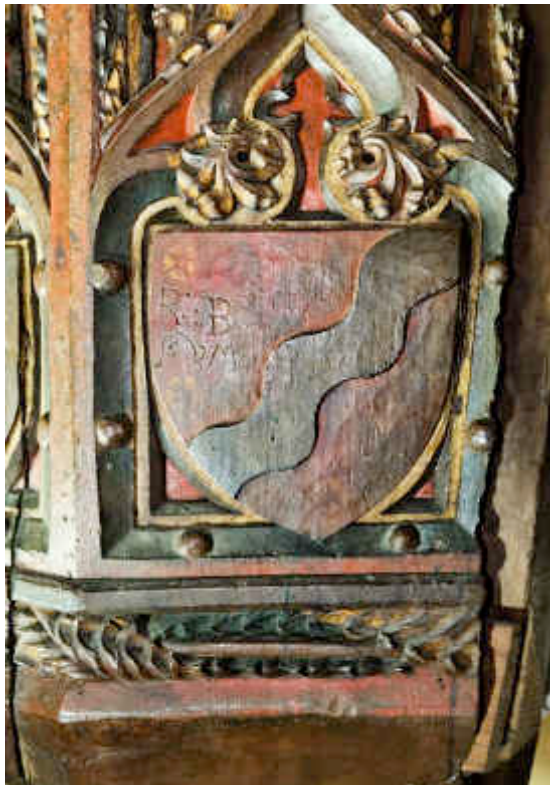
The shield facing south differs to the others and has initials cut into it, possibly graffiti.

*Figure 78 ~ Various views of the pulpit from top left; inside view; pedestal on stone base; coat of arms with graffiti initials; door and base.*

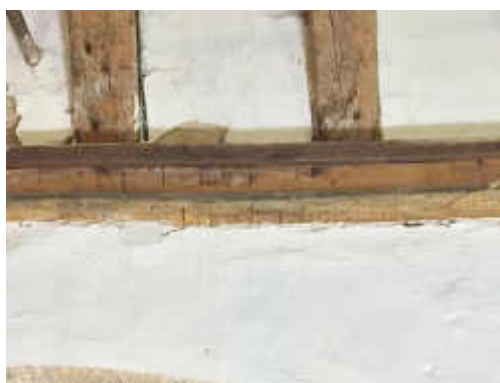
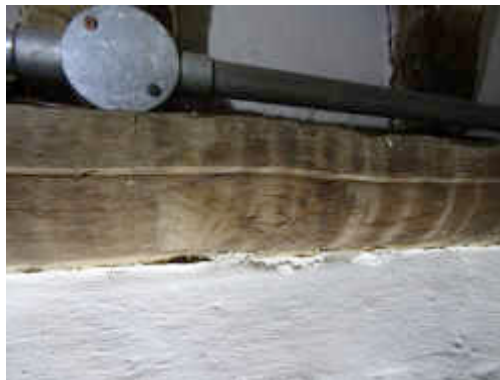
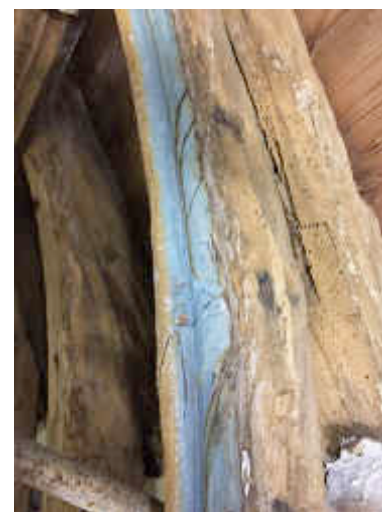
Dark staining apparent on some timbers may be due to past treatments or from water ingress. Drip runs from historic water leaks have also marked the timberwork.

*Figure 79 ~ Details showing staining from past leaks.*

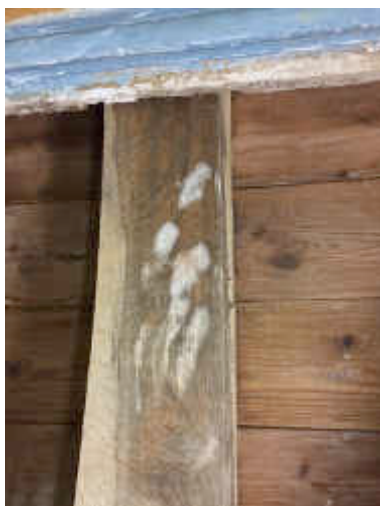
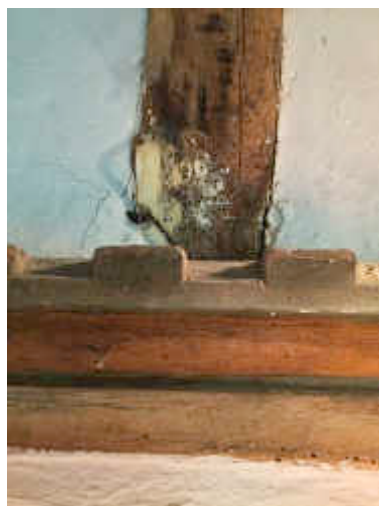
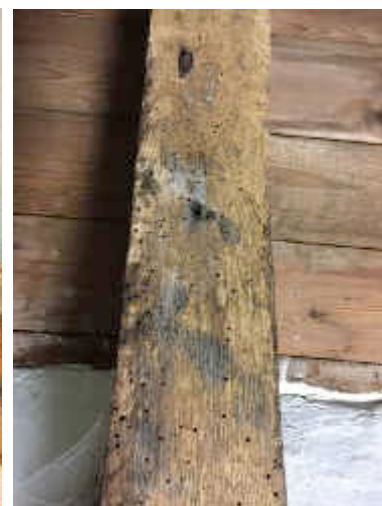
The timberwork is covered with dust, cobwebs and a general build up of dirt, particularly noted across sky facing surfaces. The soiling present on all areas has darkened the timber. Variations in colour are also due to a number of factors: piecing in of timbers during programmes of repair, the damp environment and damage from insect infestation.

*Figure 80 ~ Details of typical soiling and discolouration observed across the roof timbers.*

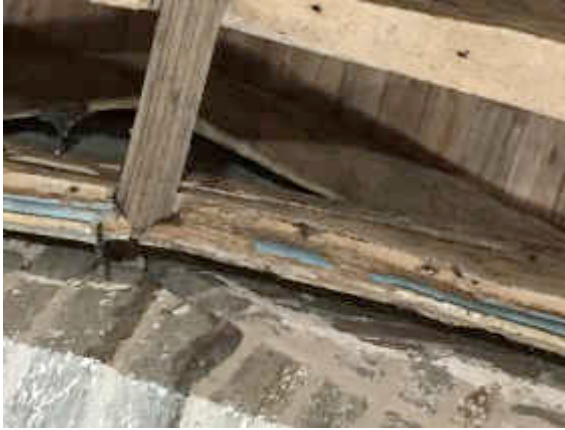
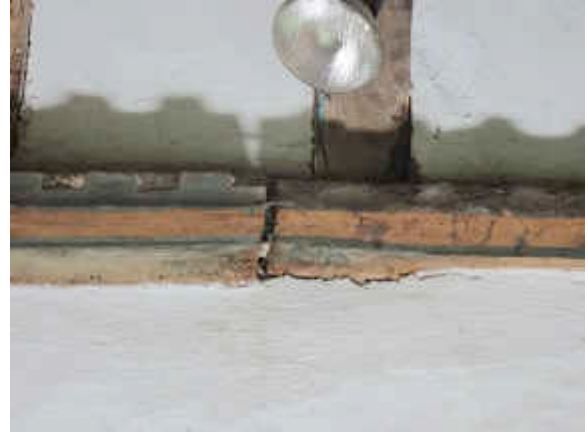
Losses to the wall plate line were observed throughout the church and many have been repaired. There were a surprising number of different designs to the wall plate.

*Figure 84 ~ losses to the timber structure in general and to the wall plate line (above right) were observed throughout the church.*

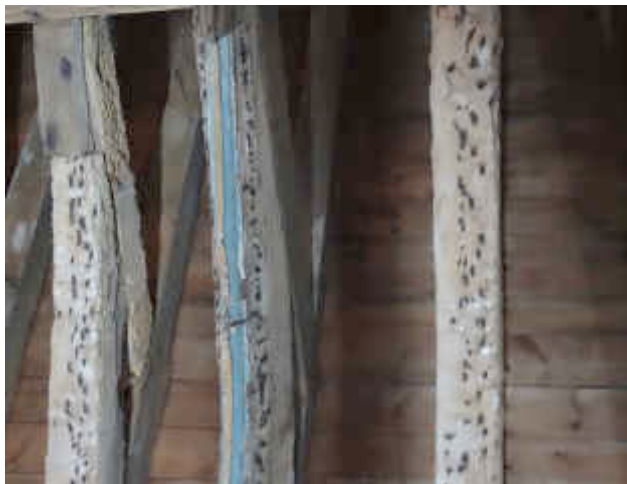
*Figure 85 ~ Areas of ribs with larger number of nail holes. It has been presumed that this area was repaired with lath and plaster at some point. A leak in the roof may have caused the original panelling to fail.*

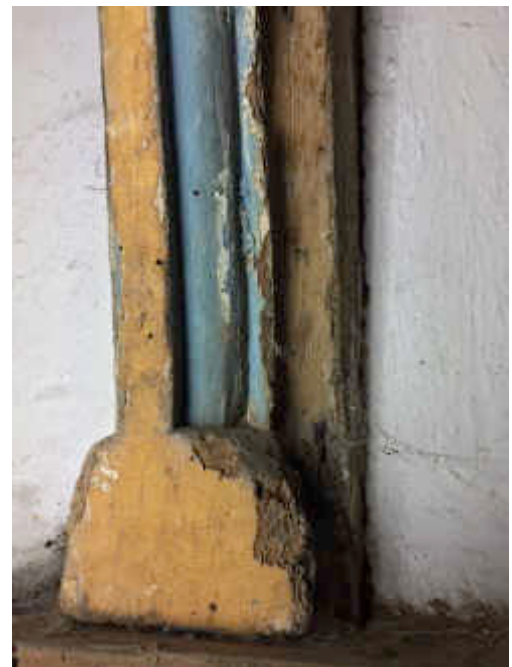
*Figure 87 ~ Detail of end of moulded rib where it meets the wall plate. The shape of the end implies that a boss may have joined at this point.*

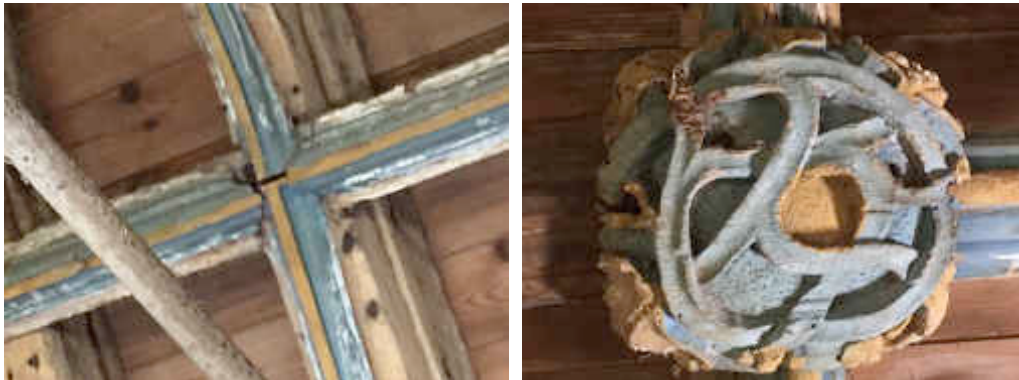
Over time the polychromy has discoloured/faded and the surfaces are worn in areas, revealing the lead white and timber beneath. Limewash applications to the surrounding wall surfaces have also been applied over adjacent timber polychromy. Localised losses to the wall paint reveal a much more intense, brighter blue colour on the previously covered timber.

*Figure 90 ~ Polychromy on the moulded ribs and purlins, ceiling bosses and carved wall plates.*

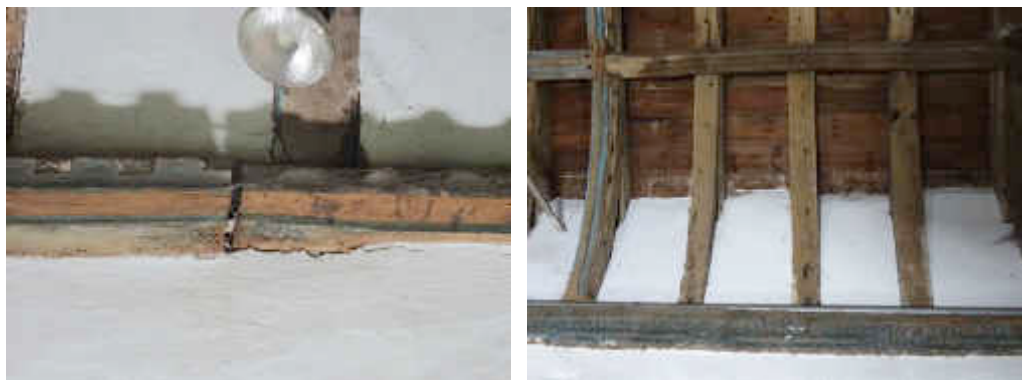
*Figure 91 ~ Polychromy of the same palette covers the original wall plate mouldings as is found across the moulded roof timbers.*

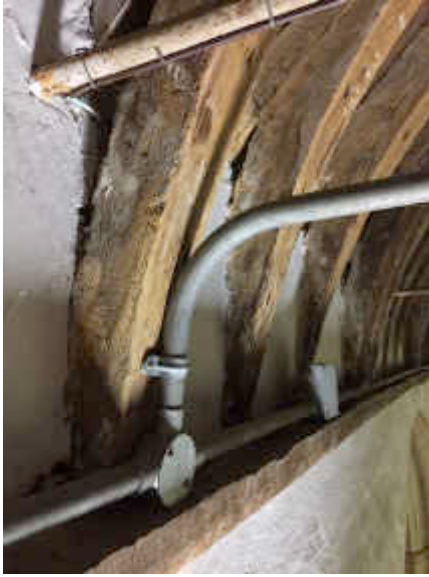
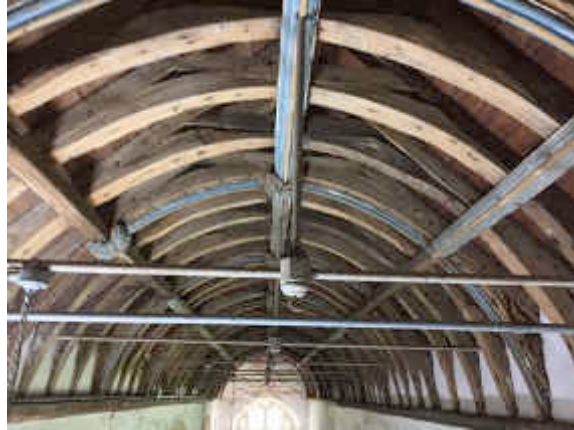
The inserted Victorian iron truss brackets/tie bars are showing signs of corrosion. Areas of detached and flaking plasterwork were noted above the wall plate line and in most cases appear to be associated with corroding rod ends.

*Figure 95 ~ Tie rods were introduced across all three areas of roof timbers during an earlier Victorian phase of repair.*

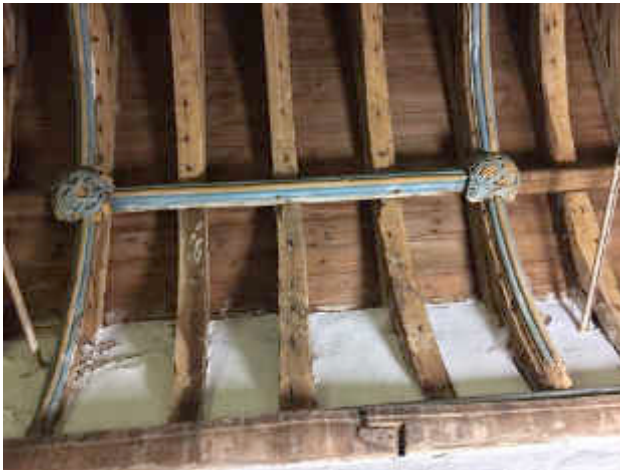
*Figure 96 ~ Timber panelling lost from between the moulded purlins and ribs.*
