ST SYLVESTER'S CHURCH ~ CHIVELSTONE

PARCLOSE SCREENS, ROOD SCREEN  
& DECORATIVE ROOF TIMBERS

CONDITION ASSESSMENT &  
CONSERVATION RECOMMENDATIONS

JUNE 2019

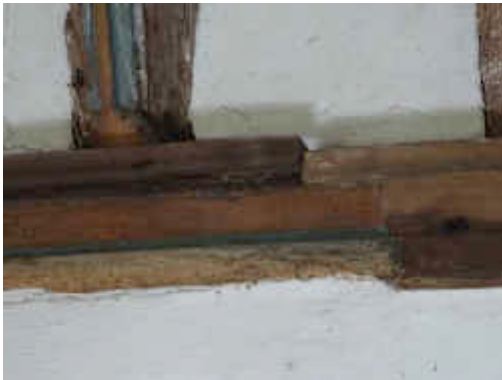
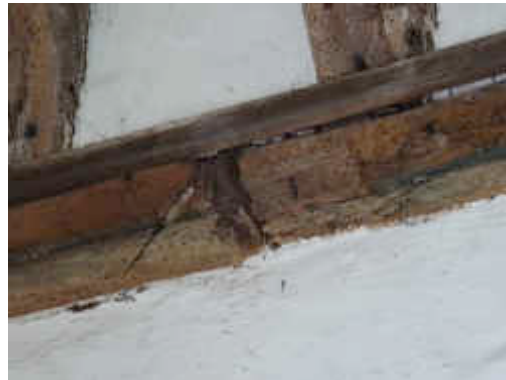
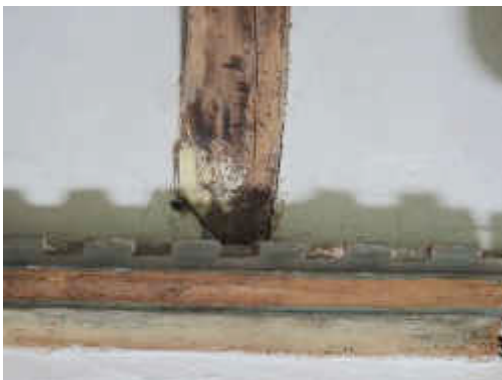
*Figure 97 ~ The fine dentil carving of the wall plate in the nave have worn or been lost in areas and the upper section of some have been covered with a plain length of timber.*

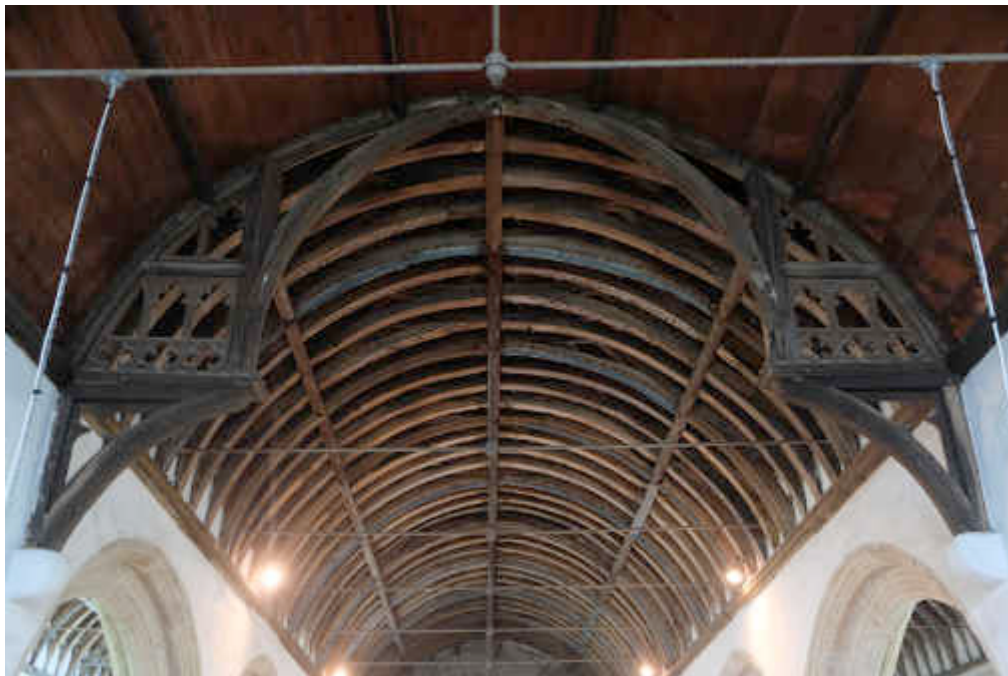
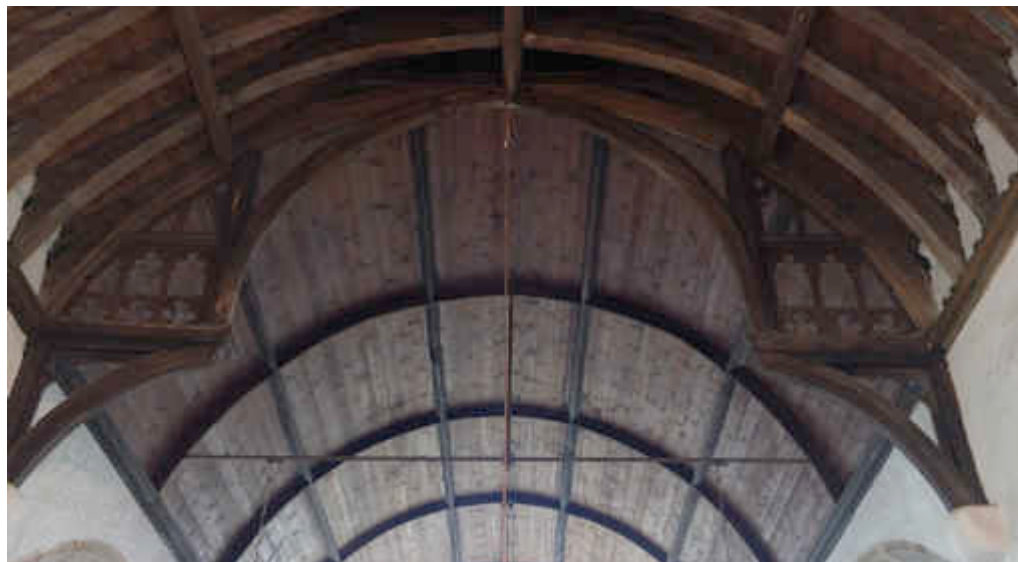
The Chancel arch timbers appear to be in relatively good condition, however movement was noted. See figure below. Close inspection was not possible from the tower access and it is not possible to tell if the movement is historic or recent.

The lower braces rest on a stone corbel. No movement or cracking was evident to the surrounding wall. However, opening of joints was noted on the lower south arch at the junction with the wall below the wall plate. It is recommended that an engineer inspect the structural integrity of the arch.

*Figure 101 ~ Chancel arch viewed from the east (above) and west (below).*

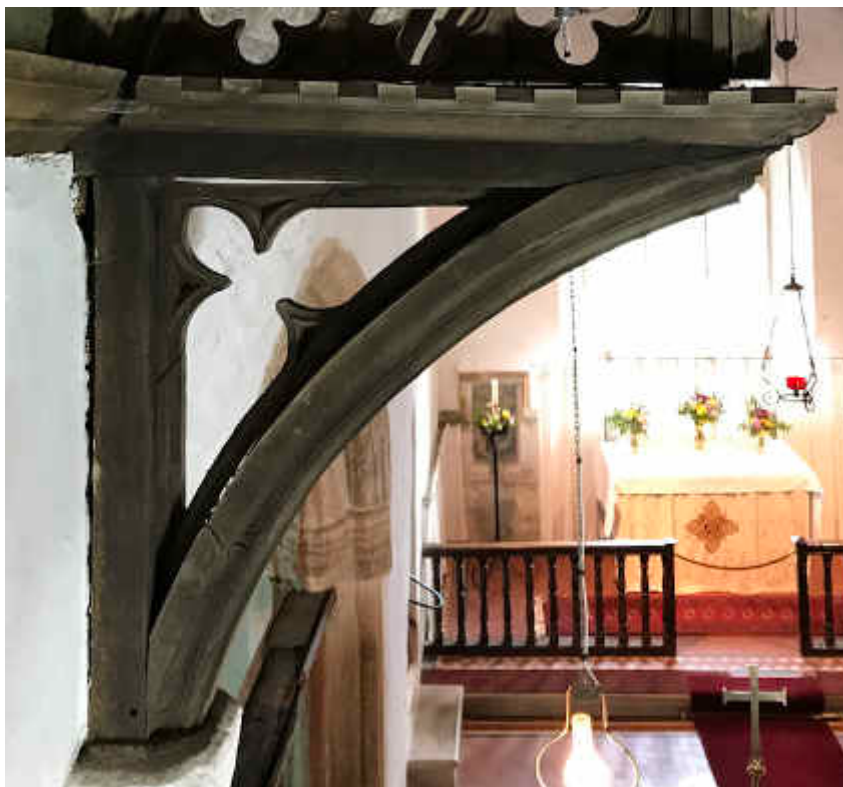
*Figure 103 ~ Detail of north bracket as viewed from the west, from corbel to wall plate.*

*The beam appears to have dropped, or tipped forward leaving a gap between the vertical post and the elevation. The gap may also be noted at the junction with the wall plate and the hammer beam and again between the beam and the upper brace.*

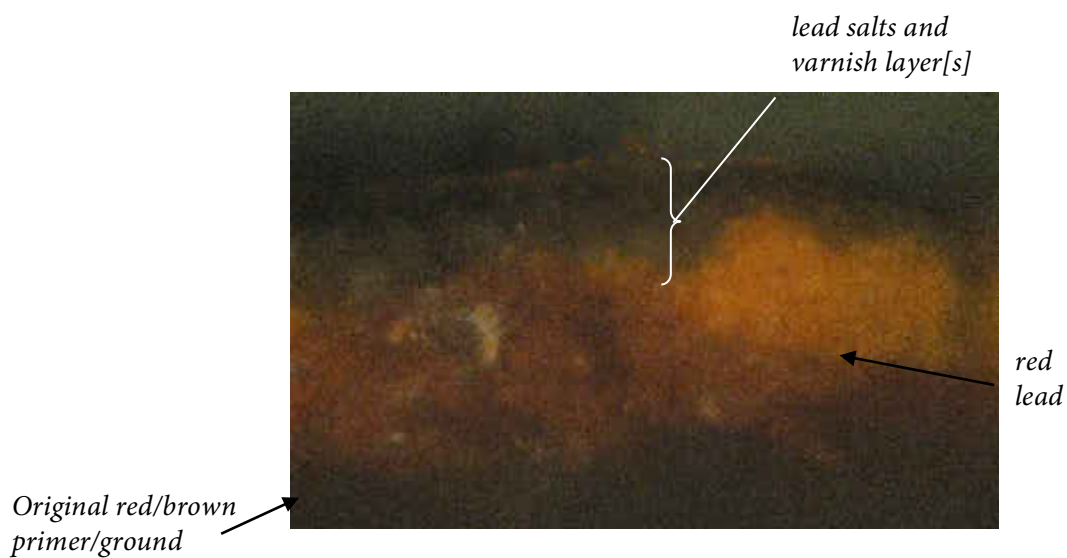
SAMPLE 12

The paint layers in this fragment are in very poor condition, but this is the only sample which suggests red lead is part of the original scheme

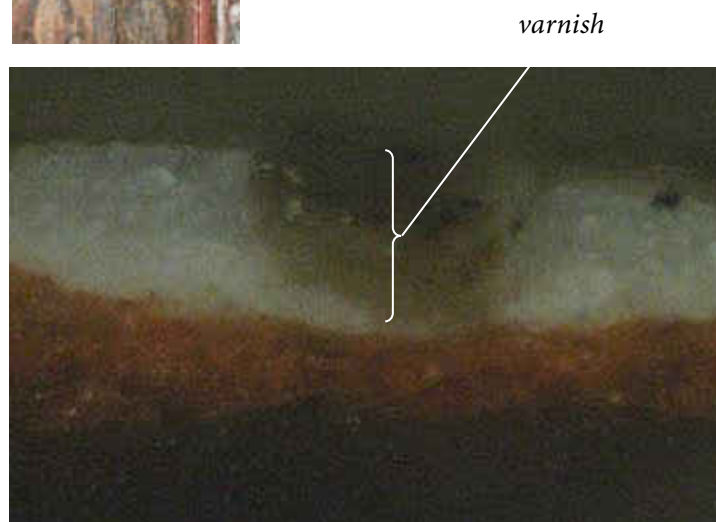
SAMPLE 13

Rood screen - nave  
 First bead moulding around panel – gold

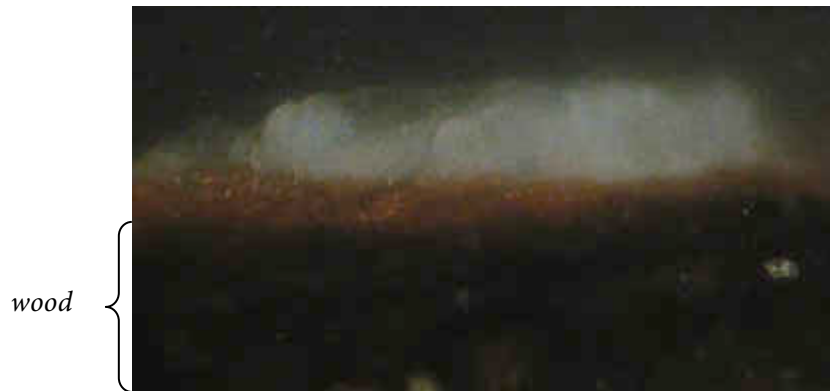
Fragment (ii)  
showing the red resting on wood

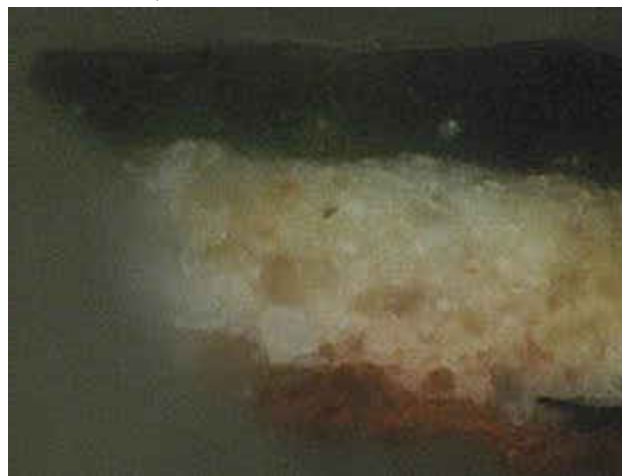
SAMPLE 15

Rood screen - nave  
Plinth/urn - ochre

In this sample the copper green glaze is over a thick layer of lead white

Detail of the glaze layer, lit  
from behind to show that  
it is translucent

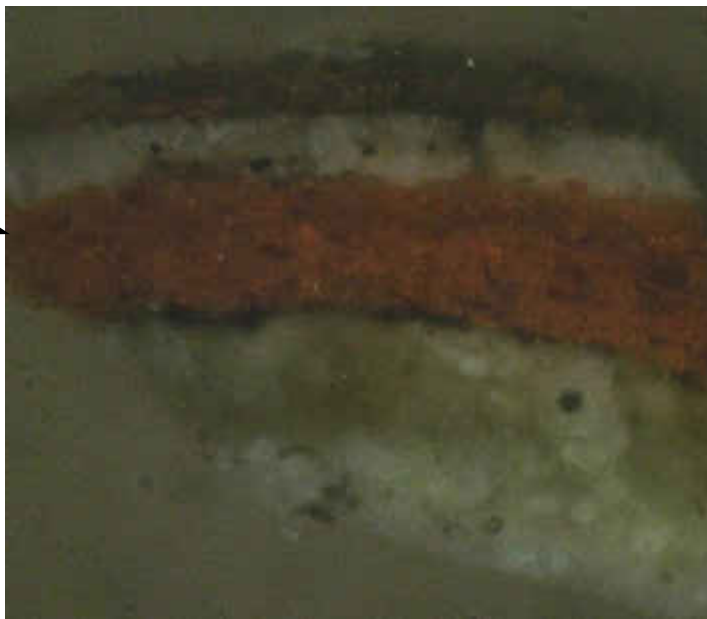
SAMPLE 16

*In this fragment there  
 are white layers above  
 and below the original  
 red/brown  
 primer/ground*

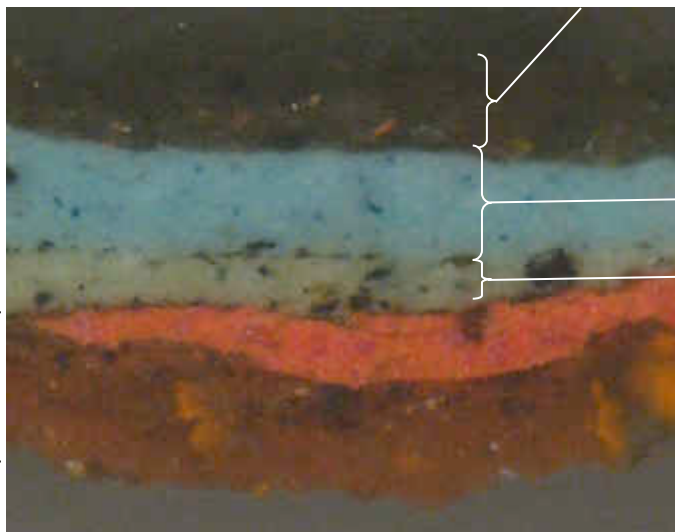
SAMPLE 17

Rood screen - nave  
 Base of upright on screen  
 left of opening to chancel  
 green

*2<sup>nd</sup> re-paint*

*grey of 1<sup>st</sup>  
 re-paint*

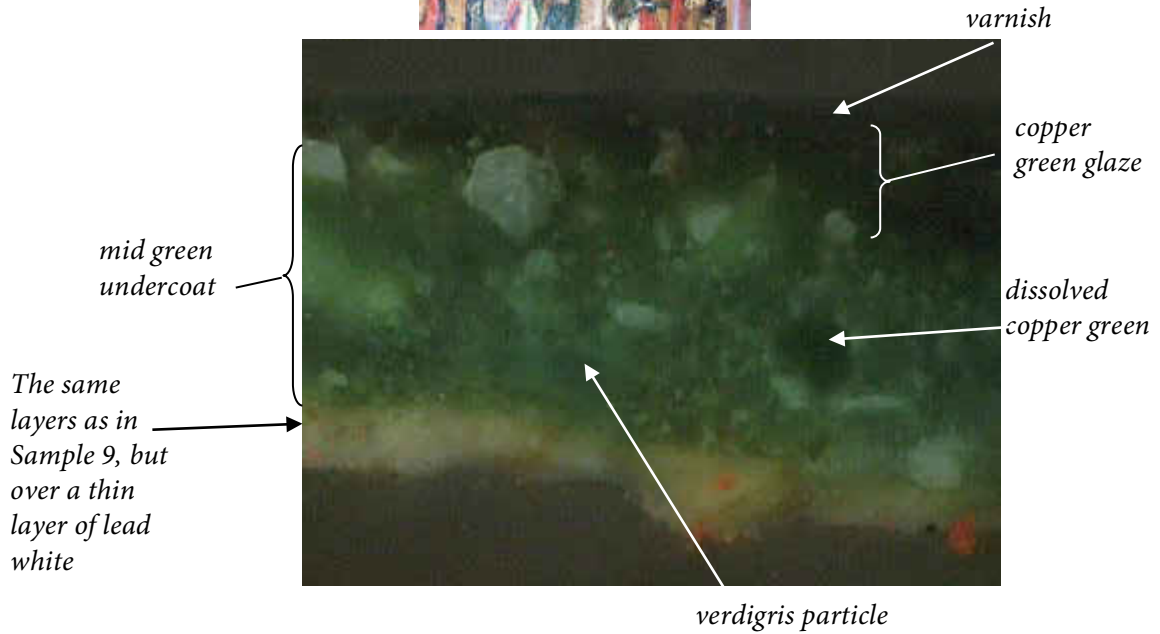
**SAMPLE 20**

Rood screen - nave  
 Fold in sleeve of robe – green

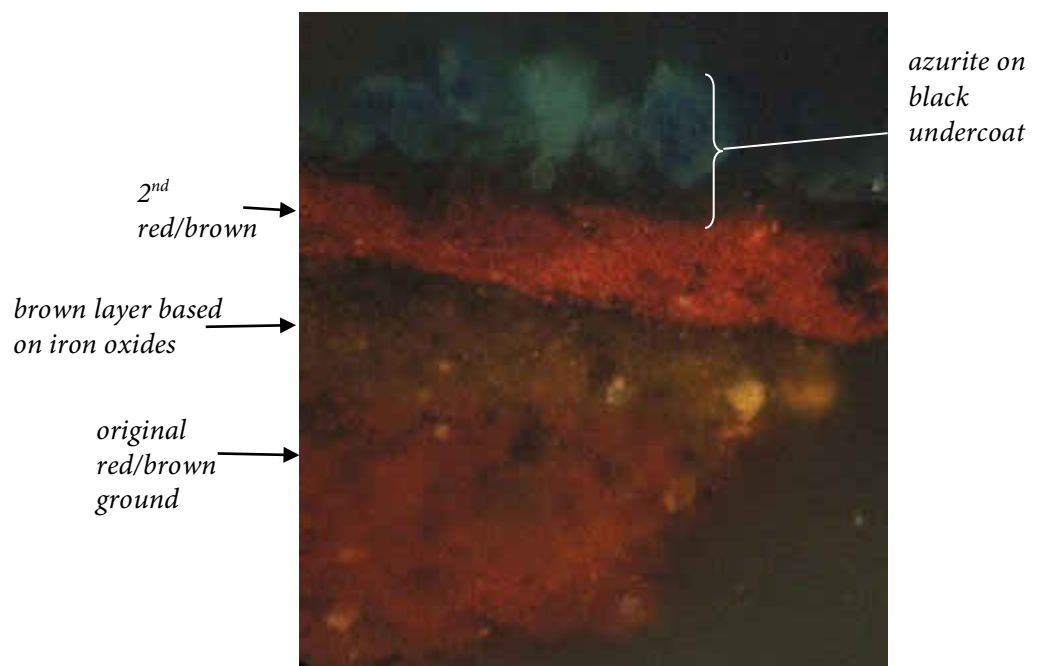
**SAMPLE 21**

Rood screen - nave  
 Background to raised foliate design border – blue

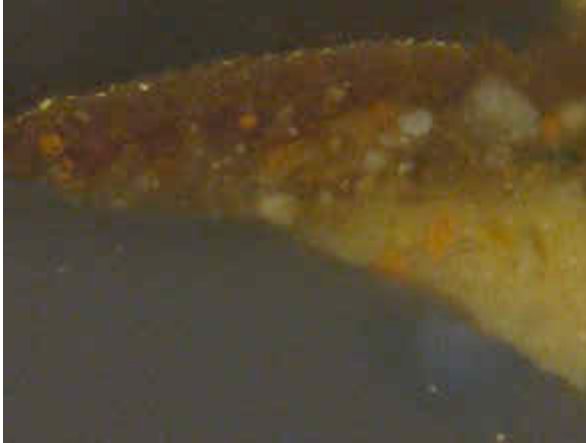
SAMPLE 22

Rood screen - nave

The gold leaf is on an oil-rich  
 layers containing red lead,  
 ochre and a little lead white

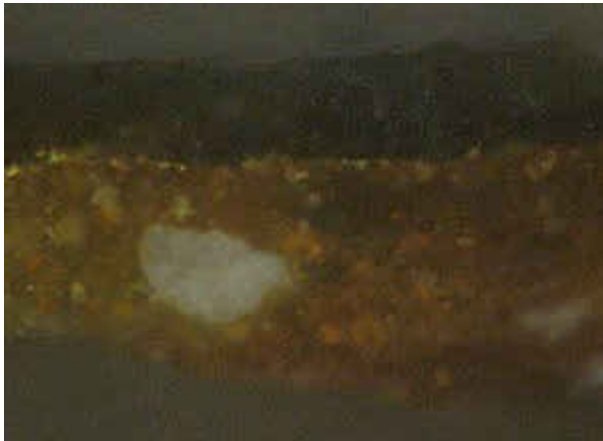
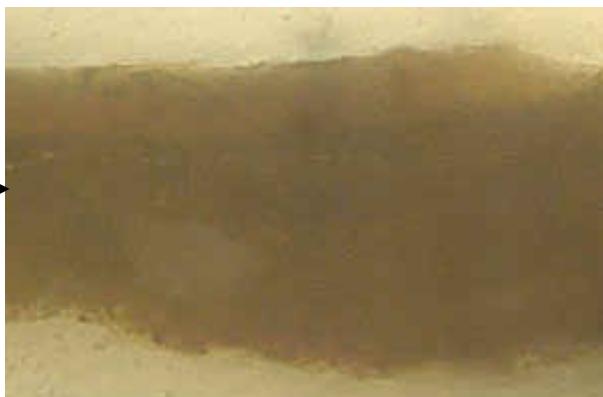
SAMPLE 23

Rood screen - nave

The same gilding layers as  
 in Sample 22, but with thick  
 varnish over the top

Lit from behind to  
 show the brown varnish

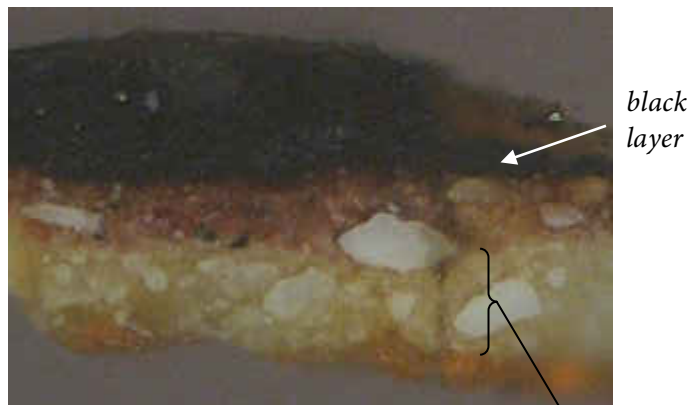
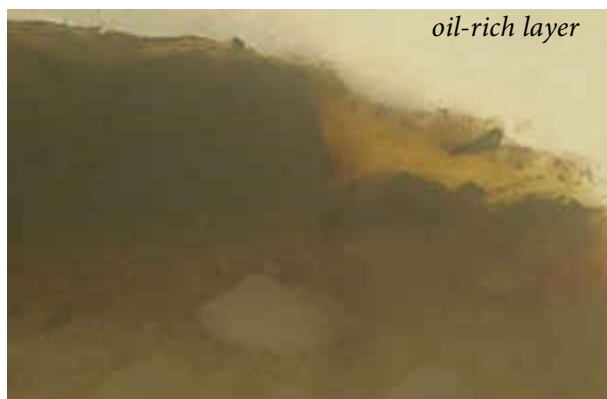
SAMPLE 25

On top of the usual red/brown ground is an oil-rich layer and then a reddish brown layer based on red iron oxide, lead white & a little black and finally a layer of pure black

Lit from behind to show the varnish

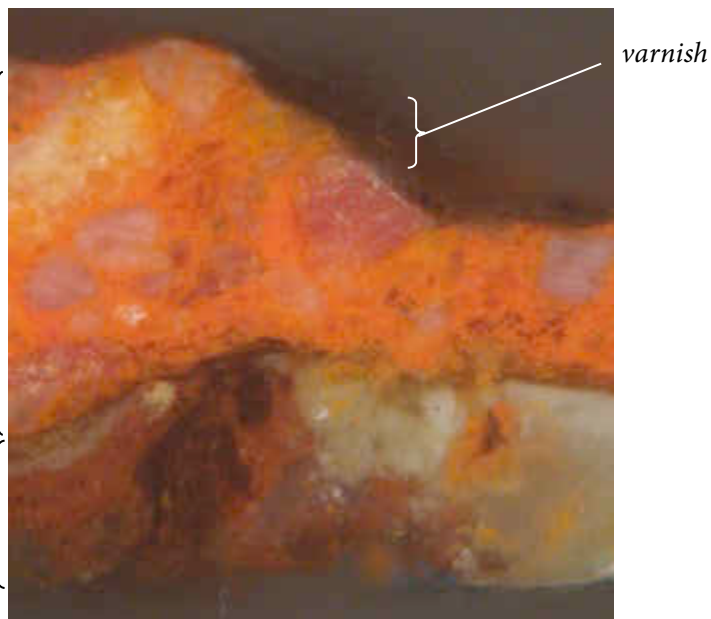
SAMPLE 26

Parclose - Lady Chapel/Chancel  
 Base of upright – red

*red lead re-paint*

*original white on red/brown ground*

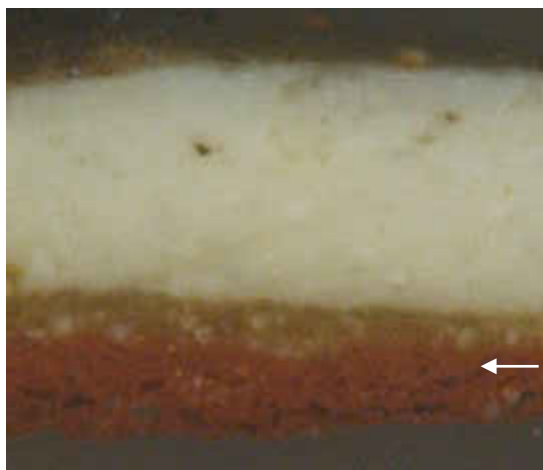
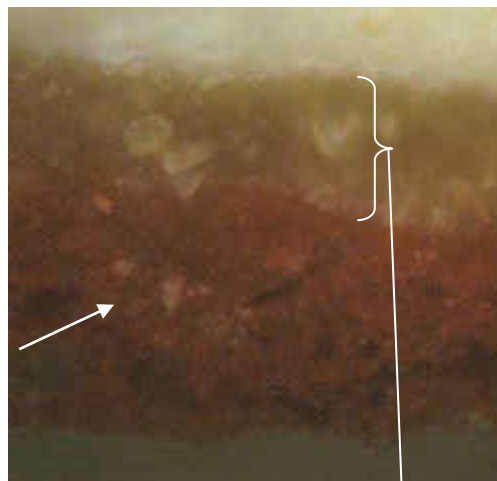
SAMPLE 27

*Detail of the ground and the 'sealing coat'*

*original  
red/brown  
ground*

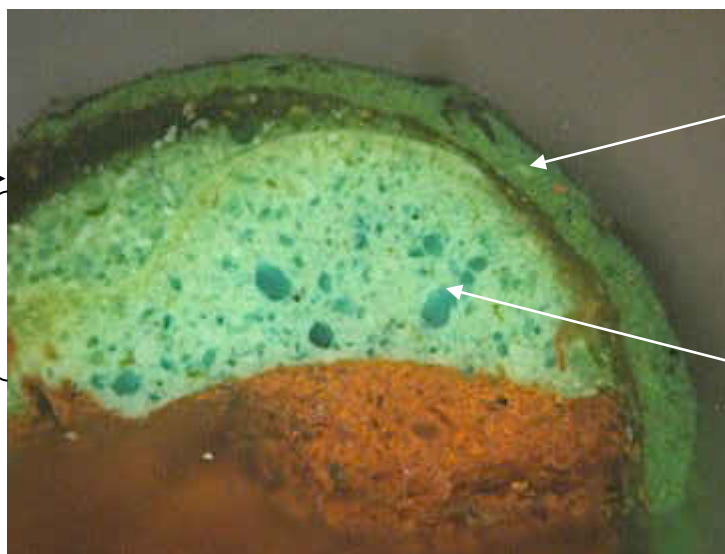
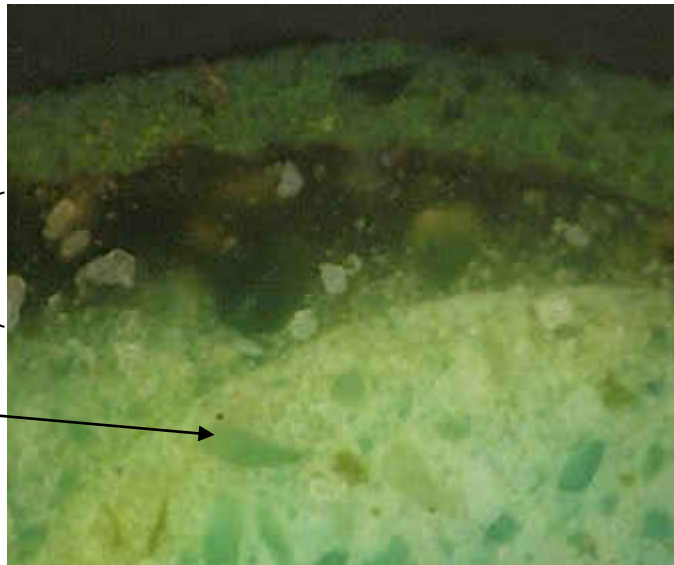
SAMPLE 32

*original dark  
green glaze*

*original light  
green undercoat*

*C19th or early  
C20th green*

*the 1<sup>st</sup> layer of  
original green  
contains  
globular  
particles of  
dissolved copper  
green*

*Original dark copper  
green glaze*

*upper layers of light  
green undercoats  
contain particles of  
verdigris*

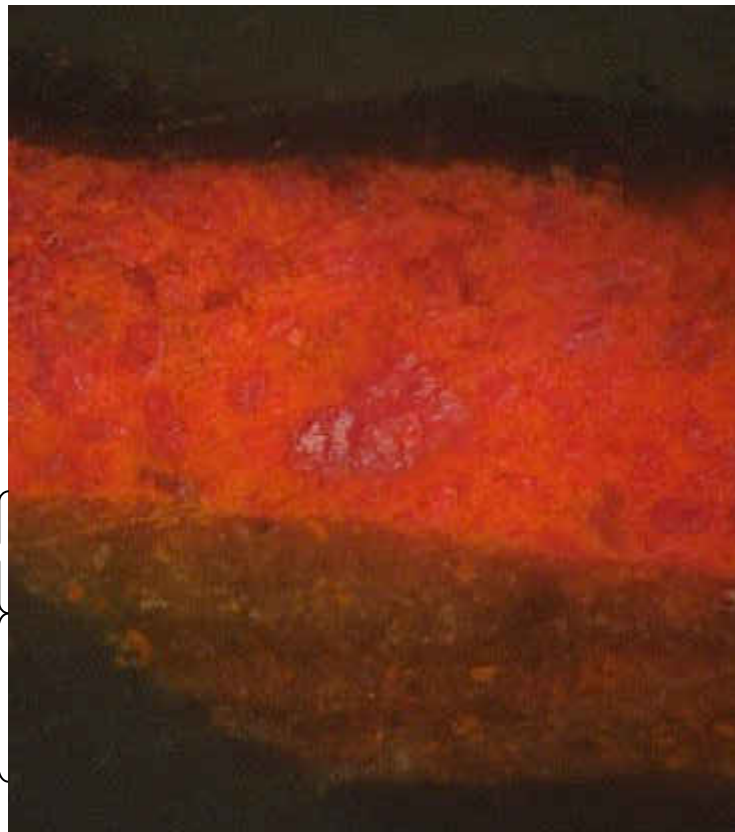
### SAMPLE 34

Pulpit in Nave  
 Chamfered inside  
 edge of stylised trefoil  
 on upper section - red

*oil-rich upper layer of  
ground, or 'sealing coat'*

*original red/brown  
ground*
